ECOLOGICAL REPORT
OXFORD FLOOD ALLEVIATION SCHEME
BAT SURVEYS

20th February 2018 V1A

Bat Surveys, Oxford Flood Alleviation Scheme

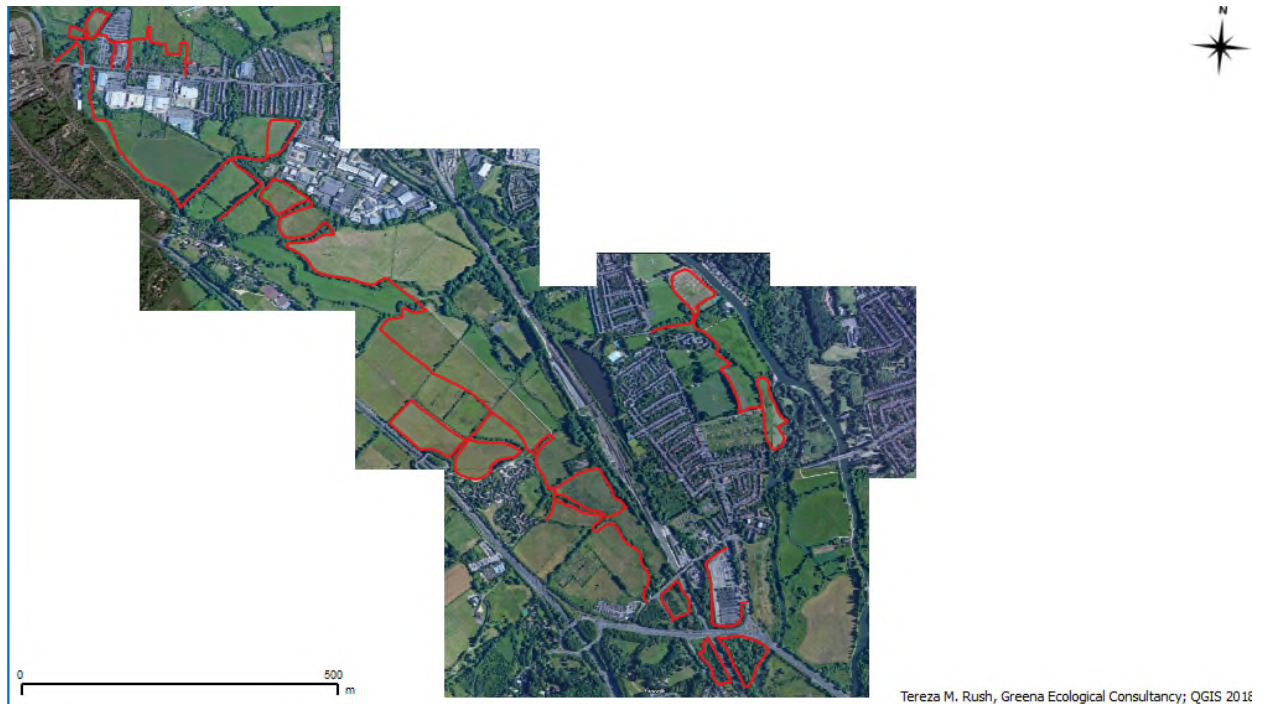
Figure 2 Transect route marked in red

Bat activity was monitored using BatBox Duet heterodyne bat detector together with Roland 09 recording device and Petterson D-1000. Weather conditions were suitable for bat emergence and foraging during each transect.

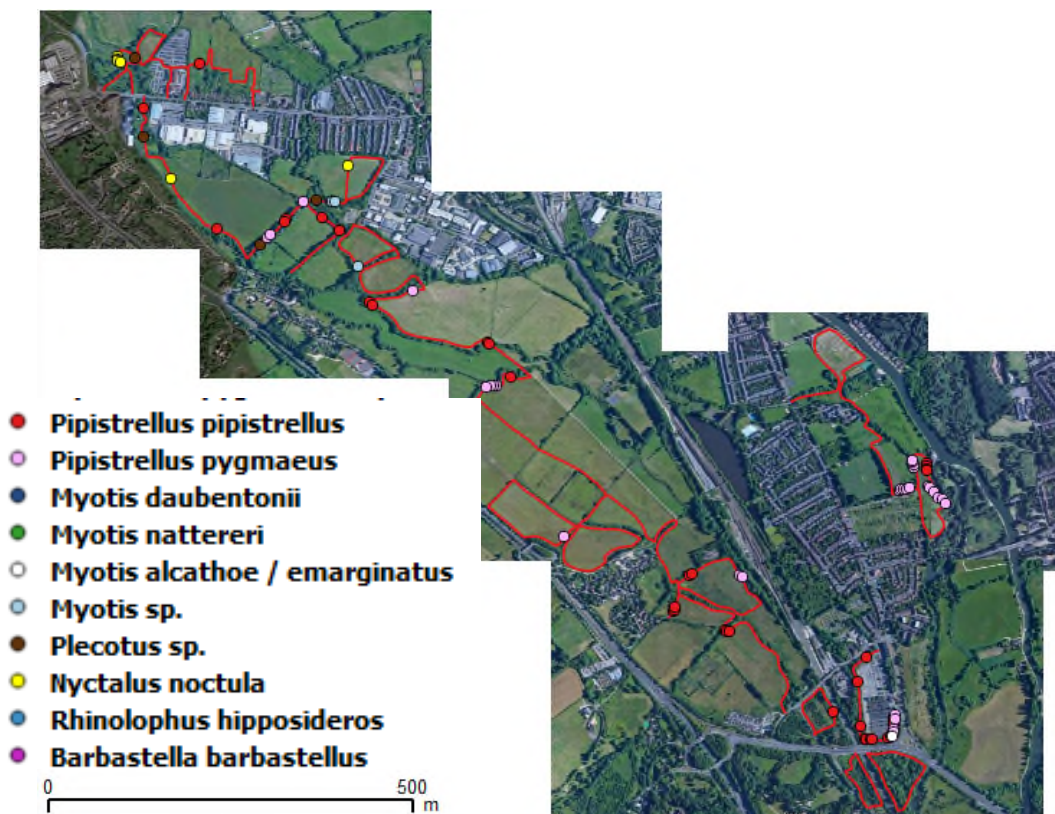
Figure 10 Results of the second August transect survey

Bat activity dropped dramatically during the second part of August. The number of recorded bat calls was 76, less than half of that recorded earlier in August. Common pipistrelles were represented by 45%, Soprano pipistrelles by 37%, Myotis bats only by 5% and the remaining calls belonged to Noctules, and Long-eared bats. Geoffroy's bat or Alcatthoe bat (the recording was not possible to identify accurately to species level) was recorded for the first time during the transect surveys in the second part of August. The results from this transect are shown in Figure 10.

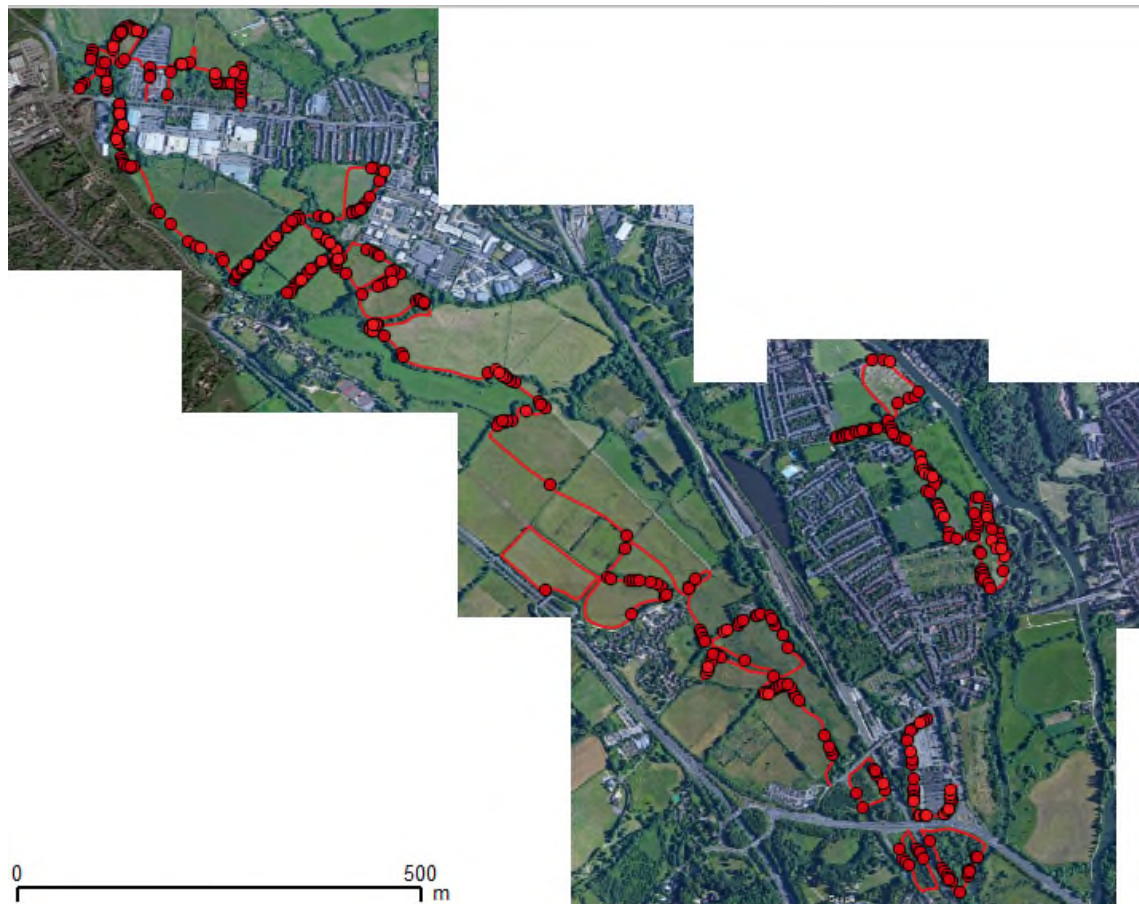
Figure 13 Combined results of bat transect surveys – Common pipistrelle throughout the season

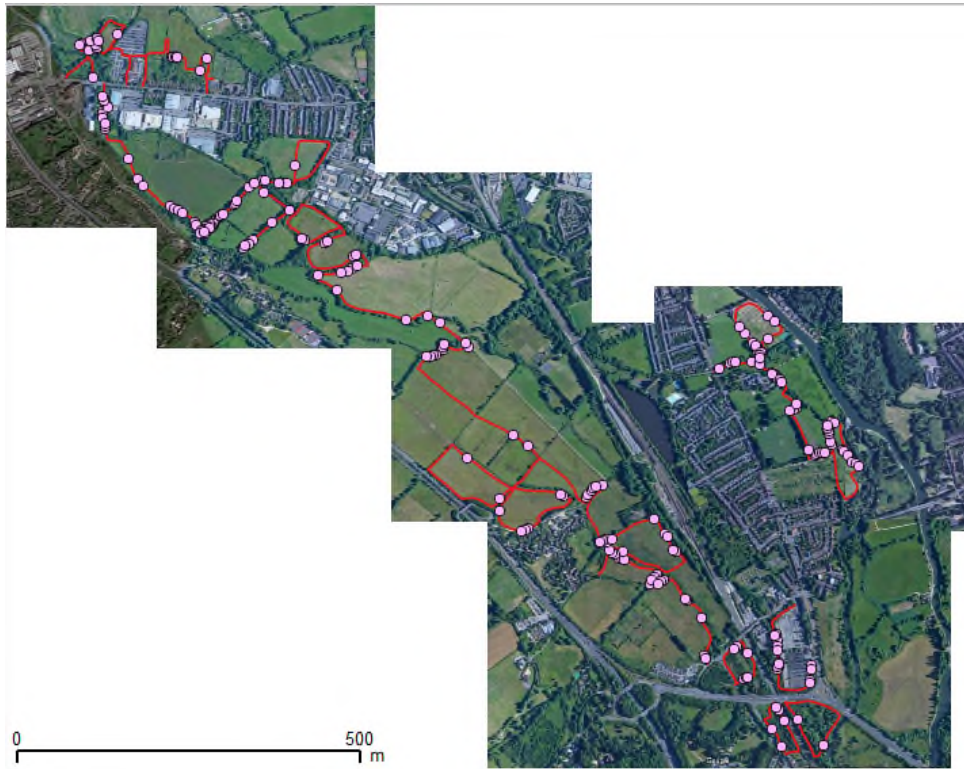
Figure 14 Combined results of bat transect surveys – Soprano pipistrelle throughout the season

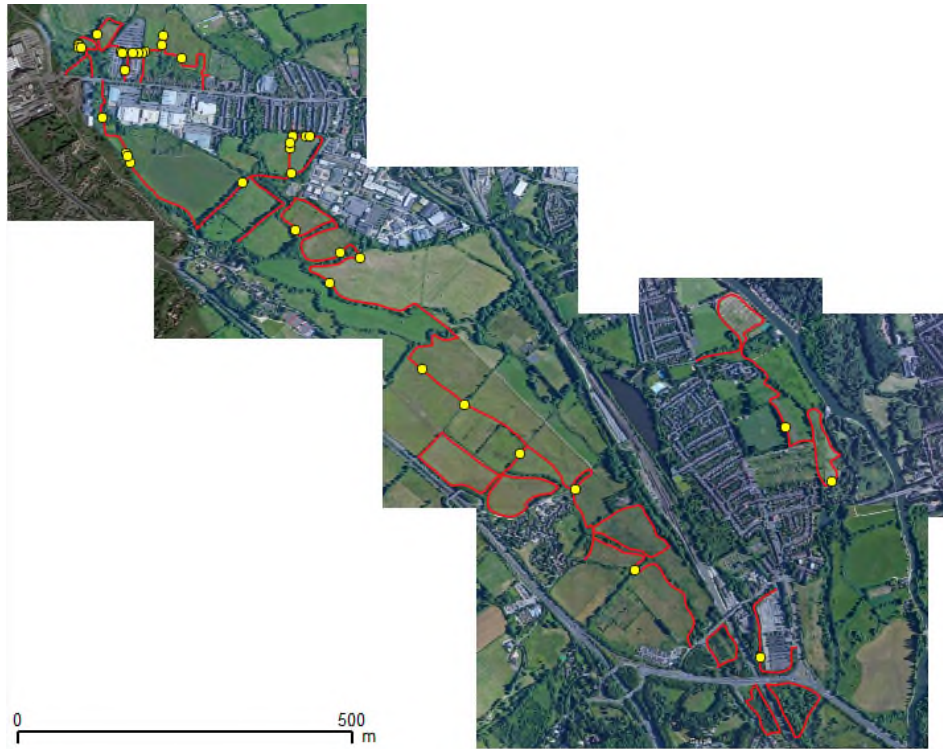
Figure 16 Combined results of bat transect surveys – Noctule bat - throughout the season
