Oxford Flood Alleviation Scheme

Otter Report 2020

Document No.: IMSE500177-CH2-XX-00-SU-EN-0731

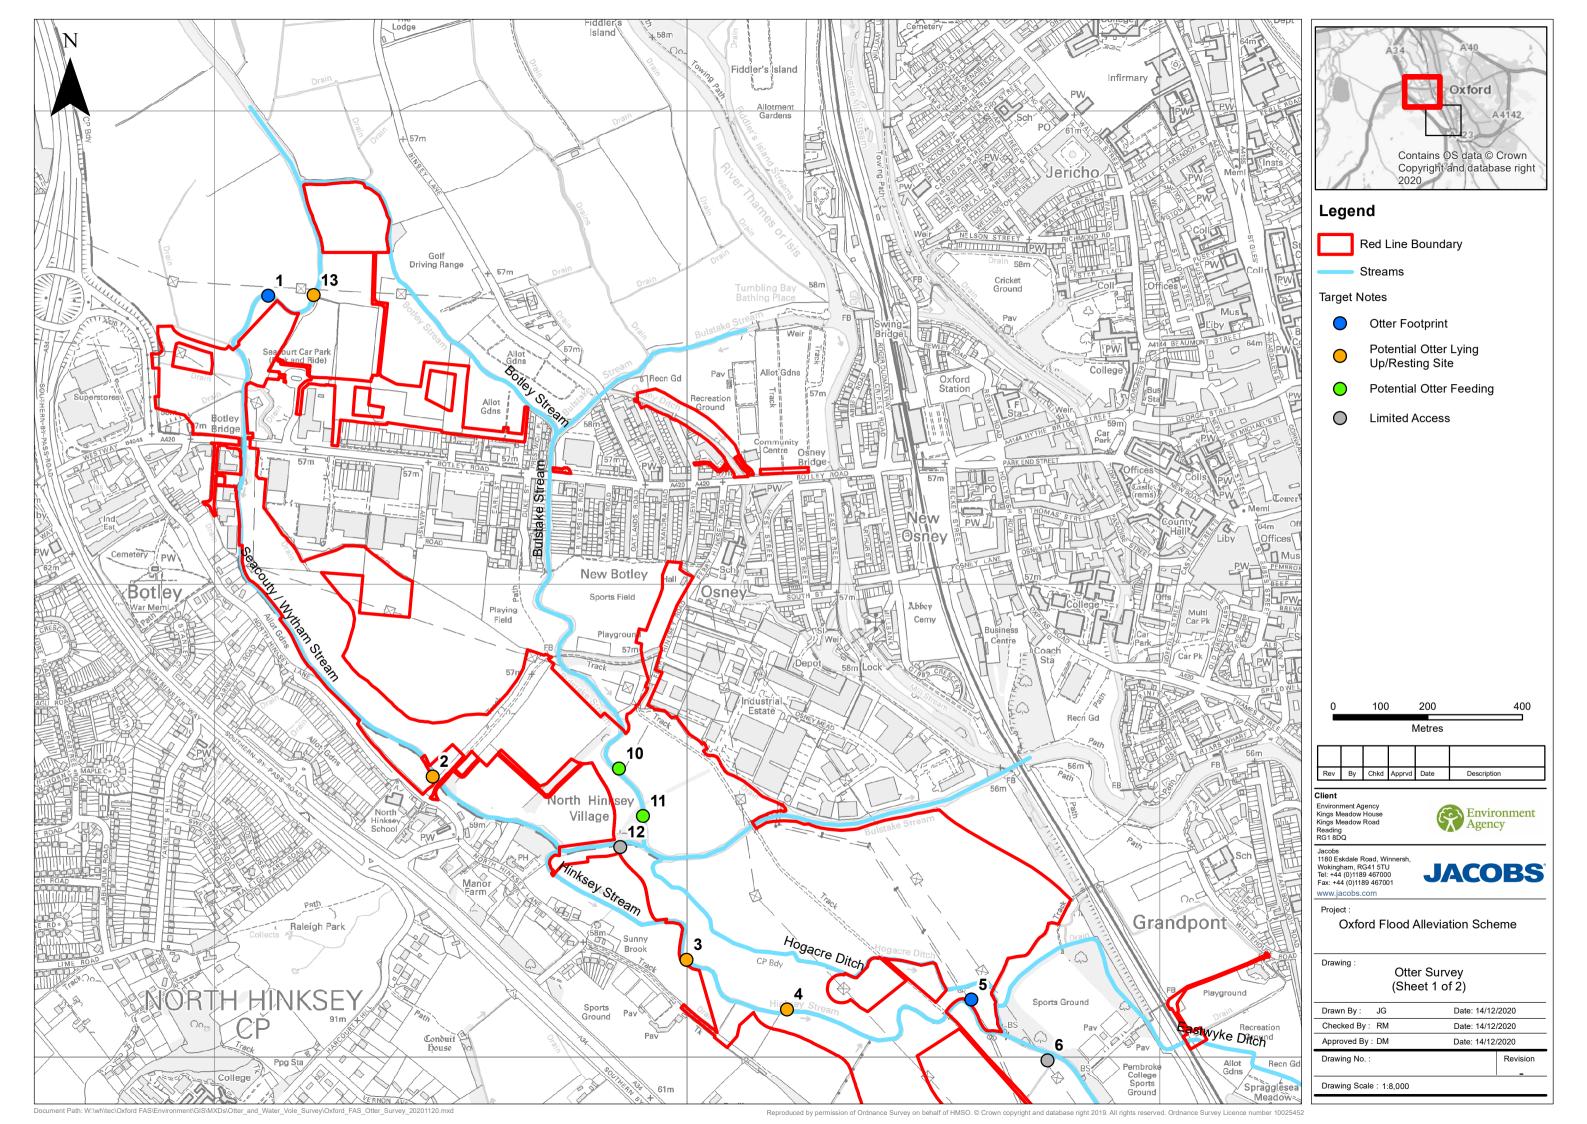
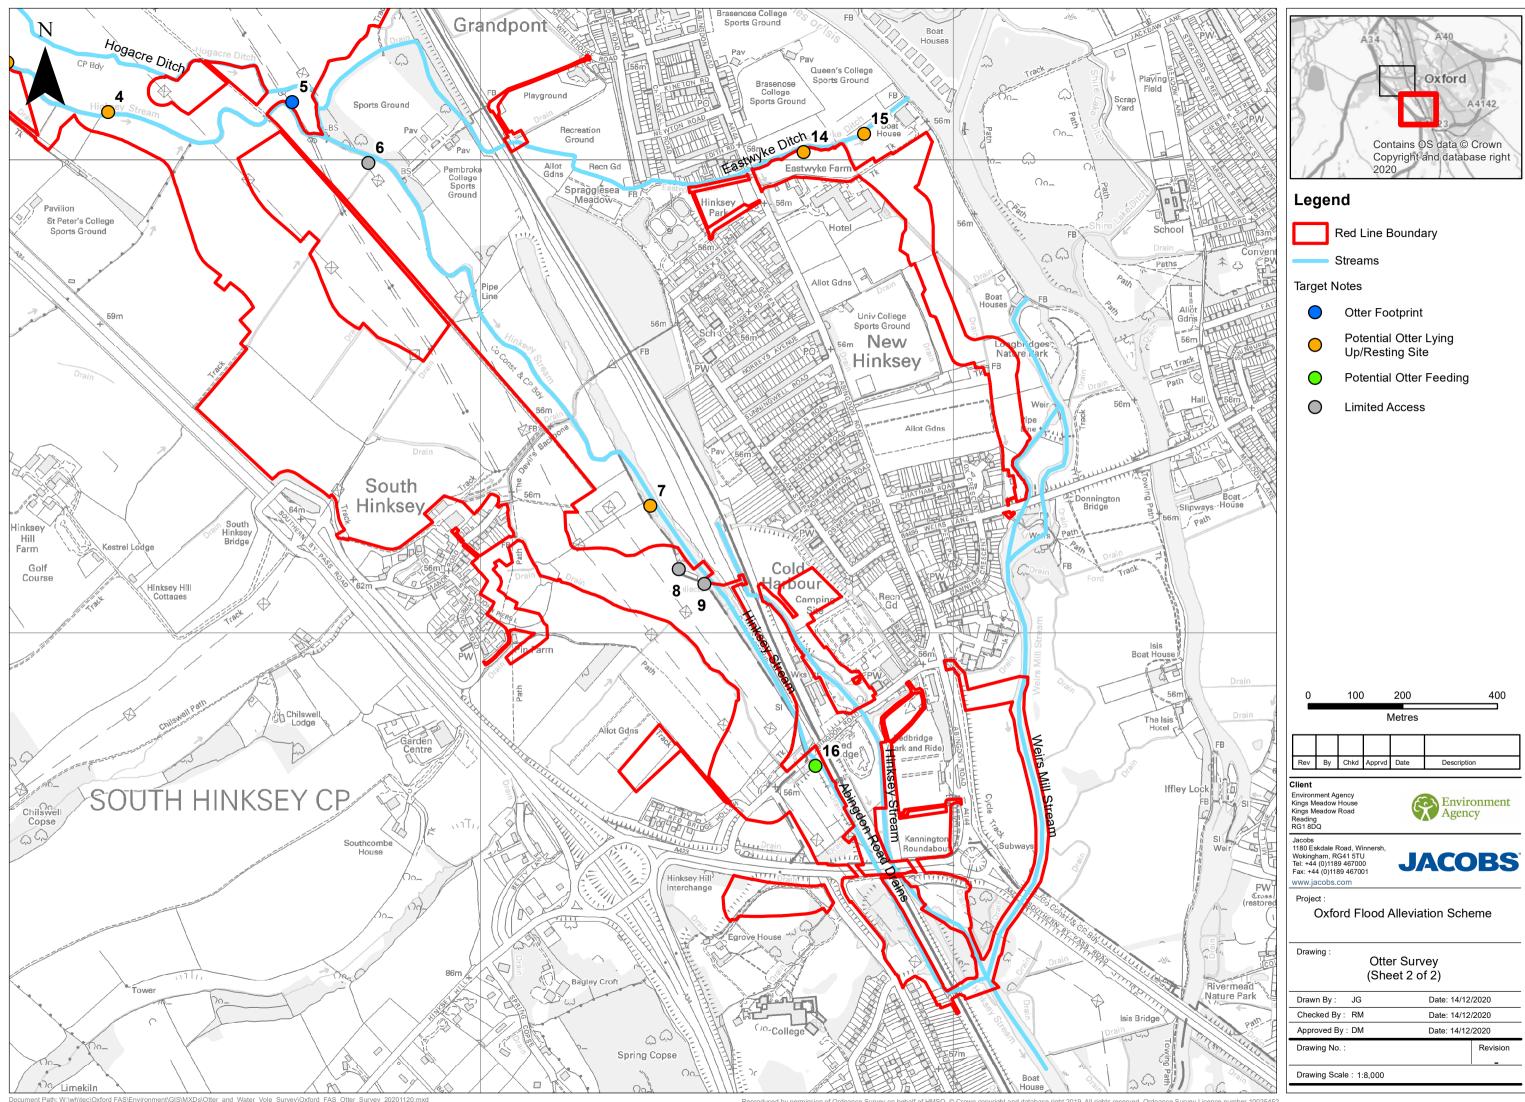
Appendix B. Survey Results and Target Note Locations

Low levels of otter activity were recorded throughout the study area during the survey but no confirmed resting sites were identified. Details of the otter habitat and field signs recorded are provided in Table 3.1 below, with Target Note descriptions appended in Appendix A and the survey area and Target Note locations shown in Appendix B.
