Oxford FAS River Habitat and River Corridor Surveys

Final Draft Report

January 2018

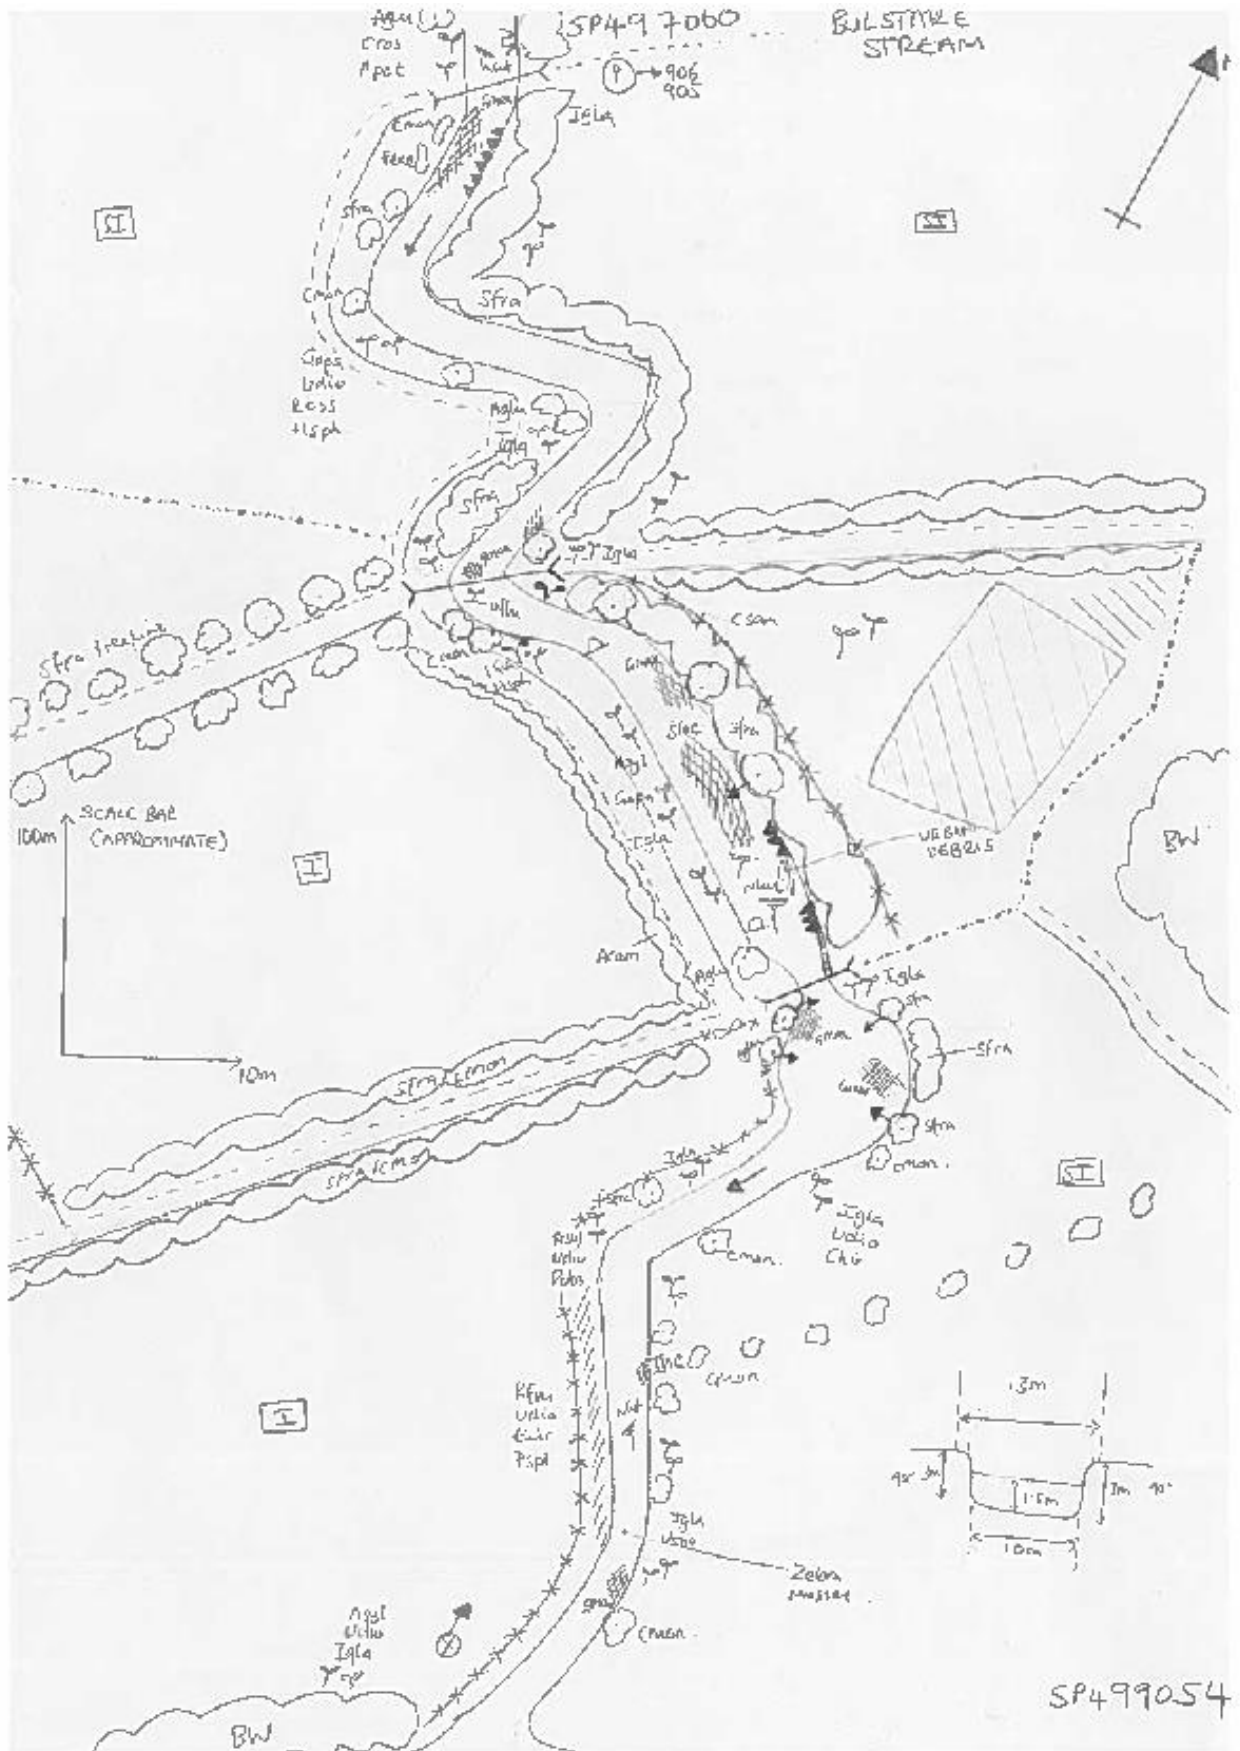
Figure 3-7: RCS Section 7 (SP497060 - SP499054)

Within the aquatic zone of Section 7, submerged Yellow Water-lily, Reed Sweet-grass beds, Club Rush beds and Yellow Iris were all present. One small stand of Water-dropwort *Oenanthe* sp. was noted. The invasive species Zebra Mussel *Dreissena polymorpha* was recorded within the channel. Urban debris in the form of tyres and general rubbish were recorded in the channel.

Numerous trees were present on the right bank including Ash, Field Maple *Acer campestre*, Crack-willow and Alder. Between the two footbridges, the Field Maple treeline was set back and the banks had a small berm. The understory vegetation was dominated by Himalayan Balsam and Common Nettle, Red Campion *Silene dioica*, Cleavers, Common Hogweed *Heracleum sphondylium*, Broad-leaved Dock and Burdock *Articum* sp., with occasional Great Willowherb.

The left bank zone was dominated by Crack-willow woodland initially, with occasional Alder and Dogwood *Cornus sanguinea* trees also present. Himalayan Balsam was dominant in the understory on the right bank. The right bank became less densely-vegetated after the second footbridge and ruderal vegetation cover included Common Nettle, Himalayan Balsam and Great Willowherb. The marginal zone was eroding in places with bare bank cliffs present as well as defunct wooden toe piling.

The adjacent land use was mainly grassland fields, with improved grassland to the right bank and semi-improved grassland fields, with some urban areas, adjacent to the left bank.

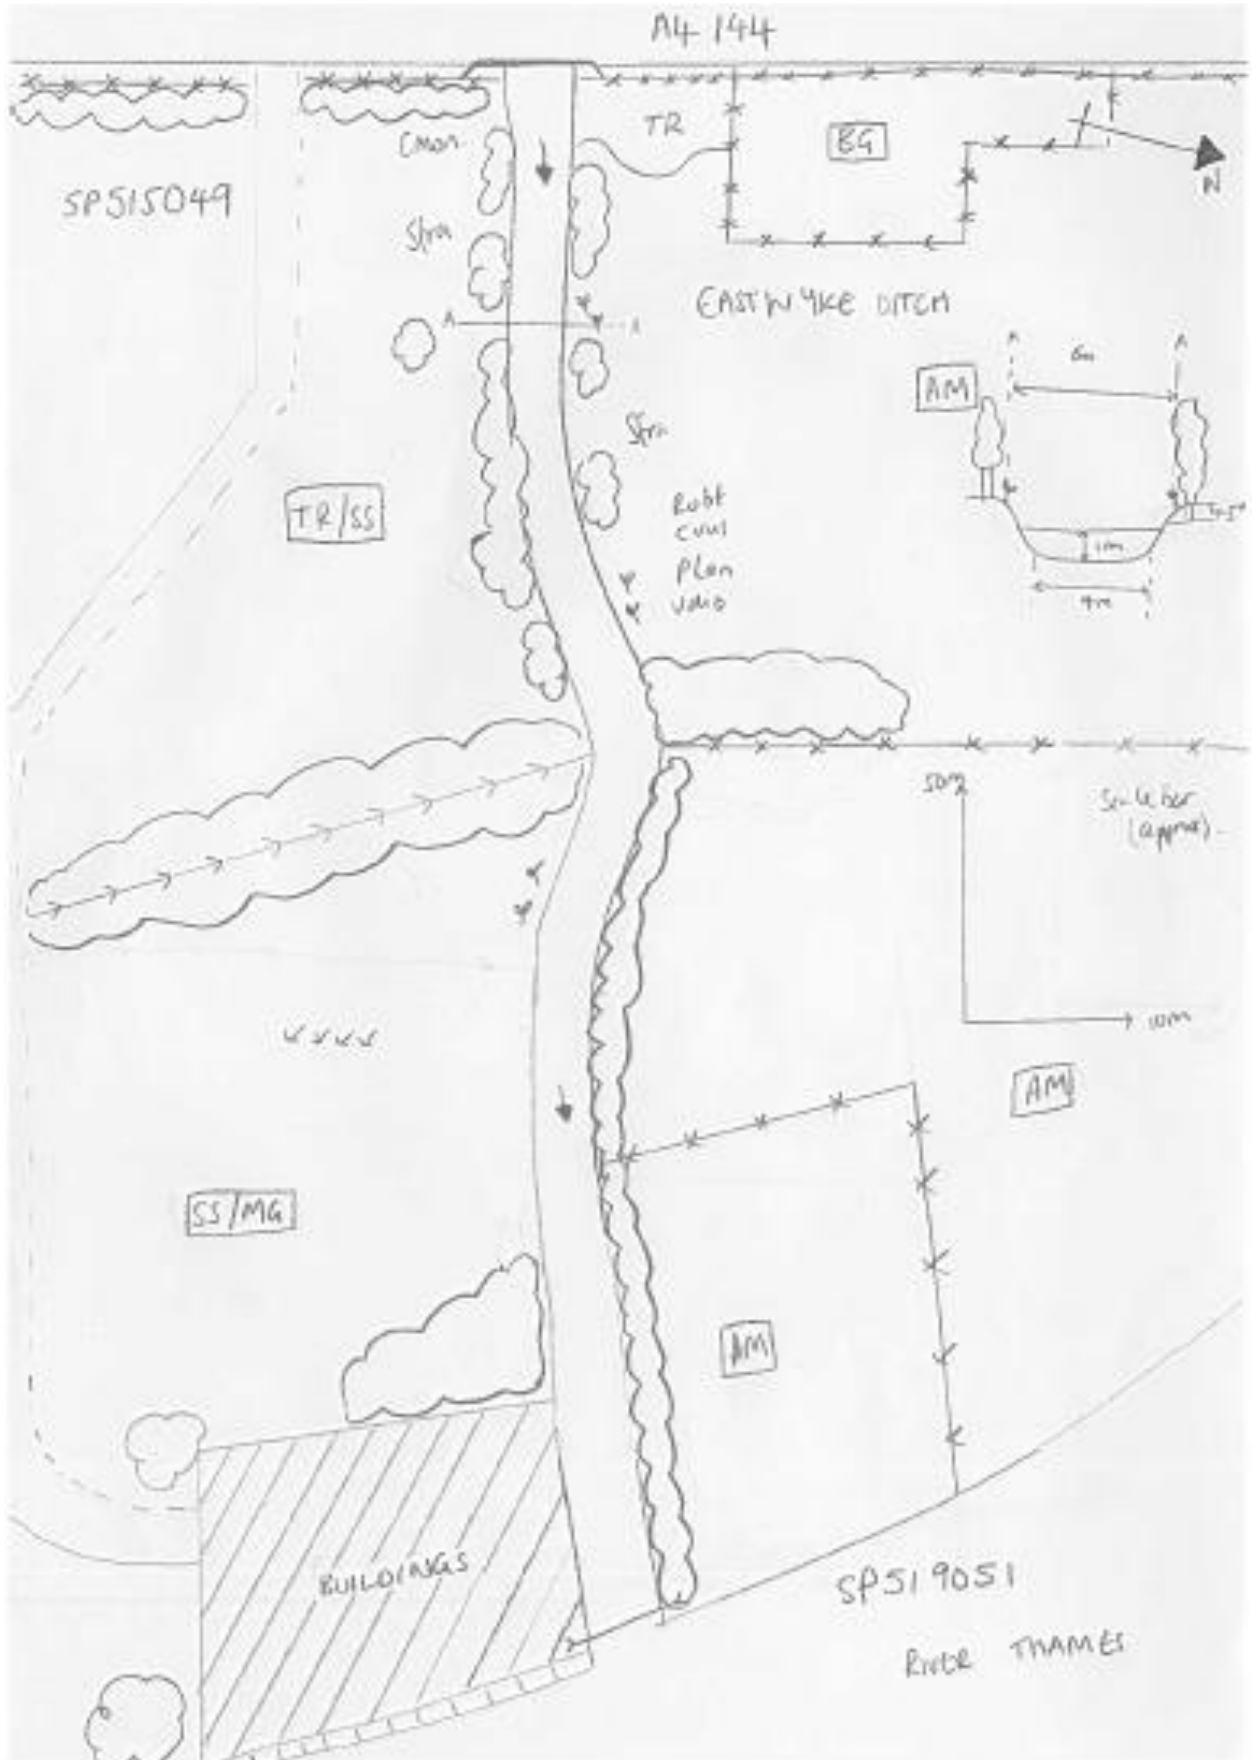
Figure 3-21: RCS Section 21 (SP515049 - SP519051)

Aquatic zone vegetation was limited in this section with occasional Reed Sweet-grass present along the bank margins. On the right bank top, Hawthorn and Crack-willow trees were recorded, with adjacent land use categorised as marshy grassland and tall ruderals, both with scattered scrub. The left bank was adjacent to two amenity grasslands. The first of which was managed to the bank top. Consequently, the riparian margin was small with Broad-leaved Dock, Common Nettle, Spear Thistle and Ribwort Plantain recorded. Within the second field, a dense treeline dominated by Crack-willow was present which overshadows the channel in places.
