Invasive Species Survey Oxford Flood Alleviation Scheme

2020 Update Survey

July 2020

For: **Jacobs**

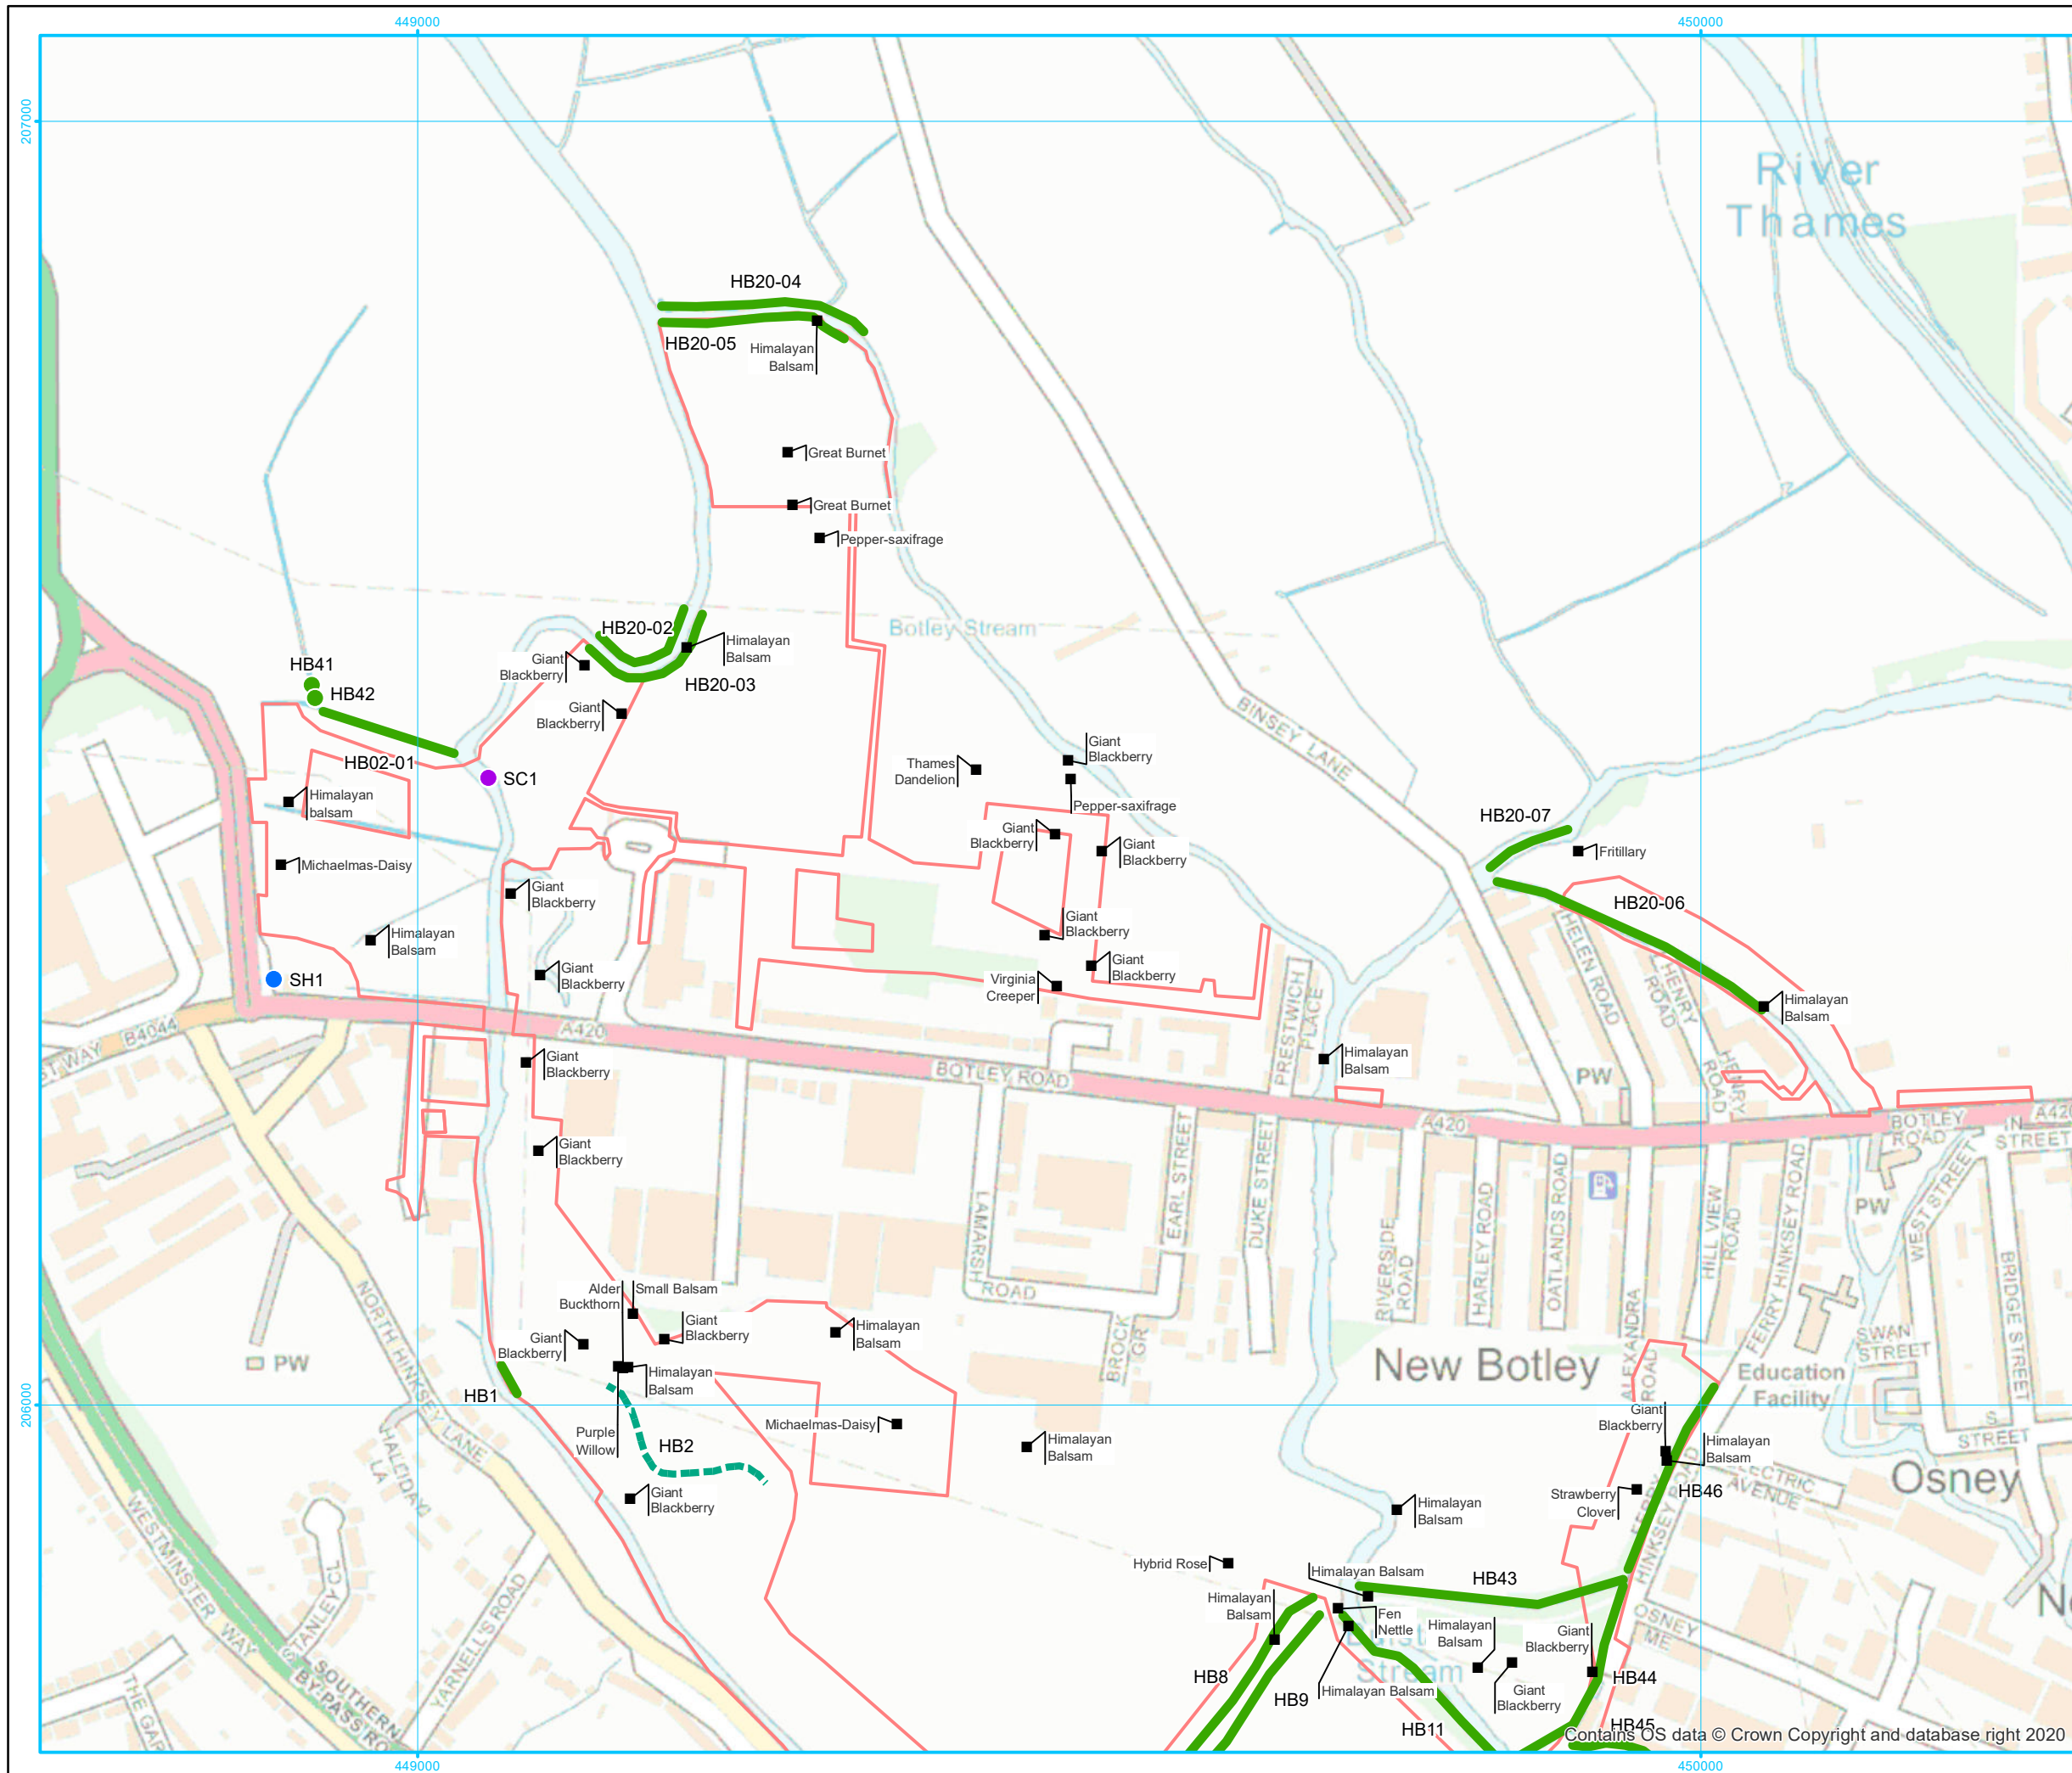
Title: **Appendix 1a: Invasive Species**

- 3.4 The majority of balsam stands were associated with water bodies or ditch channels. The main infestation was still recorded in Hinksey Meadows (Appendix 1.1), east of North Hinksey Village. However, stands had increased across much of the survey area. This species had colonised much of the stream banks, specifically where the bank was fenced, which had restricted grazing and cutting. These stands extended outside of the red line areas, being observed throughout all water bodies within the meadows.

- 3.8 A number of sites have had eradication treatments applied, with varying levels of success. A small ditch section in Hinksey Meadows (Appendix 1.1 – HB2), seem to be eradicated. However, other sections of river, which have been identified as being treated (Appendix 1.2 – HB15), has not been affected (Photo 3).

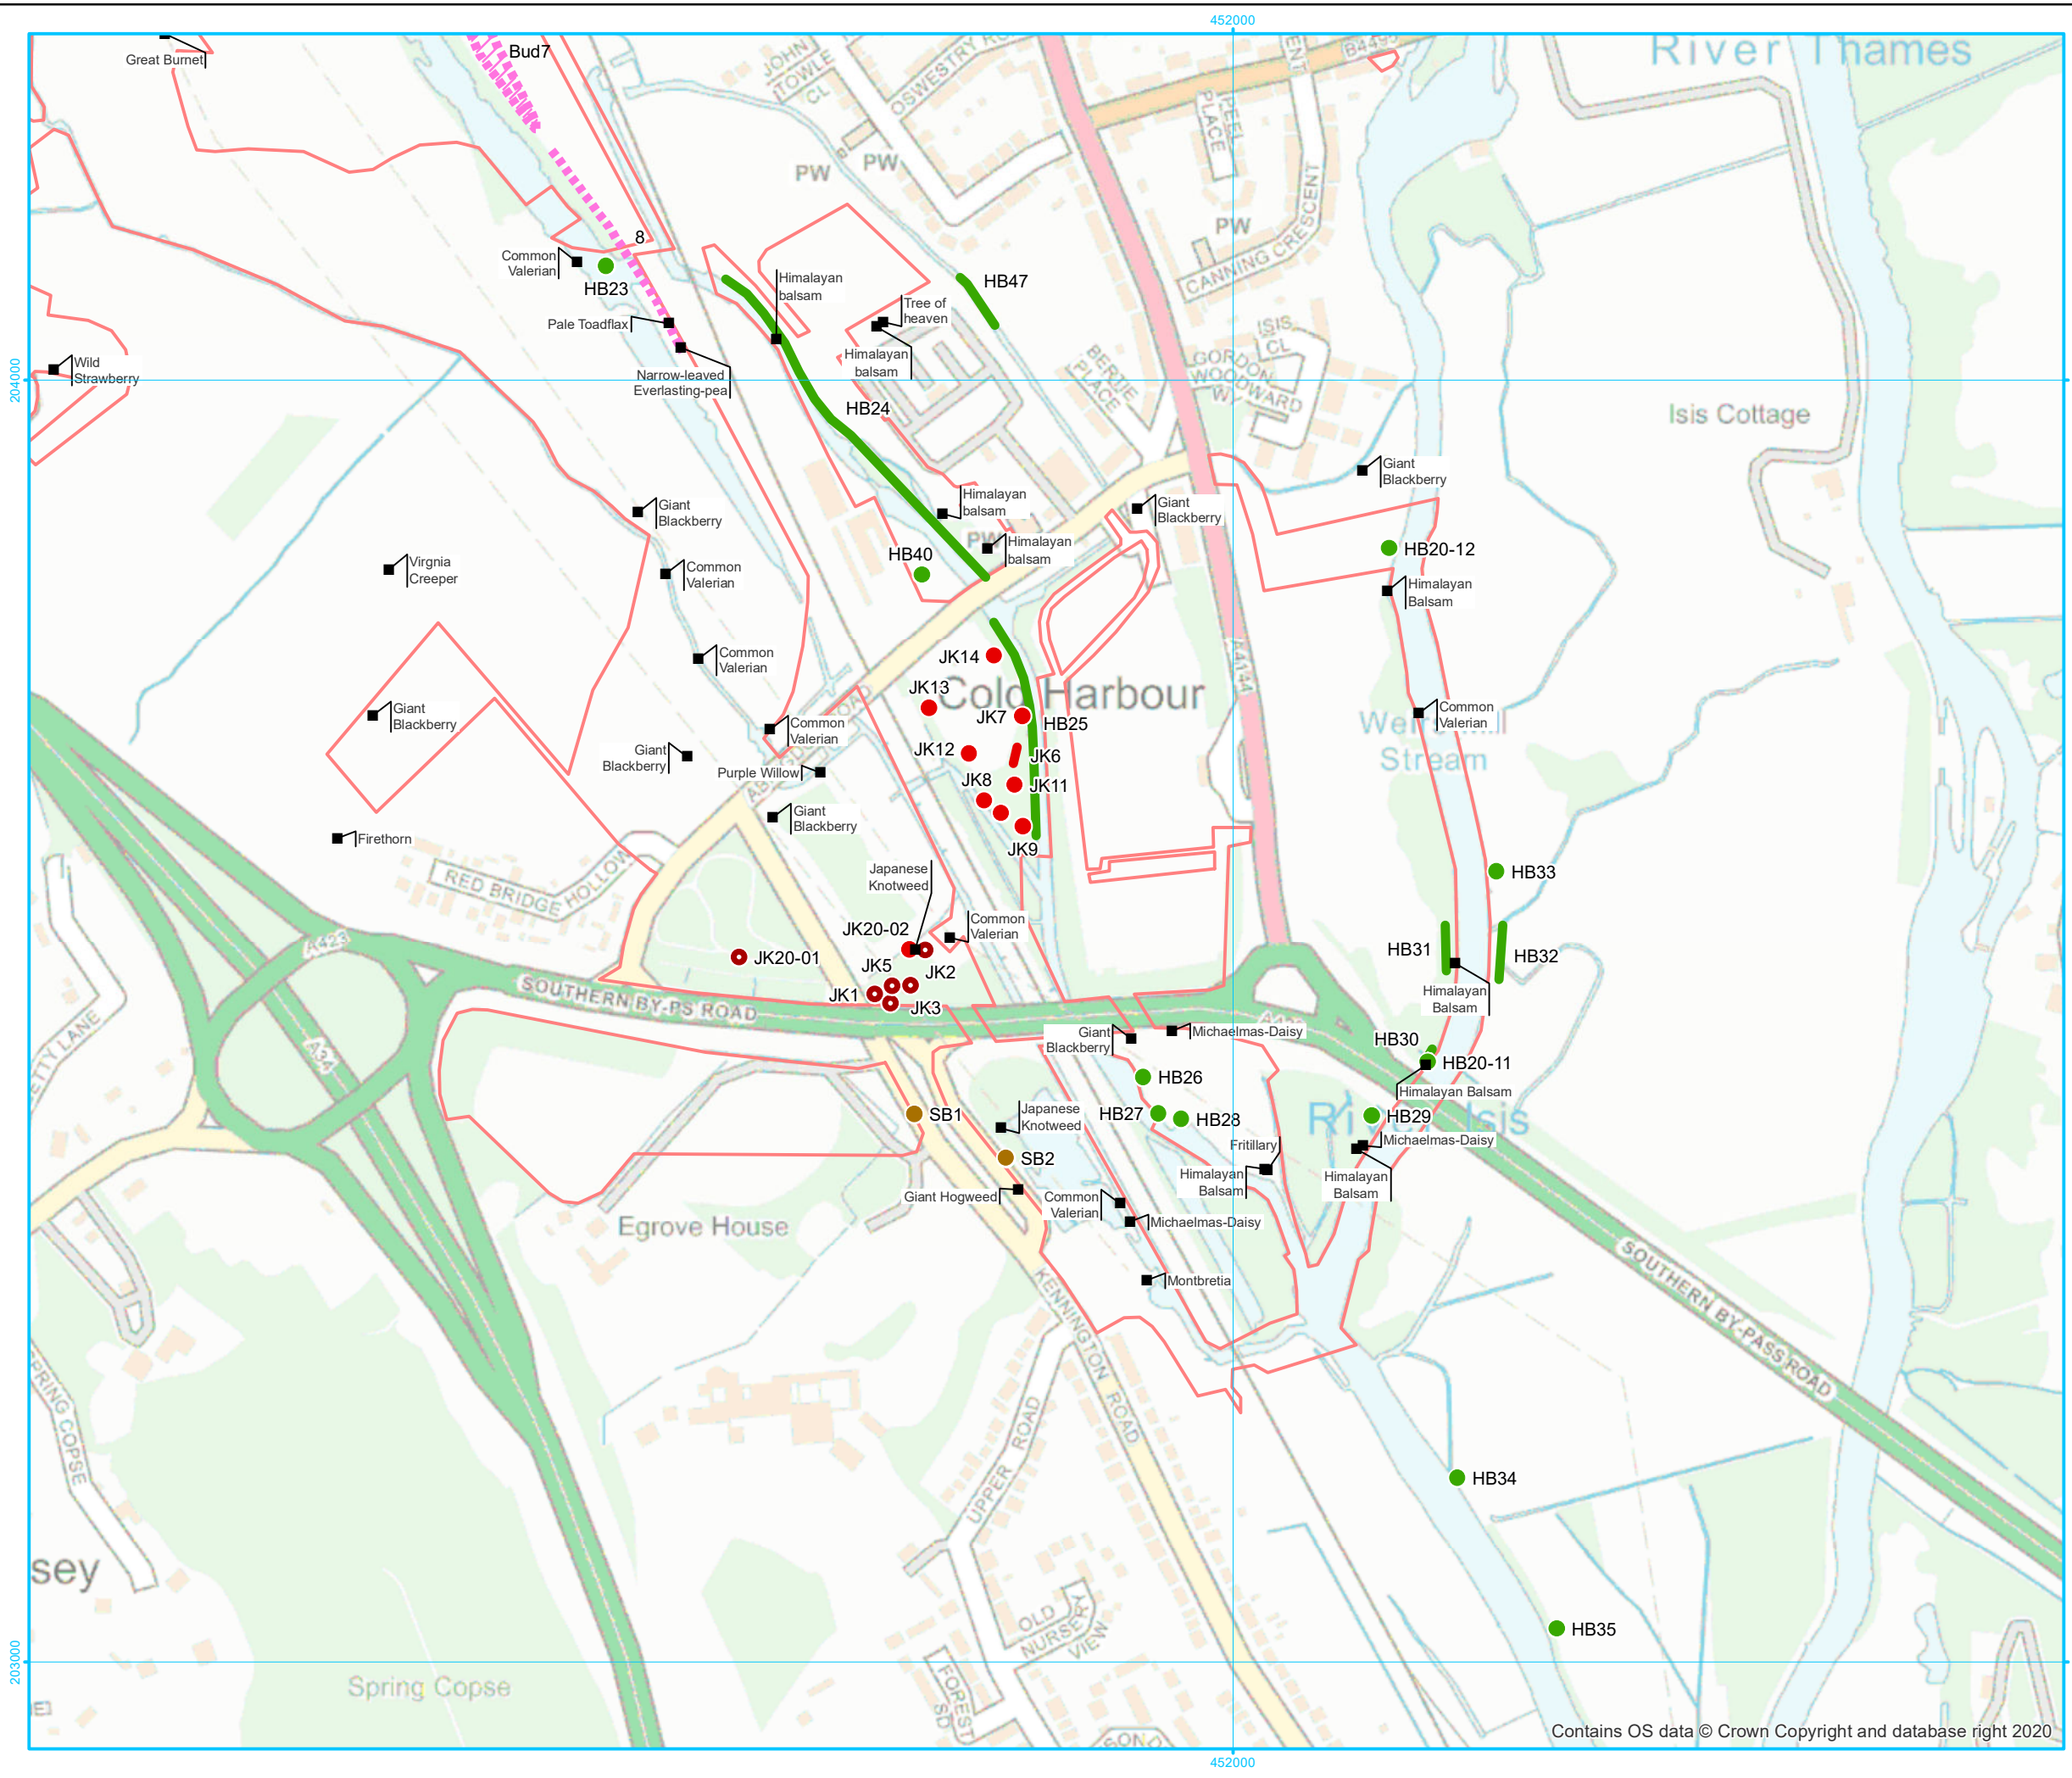
Title: **Appendix 1c: Invasive Species**

- 3.9 All knotweed stands were recorded within the southern extent of the proposed works. Additional stands have been identified with the 2020 expansion of the survey area, Abingdon Road and the Southern By-Pass (Appendix 1.5). The proximity of all stands, clustered between these two main roads would suggest a common point of colonisation.
- 3.10 The areas of knotweed which were accessible within Kendall Copse on both sides of Kennington Road, showed signs of systematic treatment (Photo 4). It is unclear if this is an on-going programme of eradication, although all stands seem to have been treated.
- 3.11 With no access via the Recycling Centre it is not known if this has been included within the treatment programme. It should be assumed that this species is still present in the area.

- 3.16 Stands of this plant were still present in the area, either side of the Southern By-Pass slipway (Appendix 1.5). These were both large stands dominating their position, outcompeting the surrounding plant communities. SB2 was found within a wooded section of the embankment.

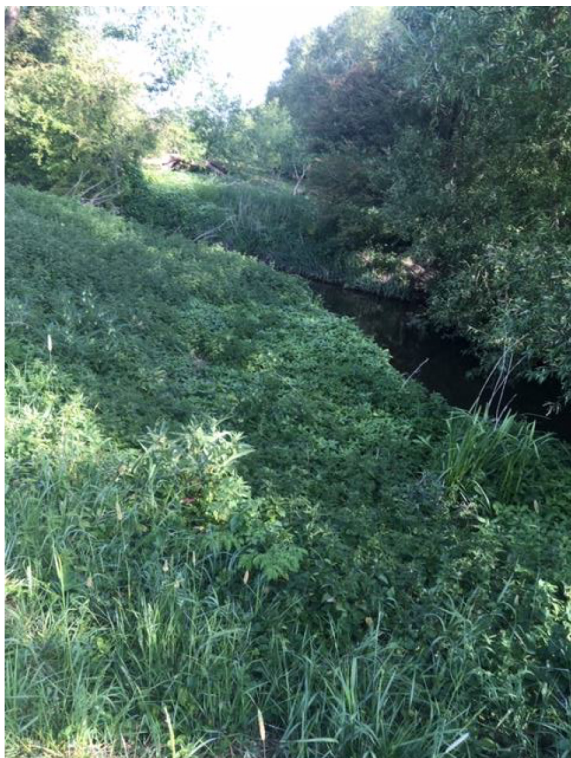
Photo 1: New area of Himalayan balsam to the north of Botley Road (Appendix 1.1). Species spread along both banks.

- 3.7 Smaller isolated clumps were recorded throughout the survey areas. Many of these have again expanded which have not been restricted by woodland and scrub which dominated those sections. Additional areas added to the 2020 survey all recorded some incidences of this species (Photo 1 & 2), particularly the water channels.

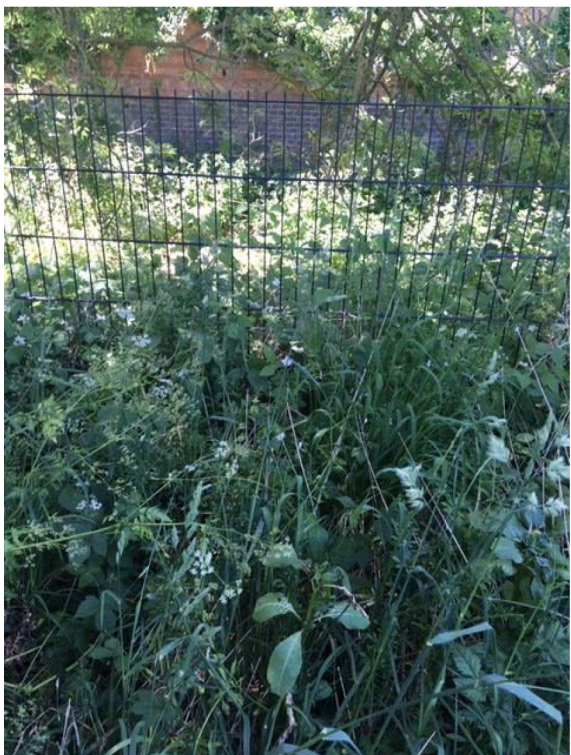
Photo 2: Himalayan balsam along channel adjacent to Botley Park (Appendix 1.1).

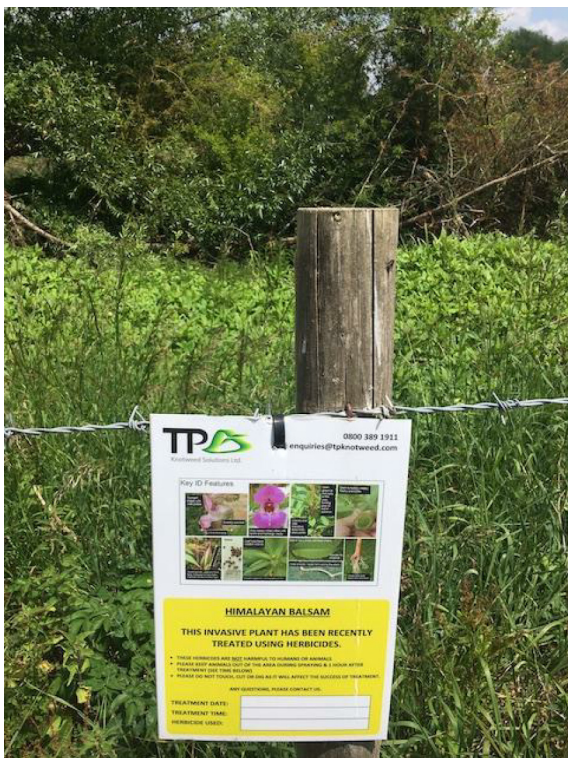
Photo 3: Signage adjacent to Himalayan balsam stands close to North Hinksey village, where treatments has not impacted the stand.

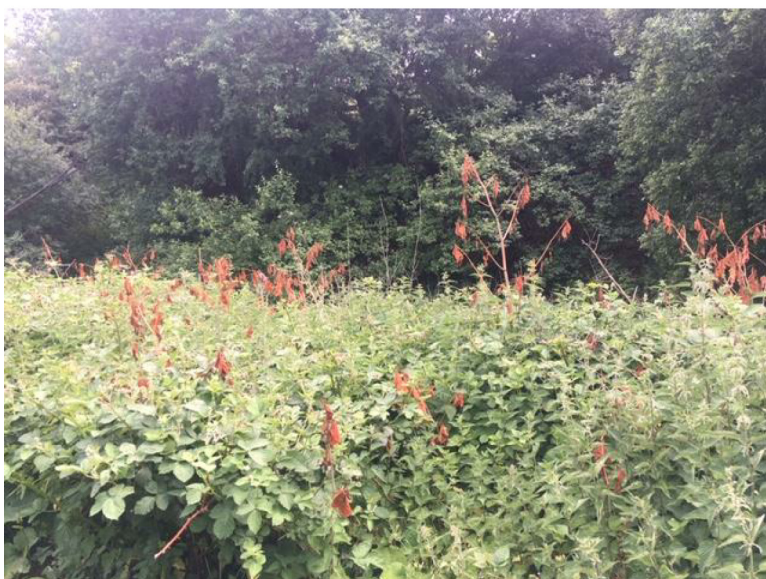
Photo 4: Japanese knotweed within Kendall copse (west of Kennington Road), show eradication treatments.

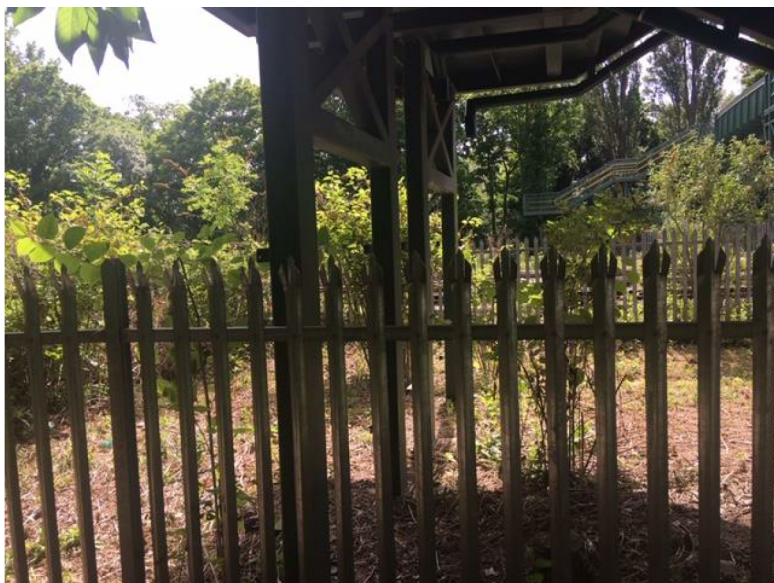
Photo 5: Japanese knotweed within rail foot bridge.

- 3.12 The stands of this species identified in the 2017 survey, were still present and associated with the rail line north of New Hinksey (Photo 5). No treatments seem to have been applied.

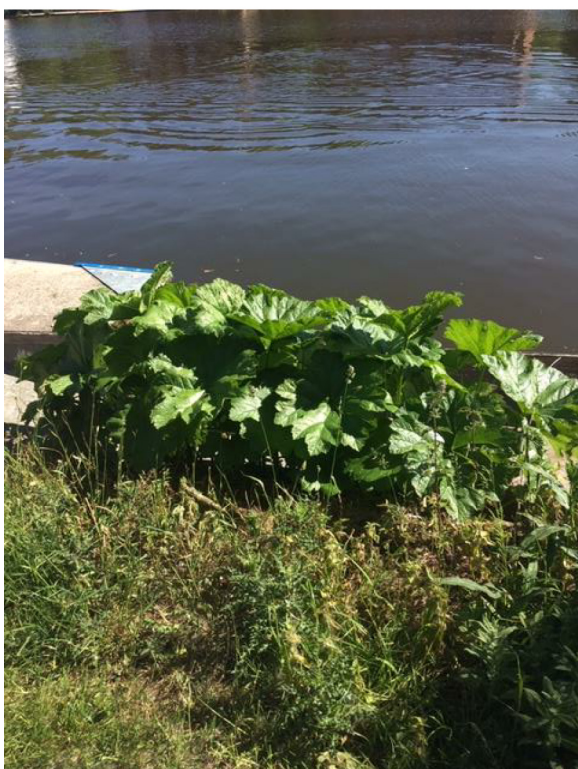
Photo 6: Gunnera species on tow path River Thames, adjacent to survey area.

- 3.14 A small stand of this species was found on the main River Thames (Photo 6), north of New Hinksey (Appendix 1.3). Although this was not technically within the red line boundary, the section of tow path was walked as part of the site surveys.
