## **Oxford Flood Alleviation Scheme Phase 2 Appendix 12 Additional Information**

## **4 BOTLEY MILL, BOTLEY ROAD (HER REF. PRN D6398)**

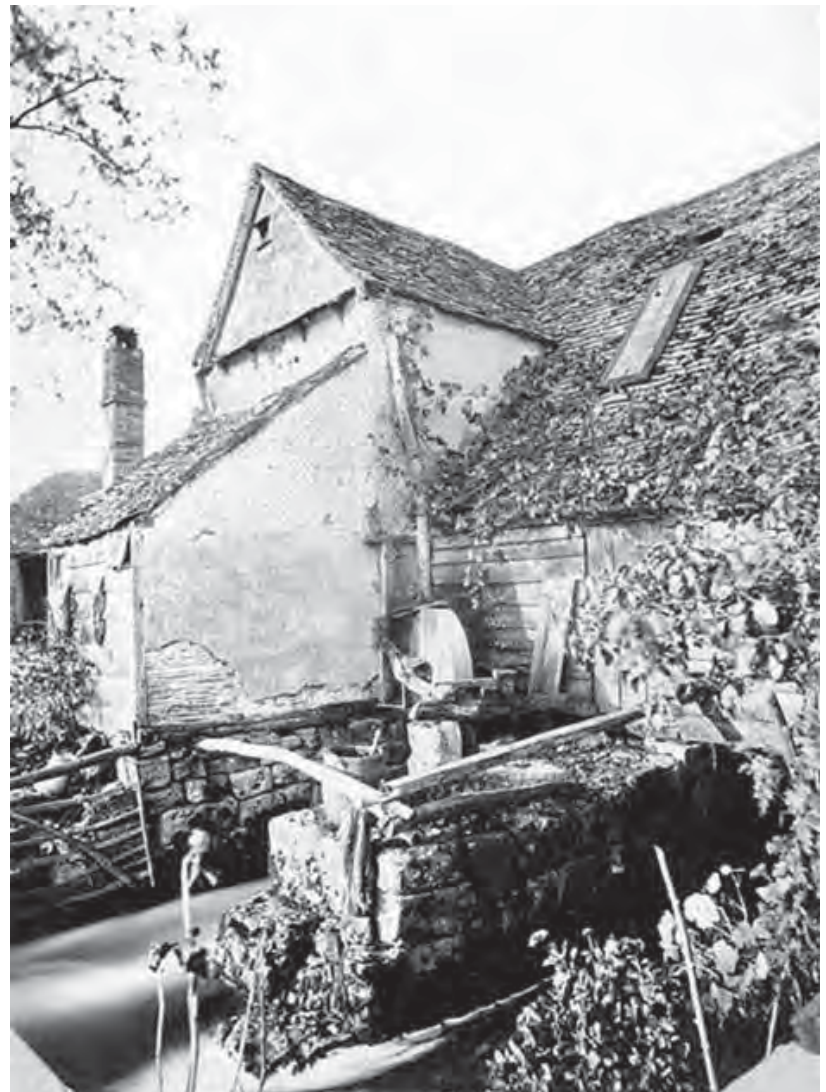
Figure 40: Botley Mill in a state of some disrepair, showing the mill stream and a large whetstone in the foreground, 1875 (Ref. HT1815)

- 4.8.6 Several photos of the mill exist from the period when the mill was owned and operated by the Hunt family. A photo of 1875 from the Taunt Collection shows the building in a state of some disrepair (Figure 40). The mill stream and a large whetstone can be seen in the foreground, and a wattle and daub structure abutting the building is also evident. Another photo from the Taunt Collection, dating to 1885, suggests that some renovation had occurred from 10 years earlier, as the roof appears to be in a better condition and there is less foliage (Figure 41). Stone revetments can be seen in the foreground on the north side of the mill-pond and water is clearly flowing into the pond from the tail race from an open section between the revetments.

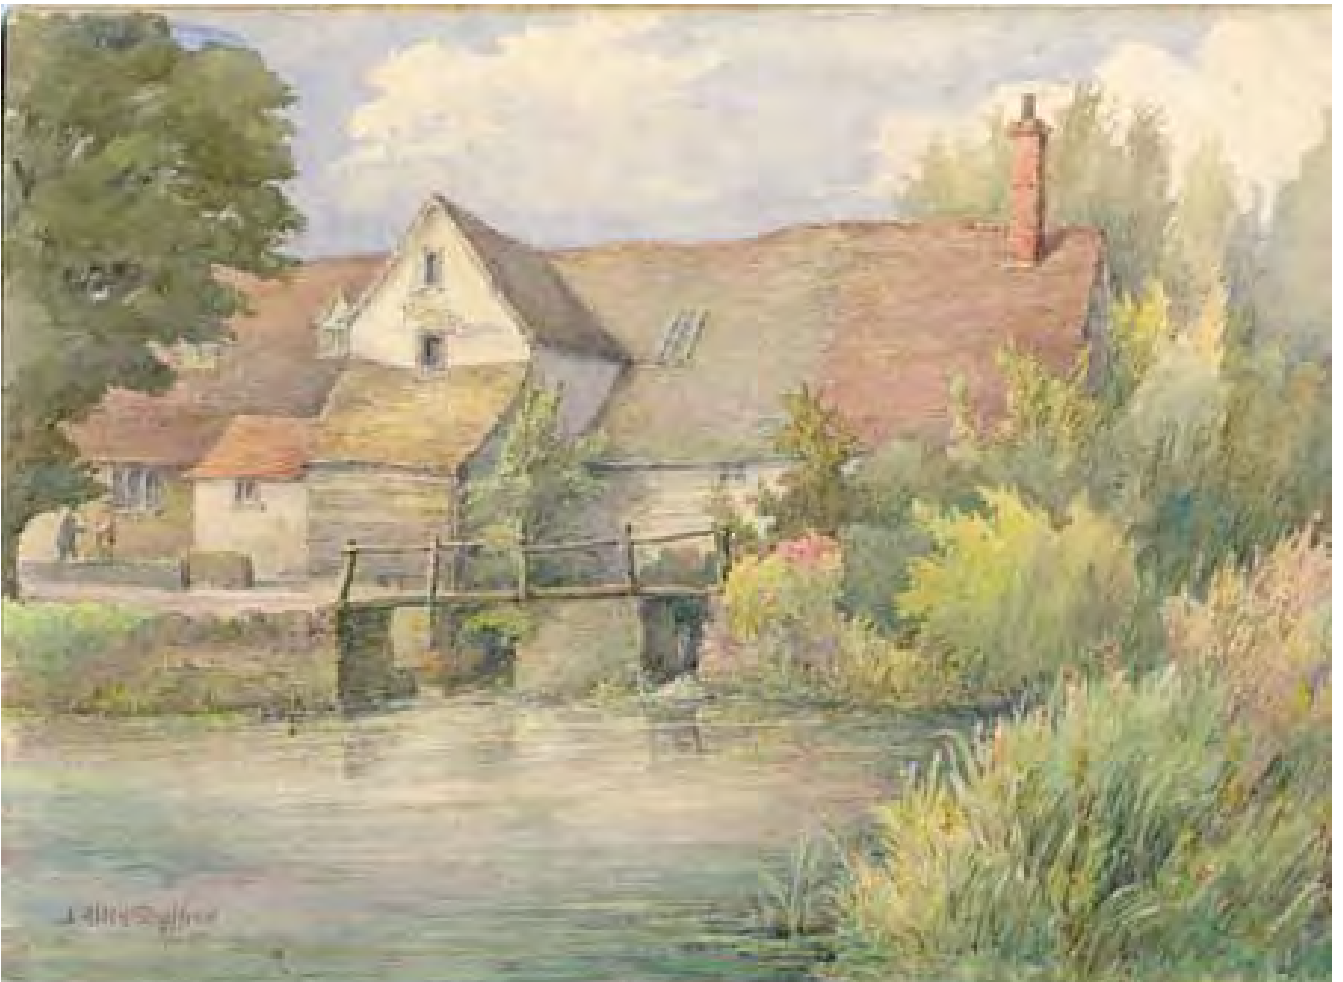
Figure 41: South side of Botley Mill from the pond with three mill-workers, 1885 (Ref. HT1885)

- 4.7.5 No evidence was seen on the walkover for stone revetments which defined the leat to the north of Botley Road and the mill pond to the south of the mill. These stone revetments can be seen along the western mill bank in the 1924 photograph (Figure 43) and on the 1885 photograph around the mill pond (Figure 41). It is possible that during the medieval period there may have been wooden revetments defining the watercourses associated with the mill. It is possible that wooden or stone revetments may survive under the ground surface within the wider environs around the mill site.

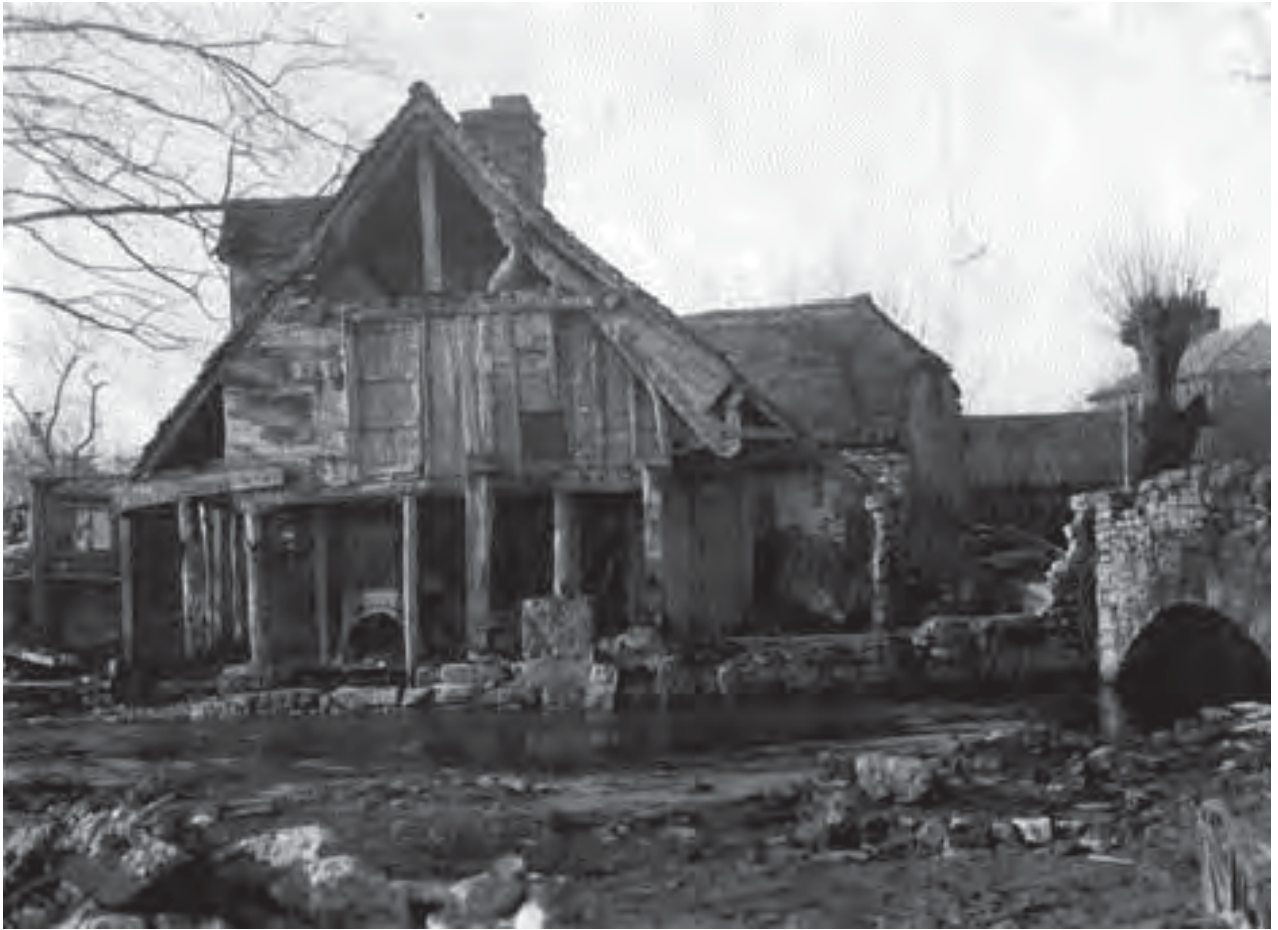
Figure 43: Botley Mill partly demolished during Botley Road widening, 1924 (D262792a)

- 4.8.7 The final three historic photographs of the mill, when its east half had been demolished in 1924 (Figures 44-46) show the building without an end wall, and a timber-framed structure of the mill itself that had stood above the mill race (perhaps of 17th-century date). The western part of the building was a stone single-storey building with dormer windows, and this seems to have been left standing at least into the 1930s as it is still shown on the OS map of 1938 (Figure 37).

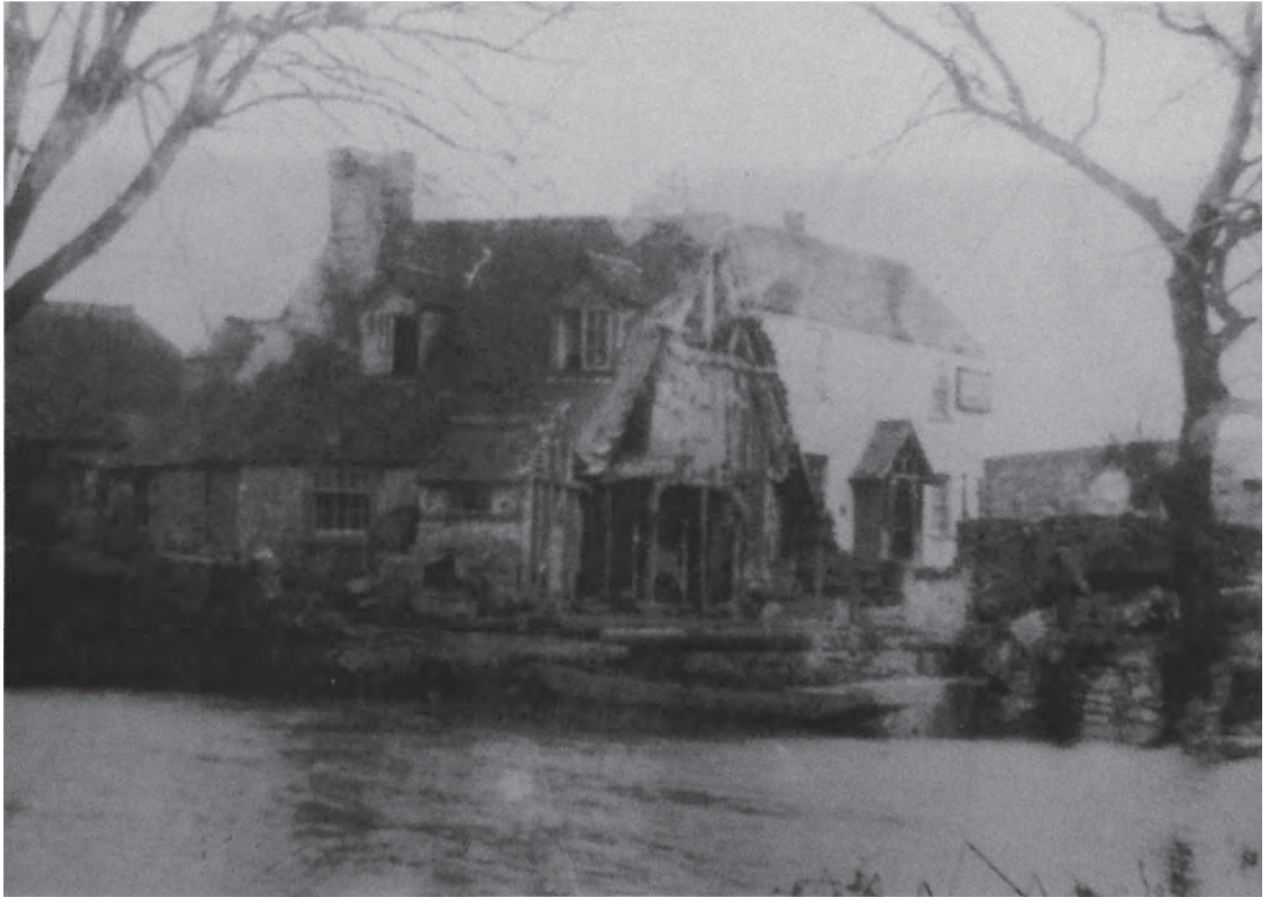
Figure 44: Botley Mill house on the right and the humpback bridge on the left c1924 (Hanson, 1995, 17)

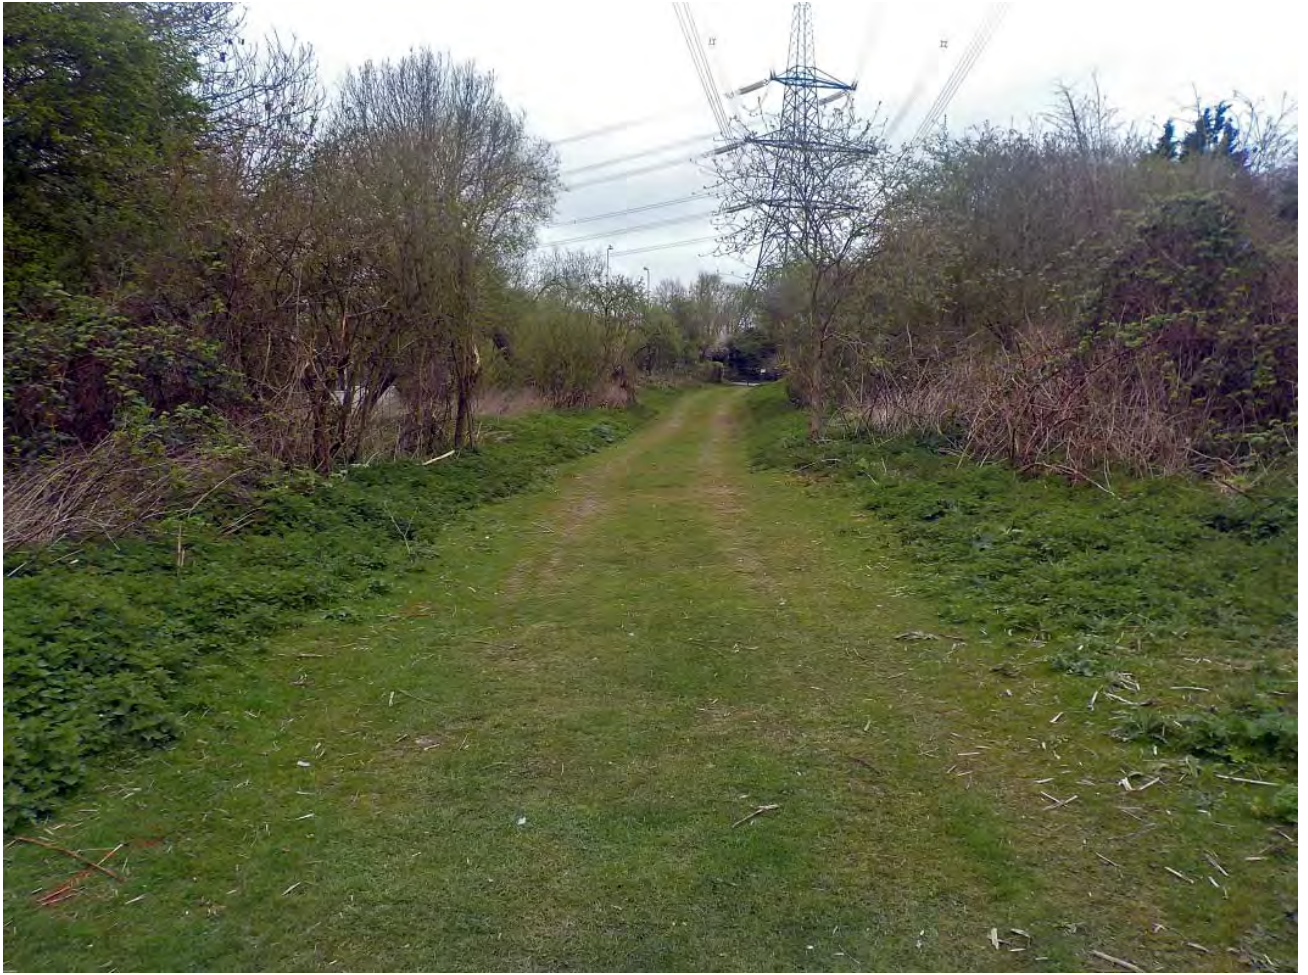
Figure 48: View of footpath leading north to Botley Road

- 4.3.1 A walk-over of the site was conducted on the morning of the 4th April 2017. Conditions were overcast and damp. The site can be accessed from Botley Road via a gate onto a public footpath which runs along the east side of Seacourt Stream, leading south to fields currently under pasture (Figure 48).

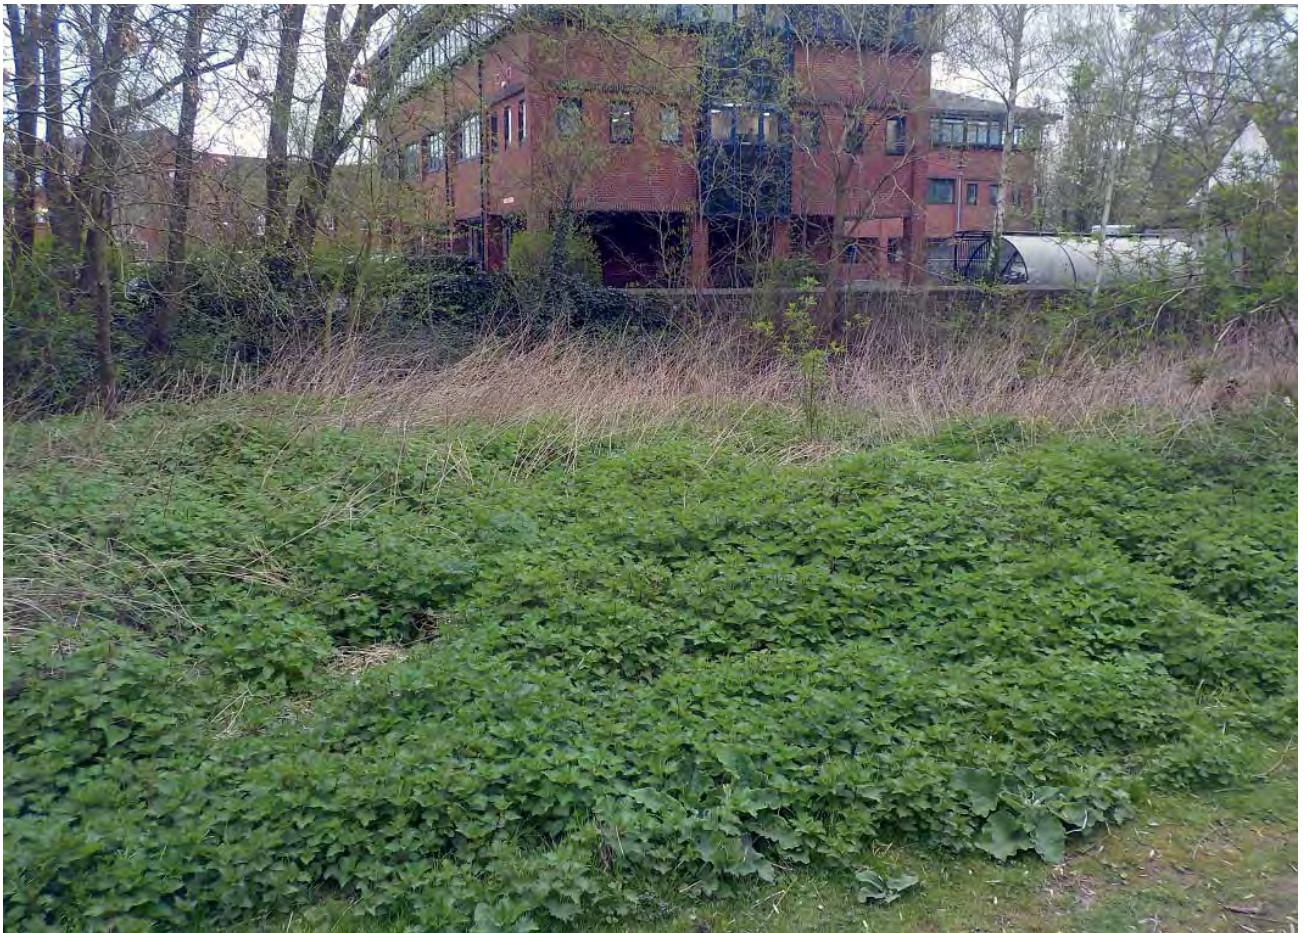
Figure 49: View of rough ground on east bank of Seacourt Stream and modern building on the west bank

- 4.3.2 On the east bank, the area between the stream and the footpath is low-lying rough ground which is largely inaccessible due to nettles, trees and other plants (Figure 49). There is no visible evidence of the remains of the mill or water management features within this area, though the east bank juts out into the stream close to where a stone bridge stood in the early 20th century (Figure 50 and 51). The ground level noticeably rises from the east bank to the pathway, and while there are some incidences of building rubble in the surface of the pathway it seems likely that this consists of modern, made-up ground, no doubt to guard against flooding.

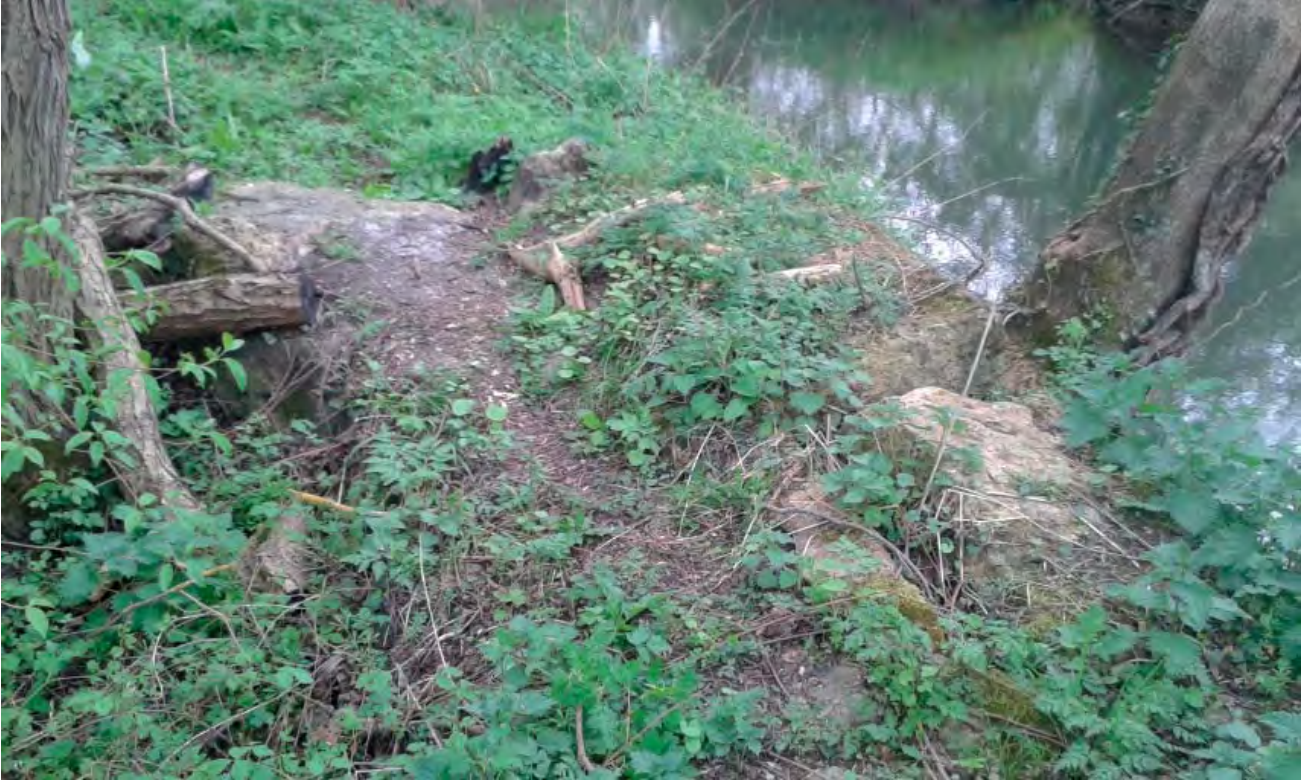
Figure 54: View of the lasher sluice to the north of Botley Road

- 4.7.6 During the site walkover a masonry structure was noted to the north of Botley Road and is likely the remains of the weir or sluice (Figure 54) at the entrance to the lasher seen on the OS maps of 1876-1936 (Figures 34-37). These four OS maps show a 'lasher' marked at the northern intersection where the stream and the leat diverge, with a line probably indicating the position of a weir.

- 4.9.3 Important objectives of any archaeological investigations of Botley Mill and its associated infrastructure would be:
- To investigate the nature of the lasher weir/sluice to the north of the road;

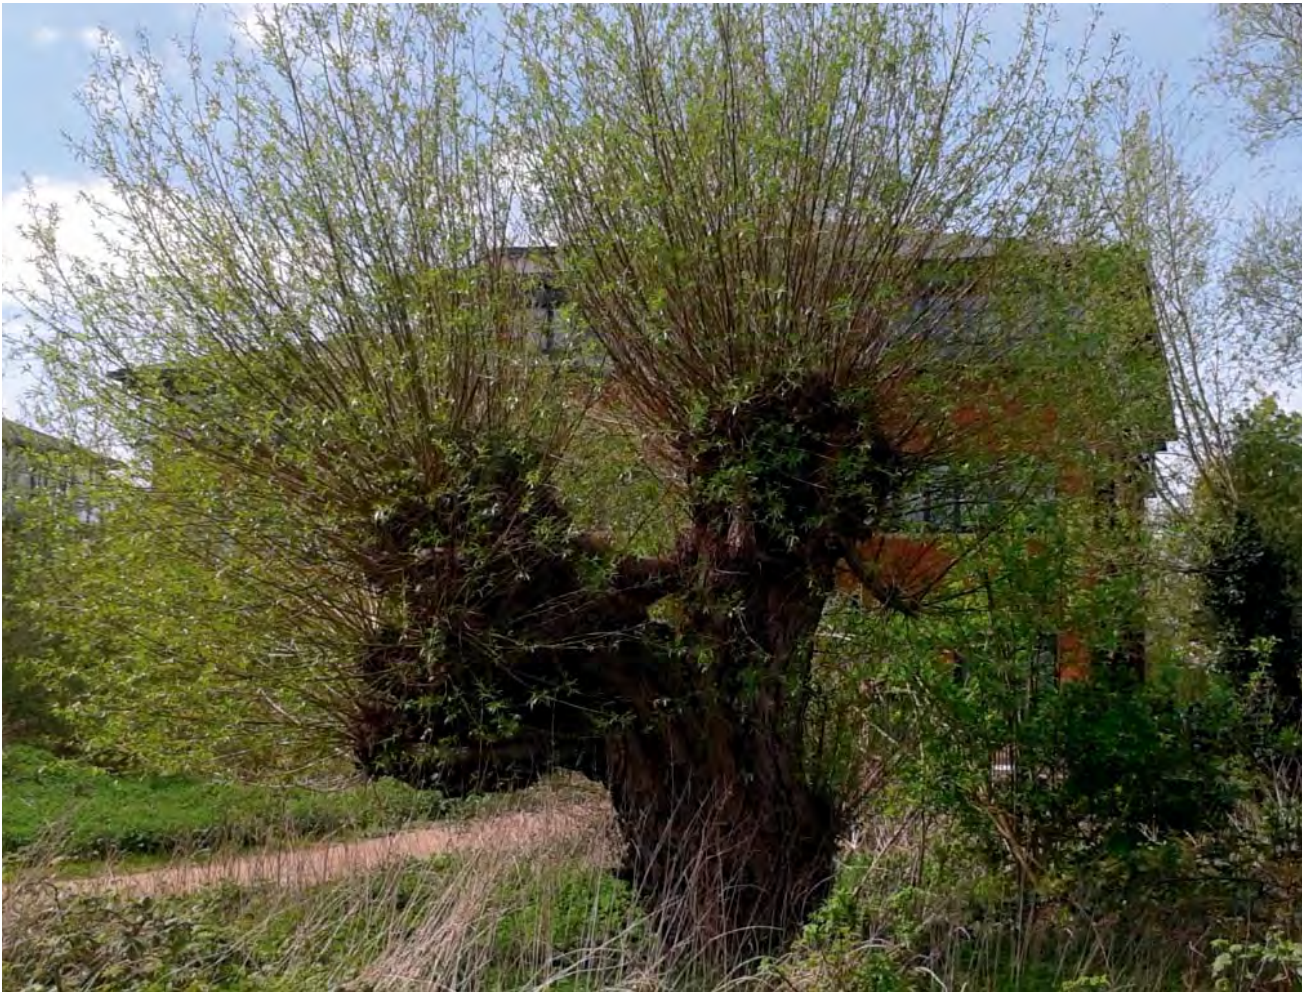
Figure 55: View of pollarded willow to the east of the site of Botley Mill

- 4.3.5 To the north of the Botley Road the historic pattern of streams is intact (although partly silted), with an irregular island shape bisected by the Seacourt Stream, and an electricity pylon standing in the eastern half of this island (Figure 53). There is at least one pre-existing water-management feature on the Seacourt Stream, where a ‘lasher’ is labelled on early Ordnance Survey (OS) maps (Figures 34-37) shown as a side stream with its entrance closed off by a line. The side stream has now become a large silted pond, and at its entrance is the remains of a stone sluice or weir that could control the flow of water into the lasher stream (Figure 54).
- 4.3.6 Several large pollarded willow trees were noted to the west and east of the site of Botley Mill and appear to be over 100 years old. These may have defined the edges of the historic watercourses (Figure 55).
