Appendix O Cultural heritage supporting studies

O1 Heritage Assessment (Wessex, 2015)

River Sowry Somerset

Heritage Assessment

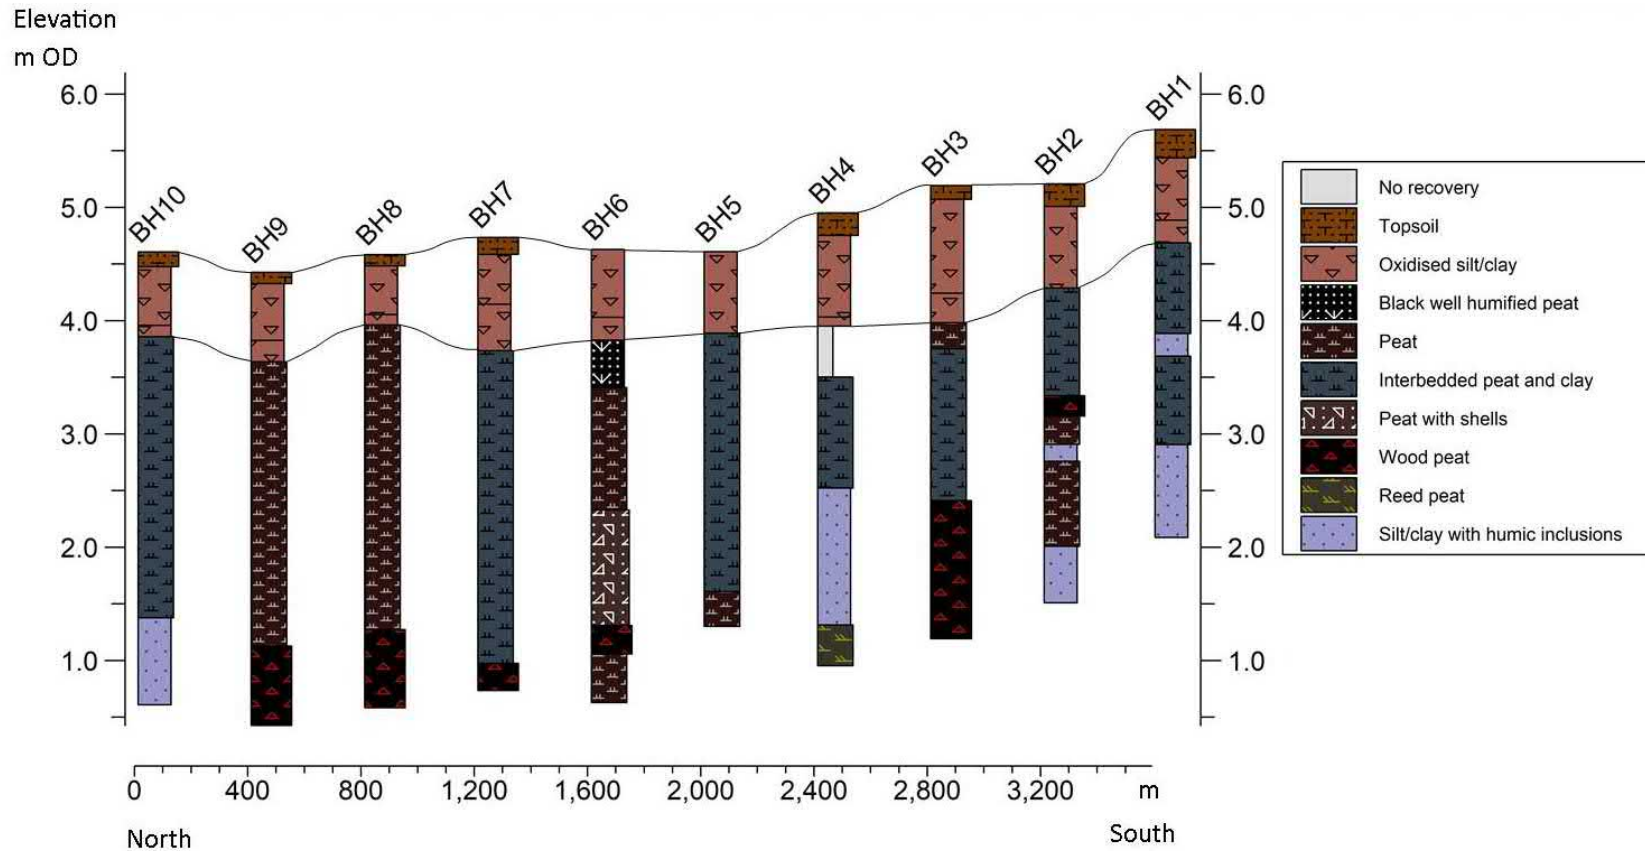
Figure 4. Lithostratigraphic cross-section at the southern terminus of the auger transect at Monk's Leaze Clyce showing interbedded peats and flood clays on Aller Moor along the north bank of the River Parrett. Note alluvium (marked as Oxidised silt/clay) as mapped by the BGS (Vertical exaggeration on all cross-sections is x400).

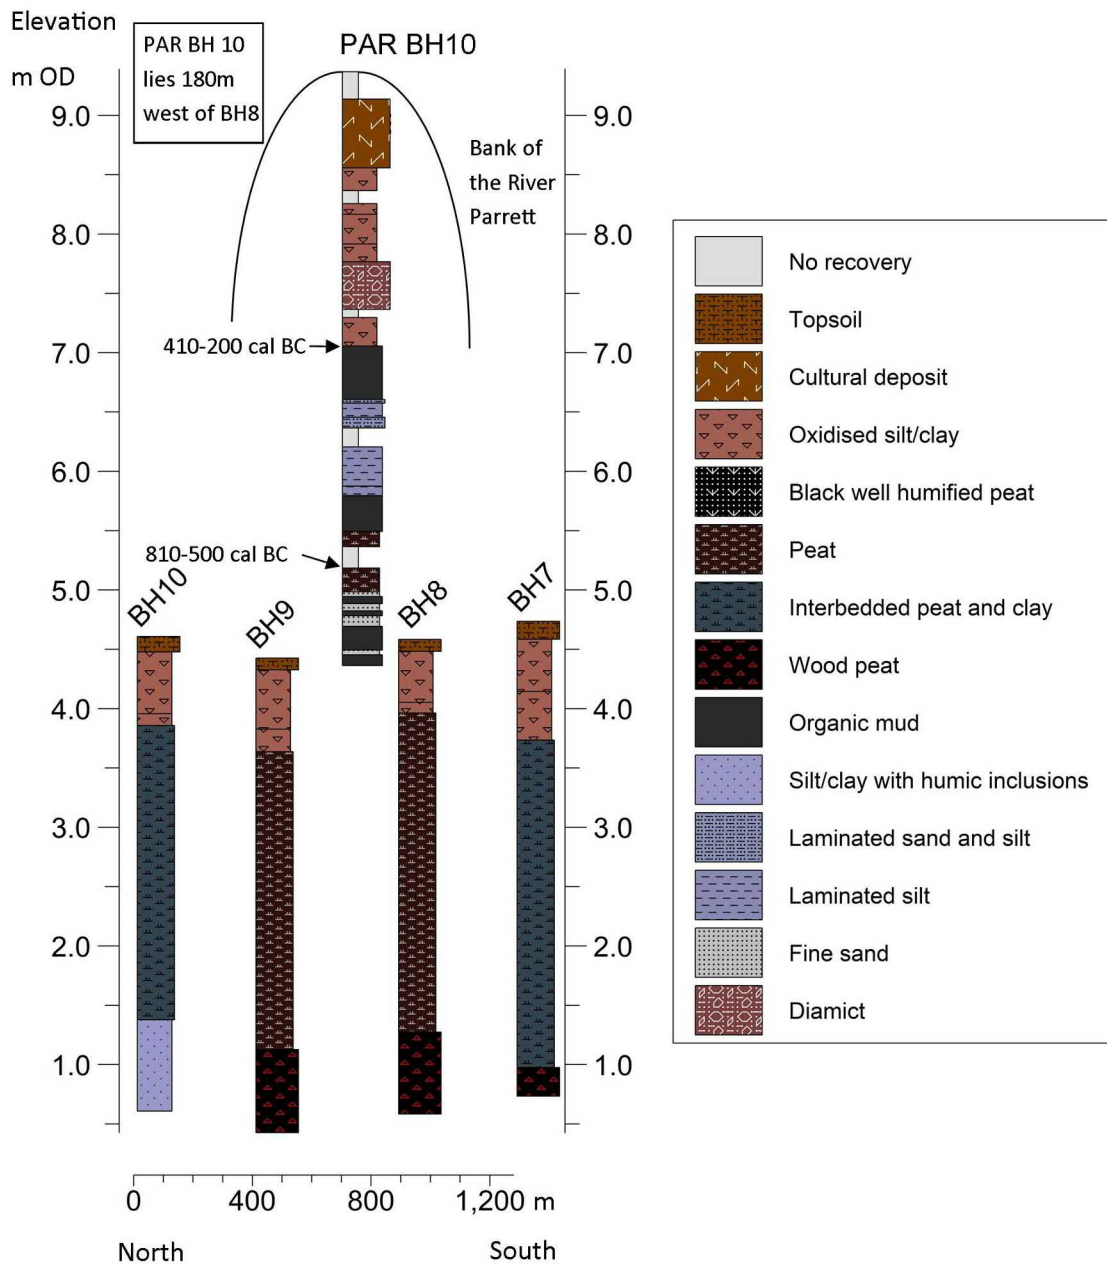
Figure 5. Lithostratigraphic cross-section showing Iron Age peat sealed below levy alluvium and artificial bank deposits on the south bank of the River Parrett, and its relationship with lower lying strata on Aller Moor.

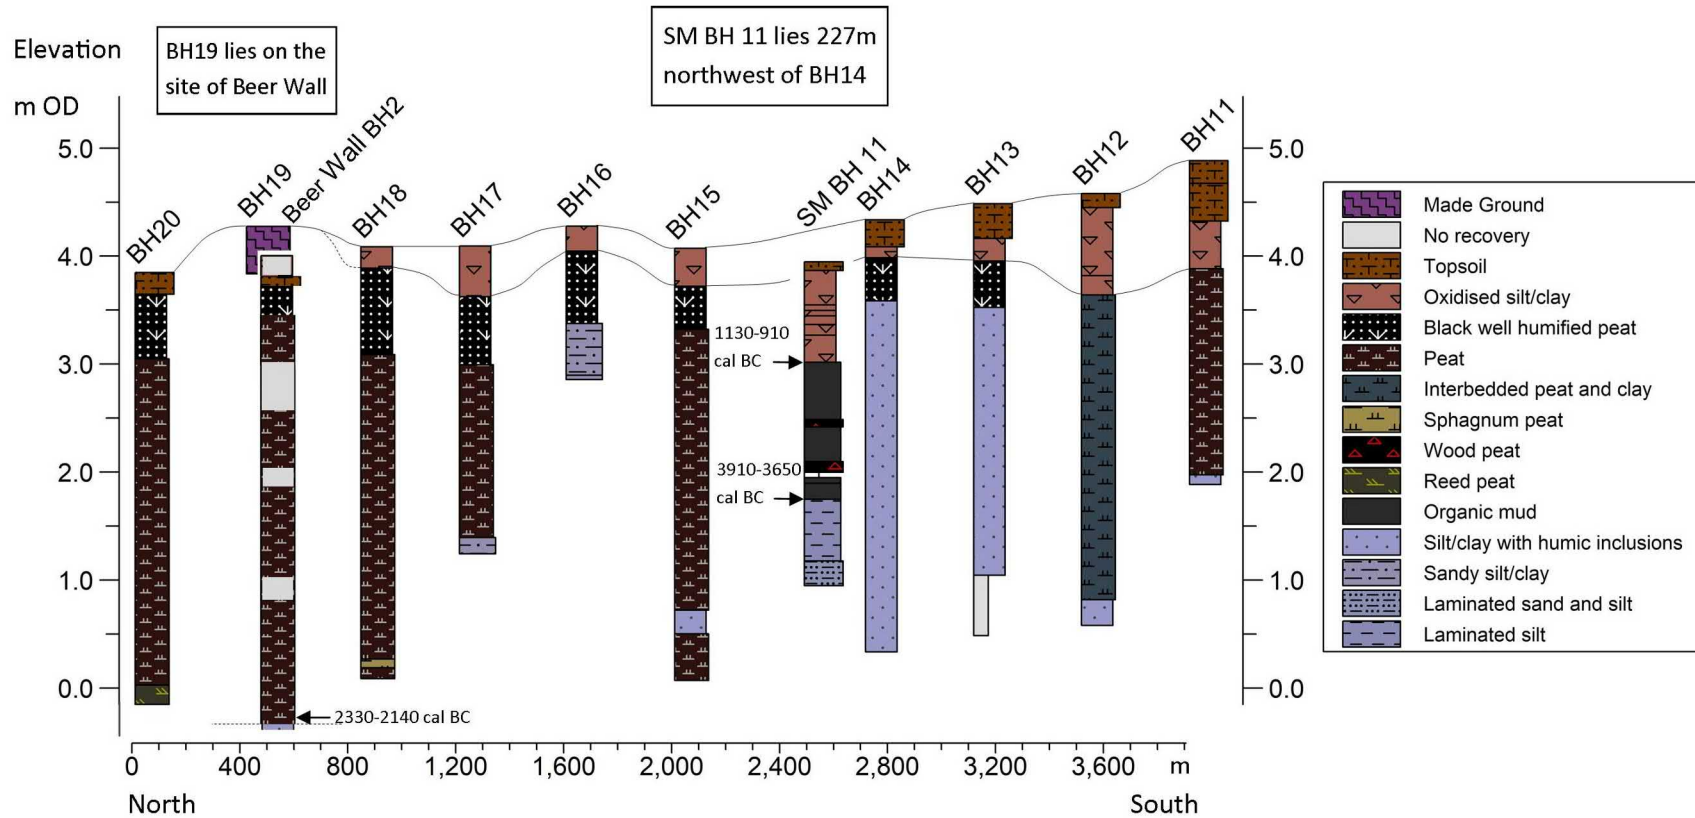
Figure 6. Lithostratigraphic cross-section showing the relationship between dated strata in the Parrett valley on Southlake Moor with strata from the auger transect on North Moor. Note the decreasing influence of flood alluvium from the Parrett (throughout the cores) and the establishment of thick and persistent peat beds from south to north in the quiet interfluvium between the Parrett and KSD / Cary valleys (BH15-30) as mapped by the BGS. Beer Wall boreholes at the location of BH19 record peat over intertidal muds at -0.48m OD and dated to the late Neolithic/early Bronze Age.

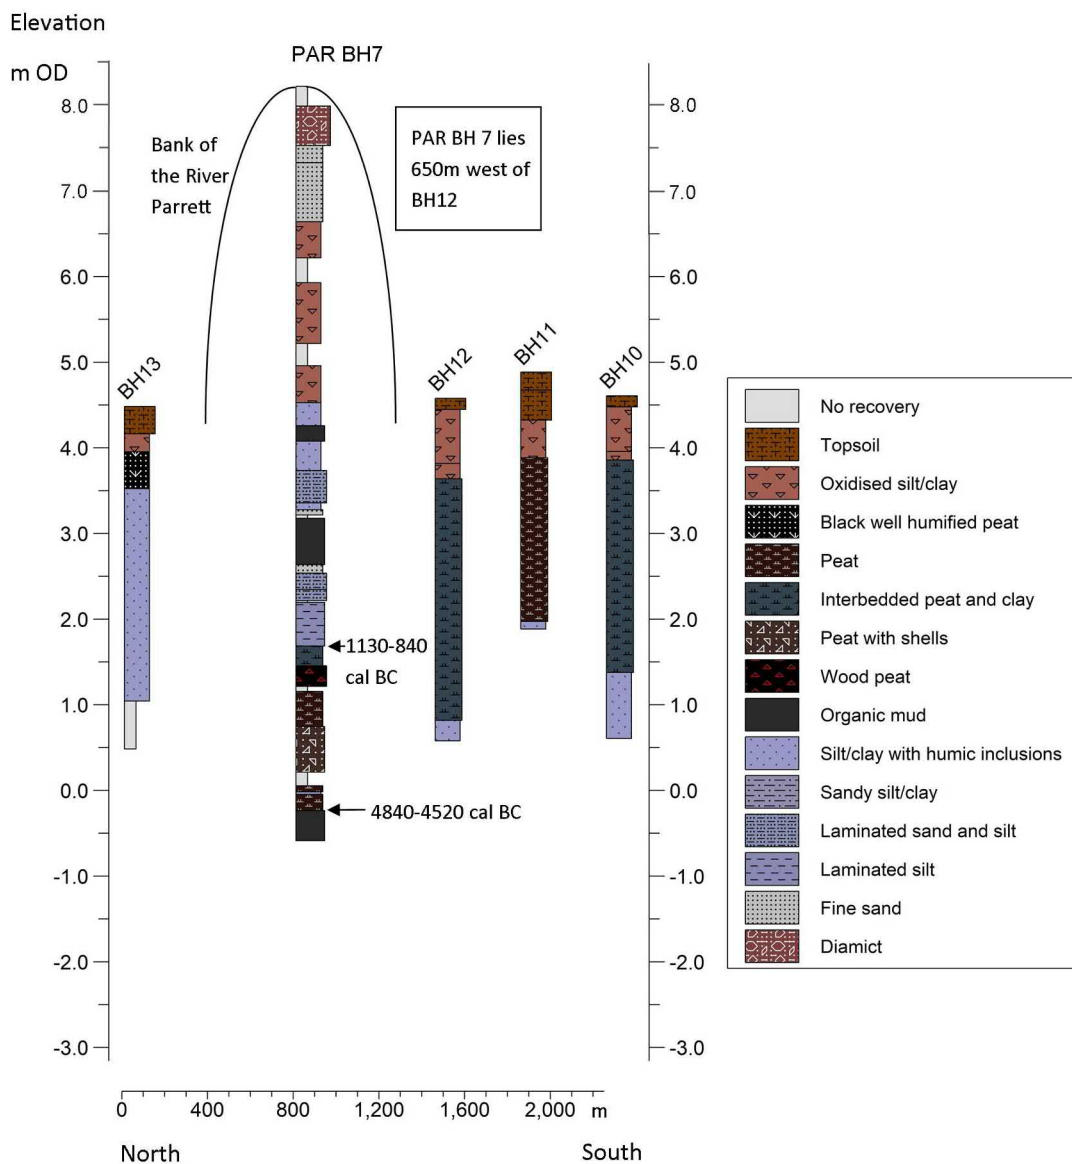
Figure 7. Lithostratigraphic cross-section showing the Late Bronze Age peat (c. +1.5m OD) below levy and bank deposits on the River Parrett near Strathe and its relationship with distant deposits from the auger transect on North Moor to the east. Note that the peat from SM BH11 (Figure 6) in the Parrett valley on Southlake Moor c. 1km north-northeast, although slightly higher in elevation (c. +3m OD) is the same date and possibly marks the cessation in peat growth on Southlake Moor and on the auger transect nearby too; erosion or oxidation of the peat may have depressed the date however. On the Parrett bank thick levy deposits continued to build.

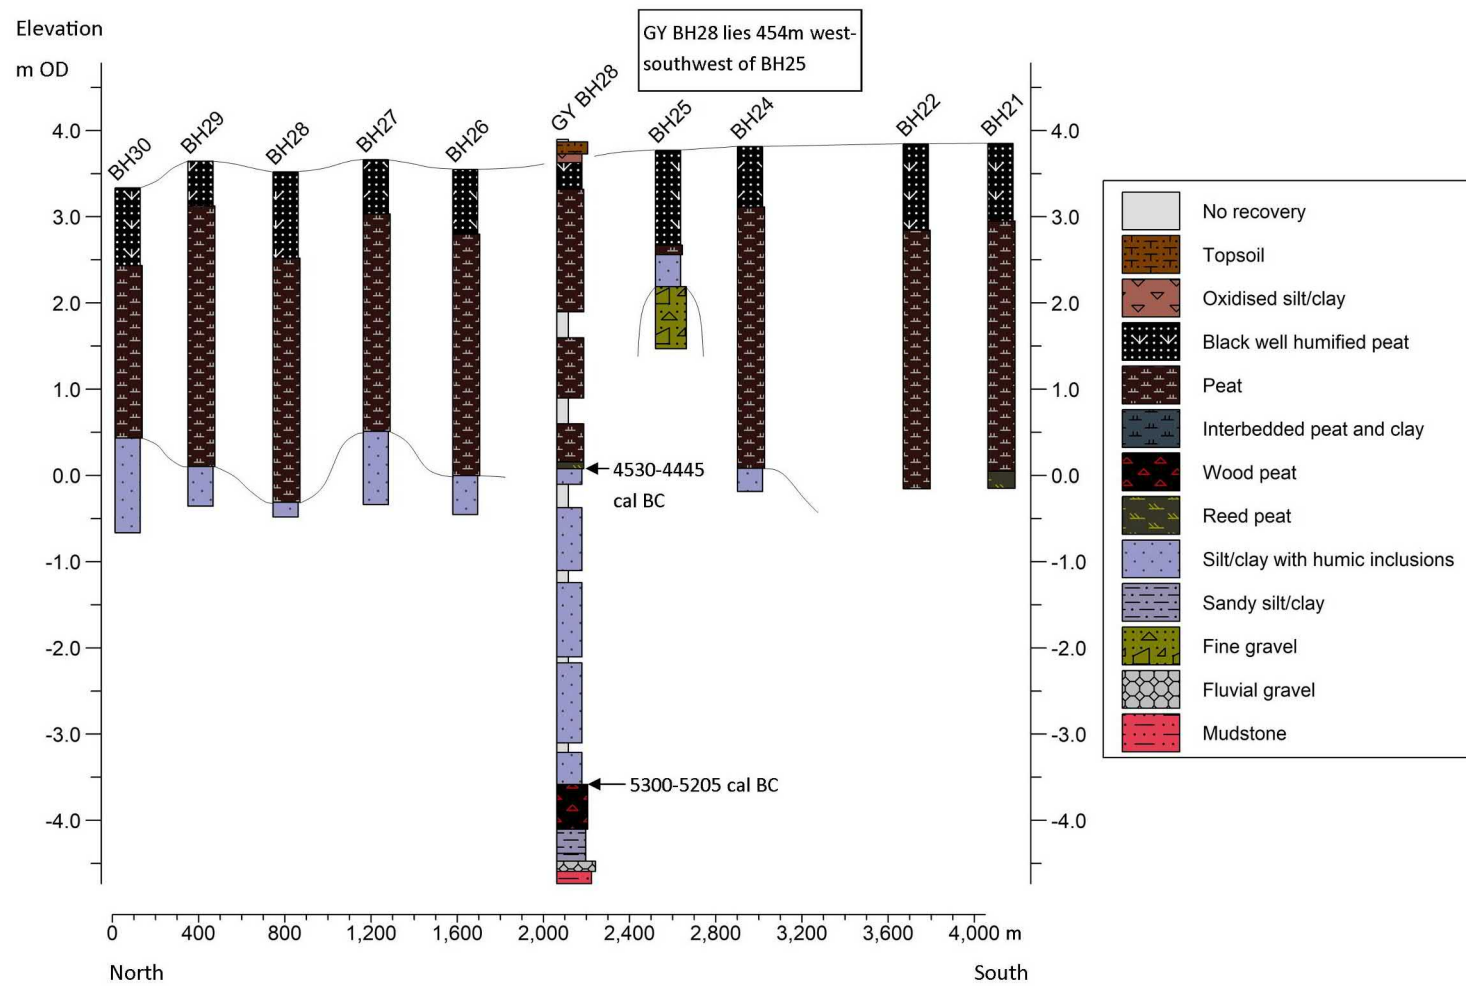
Figure 8. Lithostratigraphic cross-section showing the relationship between dated strata at Greylake, with the peat deposits from the auger transect on King's Sedge Moor. Upper peat growth began in the late Mesolithic.

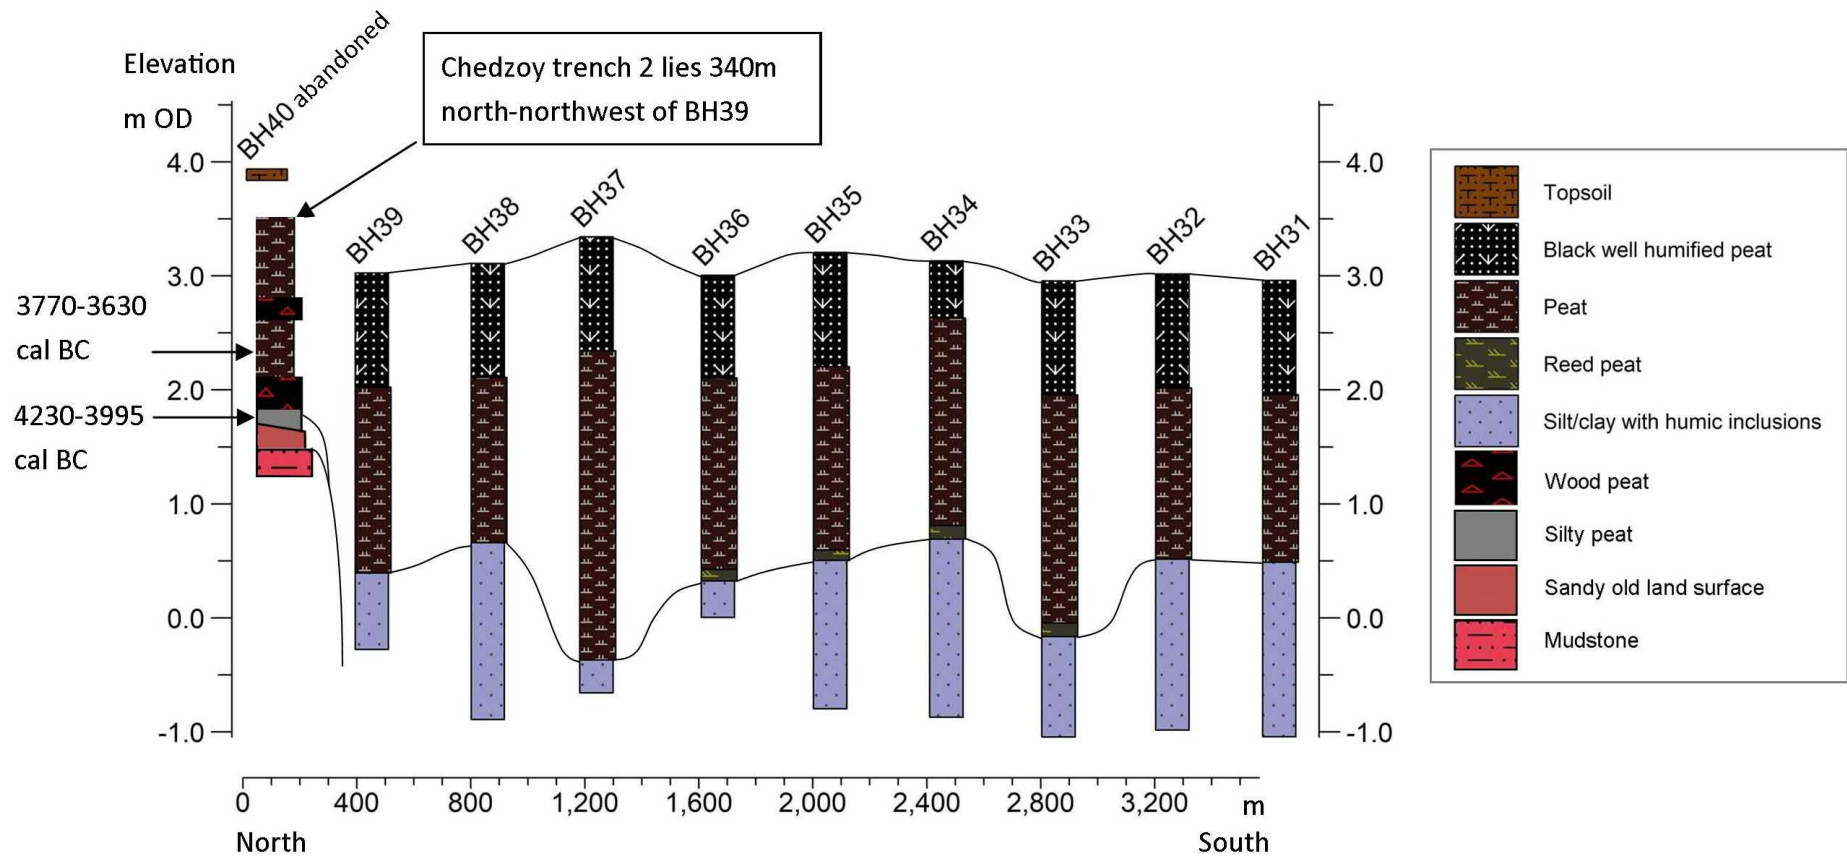
Figure 9. Lithostratigraphic cross-section showing the relationship between dated strata in Trench 2 at Chedzoy and the auger transect on King's Sedge Moor.

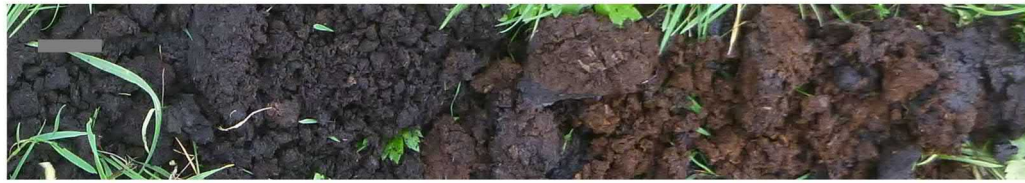
Junction of black oxidised peat with reduced peat at 0.8m bgl BH20.

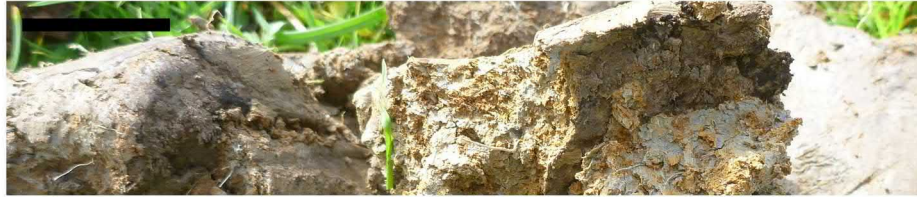
Oxidised silt/clay.

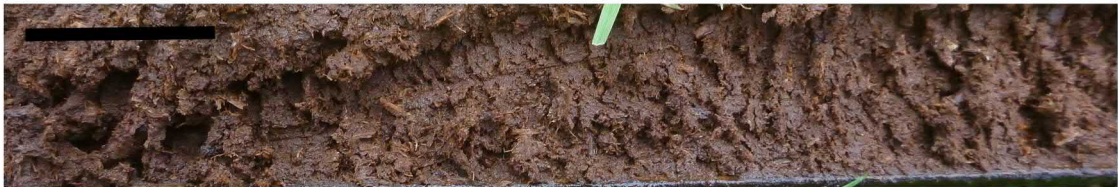
Moderately to poorly humified peat (reduced) from below the water table.

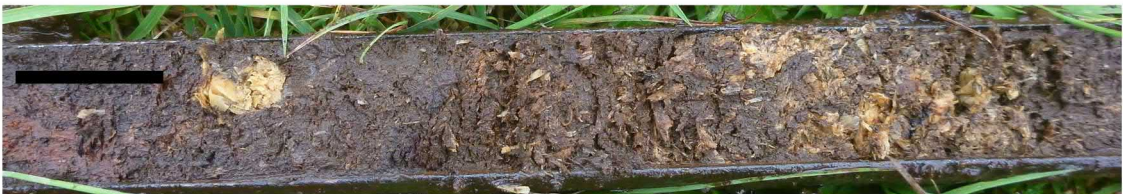
Reed peat in BH20 at 382-4m bgl.

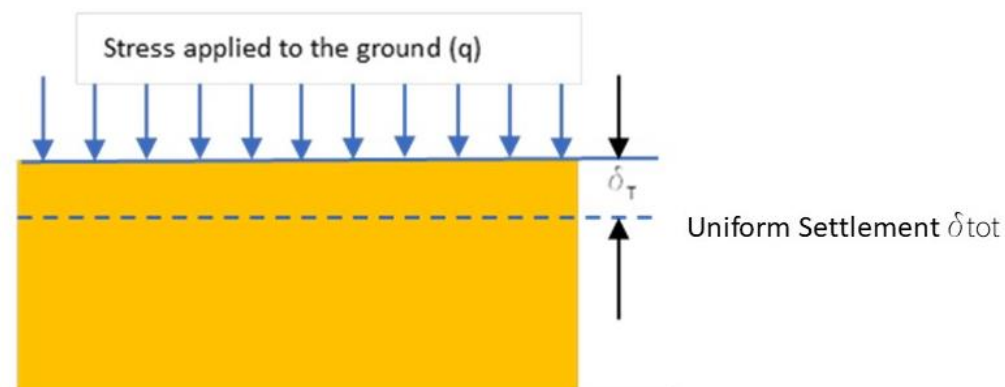
Figure 4: Typical cross section (total settlement)

The addition of permanent works fill (embankment fill) will introduce additional vertical stress to the ground from (the deadload of the fill). This will impose additional vertical stress to the artefact and may cause settlement (δ) of the ground and consequently, potentially settlement of the artefact. Settlement is usually considered in terms of total (δ_{tot}) and differential movement (δ_{diff}), illustrated by Figures 4 and 5 below:

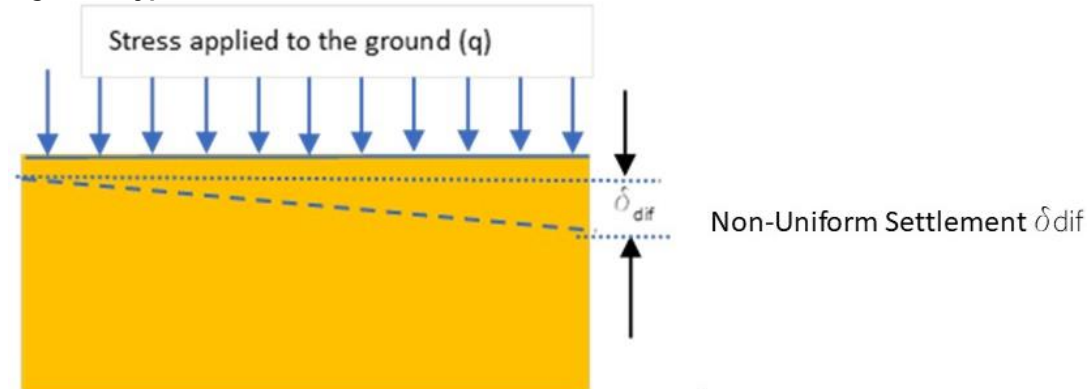
Figure 5: Typical cross section (differential settlement).

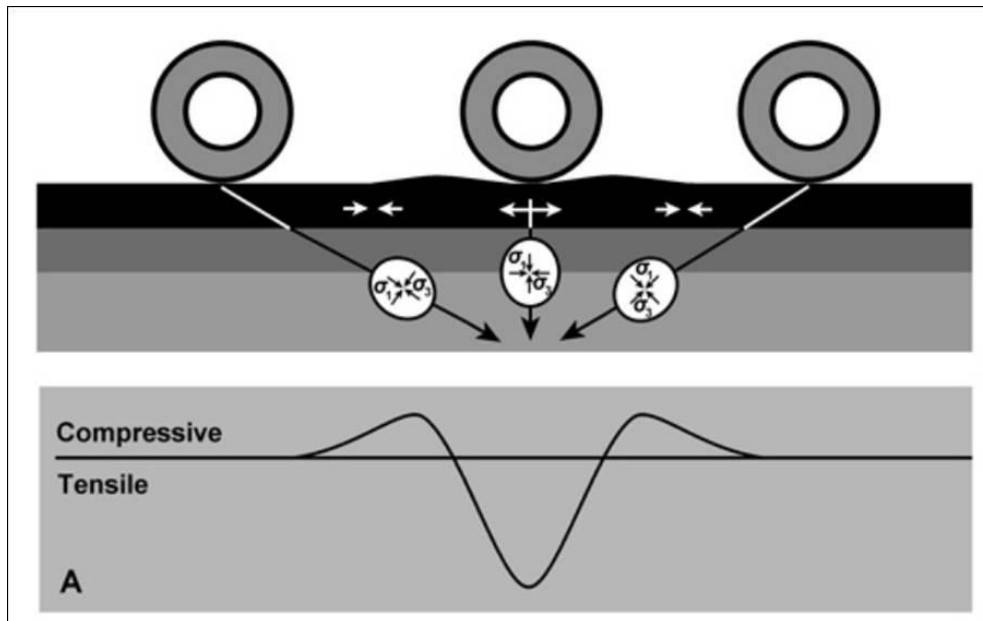
Figure 6: Typical cross section (ground shear) - after Doré and Zubeck (2008)

Hazards from construction traffic fall in to the same category as 5.1 (item 1 to 3) above: settlement; potential effect on slope stability, and bearing capacity. As with the temporary works design, consideration of any potential detrimental effects on slope stability and bearing capacity will need to be assessed by the temporary works design. With respect to settlement and in the absence of appropriate mitigation, the transient movement of plant has the potential to induce differential movement and also shearing across the 'artefact horizon' as illustrated by Figure 6.

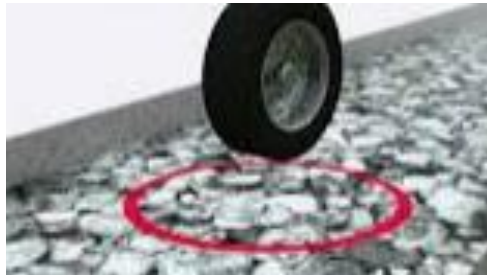
Figure 8: Wheel load distribution modelled as circular footing

For the 20t Volvo dump truck the stress distribution can be modelled as circular (as shown in Figure 8) with a diameter of 0.657m while for the 25t tracked excavator pressure bulb distribution can be rationalised as that of a strip foundation with dimensions of the track width $B=0.6\text{m}$ and length $L=4.650\text{m}$ as given in Table 2.

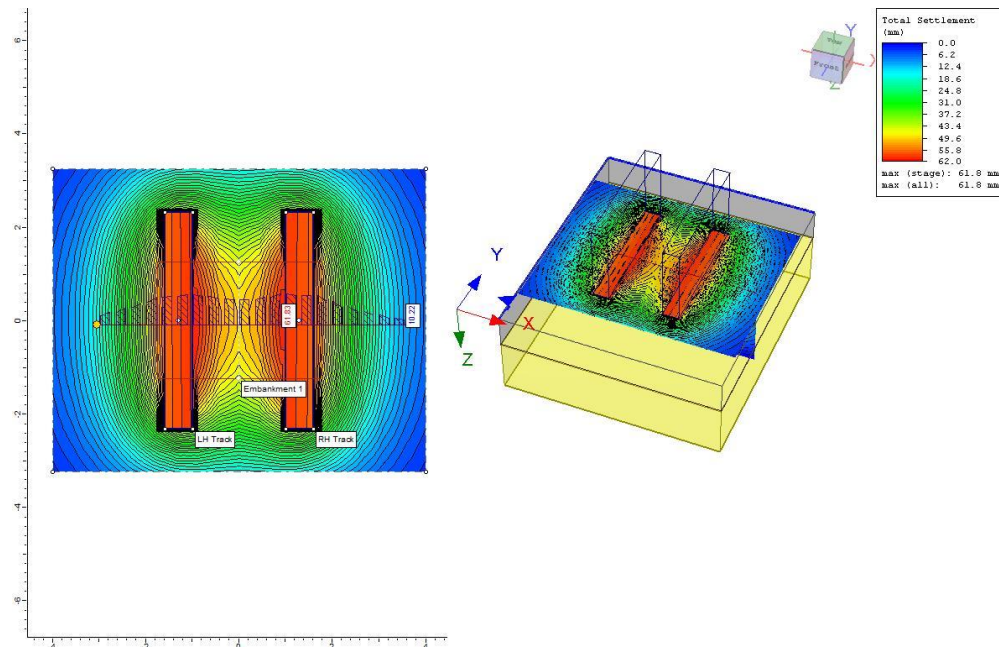
Figure A.1 Settlement assessment for static traffic load, 25t excavator

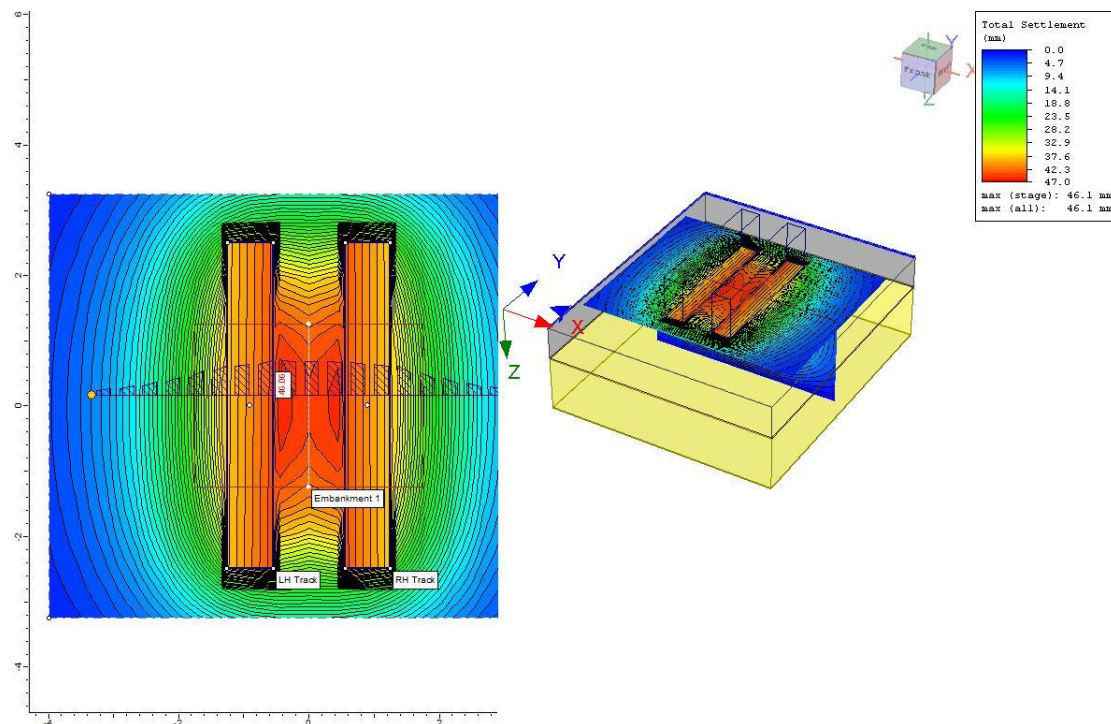
Figure A.2 Settlement assessment for static traffic load, 8t track dumper

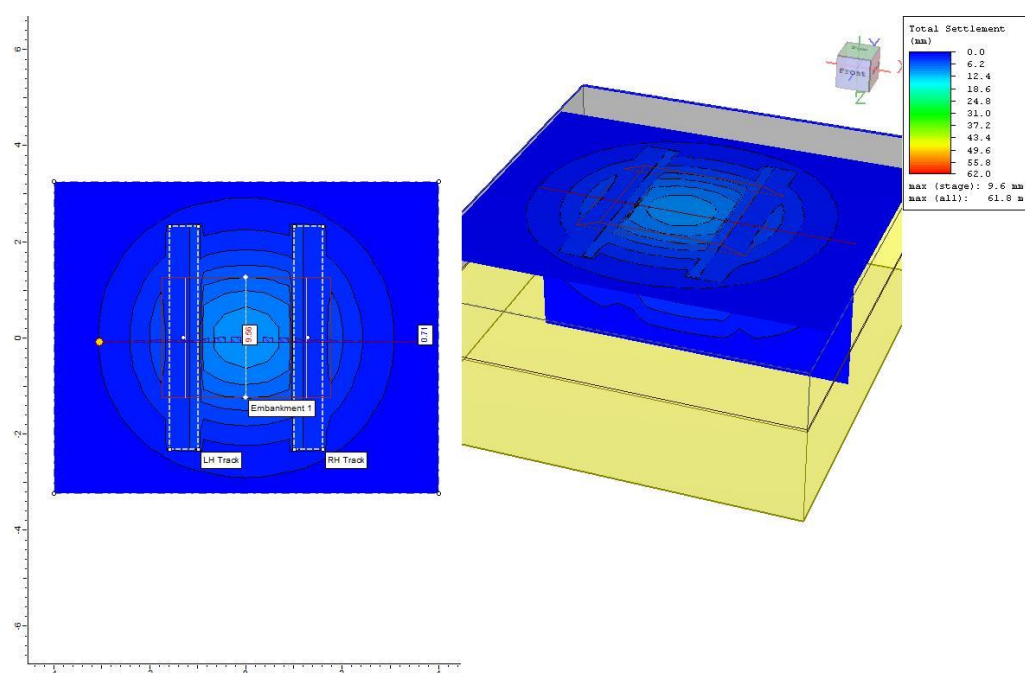
Figure A.3 Settlement assessment for 160mm embankment fill
