Site	Escrick Waste Treatment Facility		Permit Ref	104658		
Operator/ Permit holder	ACUMEN WASTE SERVICES LIMITED					
Date	31/05/2023		Time in	10:45	Out	13:20
What parts of the permit were assessed	Specified activities, Infrastructure, Management, Amenity & MRMR					
Assessment	Site Inspection	EPR Activity:	Installation	Waste Op	X	Water Discharge
Recipient's name/position	[REDACTED]					
Officer's name	[REDACTED]		Date issued	16/06/2023

Section 1 - Compliance Assessment Summary

Section 2 – Compliance Assessment Report Detail

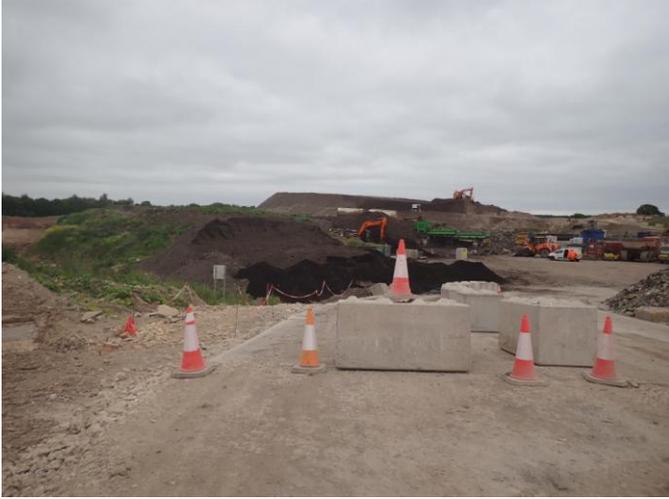
Fig. 1

Multiple piles of waste were stored on site, of which some were extending beyond impermeable surface. To the left of the bottom of the concrete ramp leading to the permitted area was a large pile of dewatered and screened road sweeper waste. The main body of this waste pile appeared to extend beyond the impermeable surface of the treatment area. The near side of this pile was darker in colour indicating that it was recently deposited. The waste further back in the pile was well vegetated on the surface indicating that it had been in situ for some time (Fig.1).

Action: You must immediately stop importing waste onto the areas outside of impermeable surface and sealed drainage.

You must submit a plan for removal of the wastes from the areas without impermeable surface and sealed drainage by **30th June 2023**. Provide evidence of removal to the Environment Agency in form of weekly updates showing the quantity of waste removed, location of site where it was removed from and its destination along with waste transfer notes if moved off site.

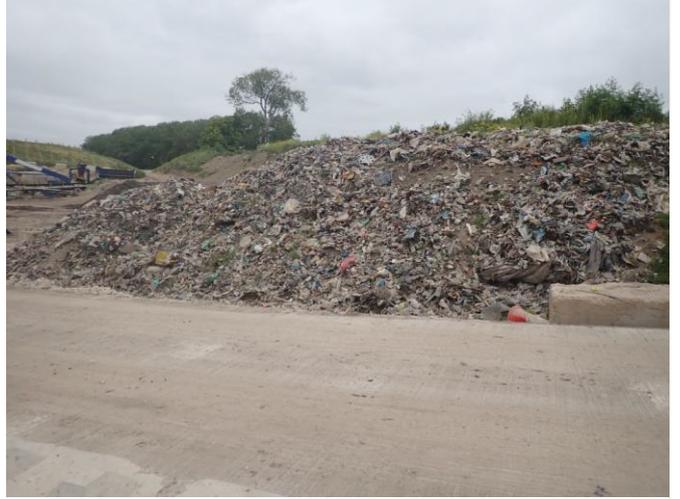
Fig. 2

To the right of the concrete ramp was a pile of larger fraction mixed wastes from the screening of road sweeper waste (Fig.2). This waste pile appeared to be located beyond the impermeable surface of the treatment pad and was weathered indicating that it may have been in situ for some time. To the right of this pile there were three small waste bays separated by concrete blocks (Fig.3). The bays were at capacity with smaller fraction waste fines from the screening of road sweeper waste. These bays were located on the impermeable surface of the concrete pad.

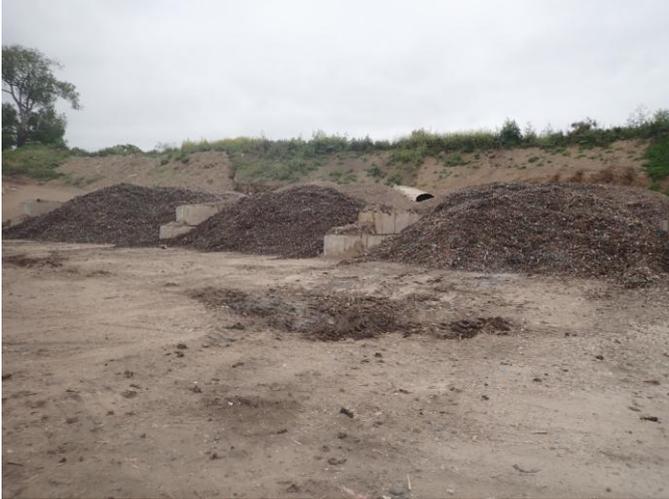
Fig. 3

A large pile of unprocessed road sweeping waste was stored to the southwest of the permitted area behind a screener. This waste appeared to be stored beyond the area of concrete impermeable

surface of the treatment pad. Areas of the waste pile were well vegetated on the surface indicating that it had been in situ for some time. To the right of this waste behind another screener was a pile of larger fraction mixed wastes contain a lot of plastics that was also stored beyond the impermeable concrete pad (Fig.4).

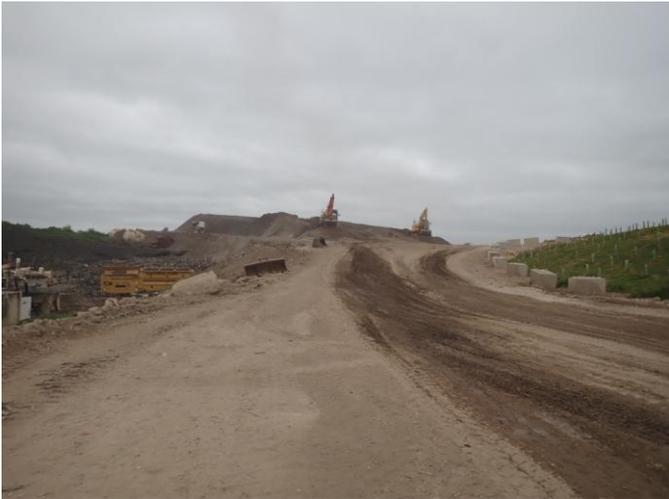
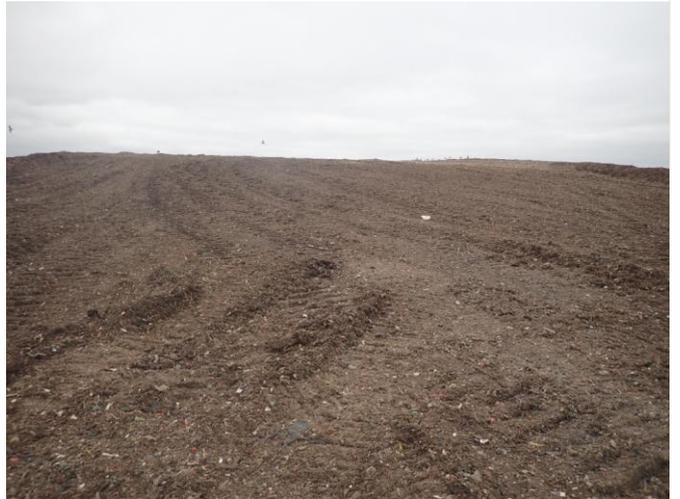
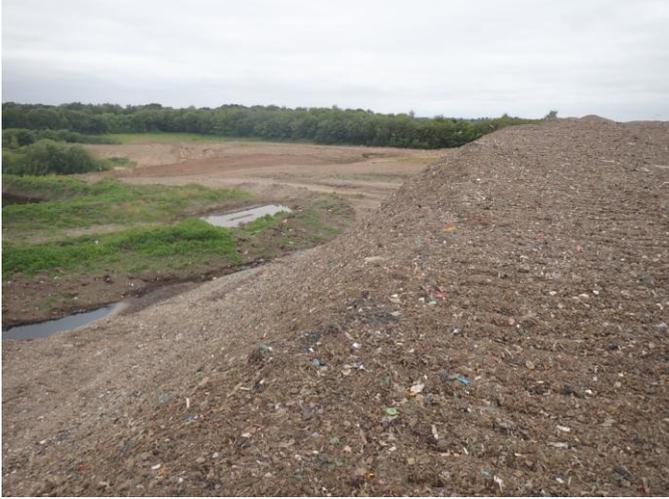
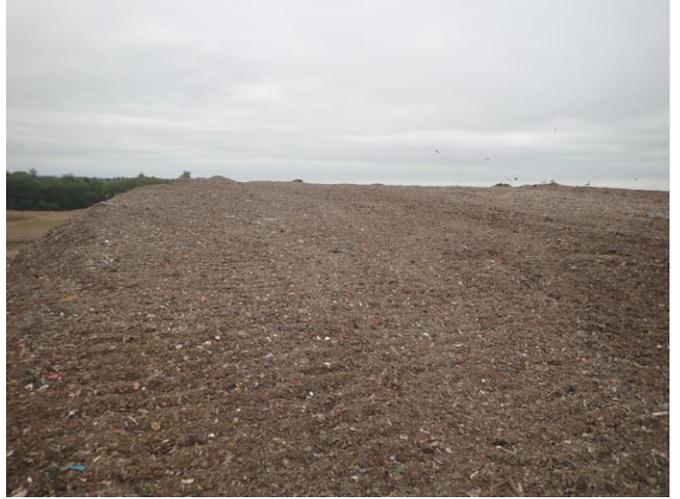
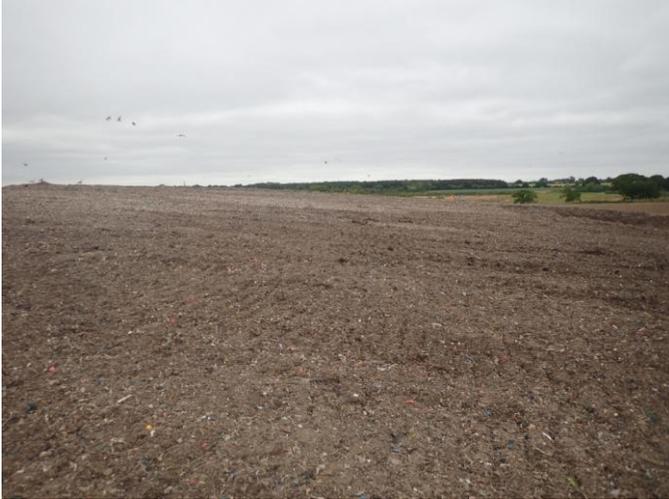
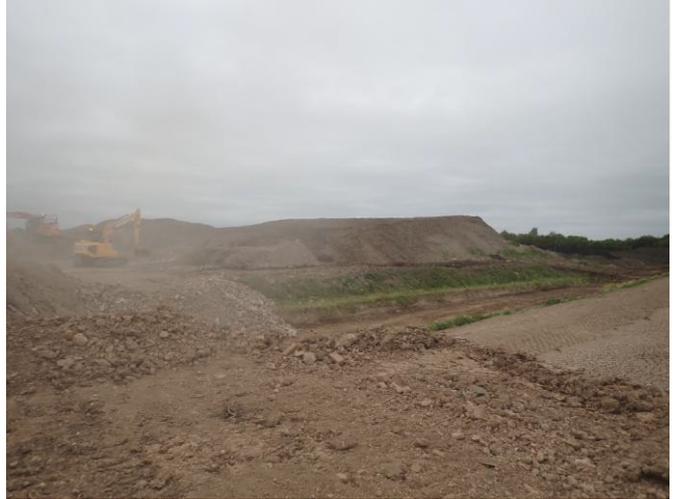
To the west of the site there was a very large high pile of waste fines being stored on site (Fig.5-10). This waste is imported into site as 19 12 12 other wastes. Visually this appears to be from the mechanical treatment of household and/or commercial waste and construction and demolition waste (Fig.11-14). This waste was stored in an area on site that extended beyond the impermeable surface of the concrete pad. There were several scavenging birds present that were on top of the waste pile (Fig.15). The presence of scavenging birds indicates the presence of non-inert, organic material within the waste pile.

While investigating the pile officers were able to detect strong intermittent odour similar to landfill gas coming from the waste mass. This offensiveness of the odour led to one of the officers having to remove herself from the location. The officers observed pools of leachate in various locations around the base of the waste pile (Fig.16-17). Waste stored in large pile contained visible pieces of plastic, foam, ceramics, wood and biodegradable organic matter. Officers also detect strong offensive waste odour from the pile similar to black bin type wastes.

Action: You must update your EMS to ensure that it meets the requirements of condition 1.1.1 of the permit. In particular, you must review the elements that cover waste storage, preventing polluting emissions and Duty of Care to ensure that the breaches identified in the CAR Form do not occur going forward. Provide amended versions of the relevant procedures by **30th June 2023**.

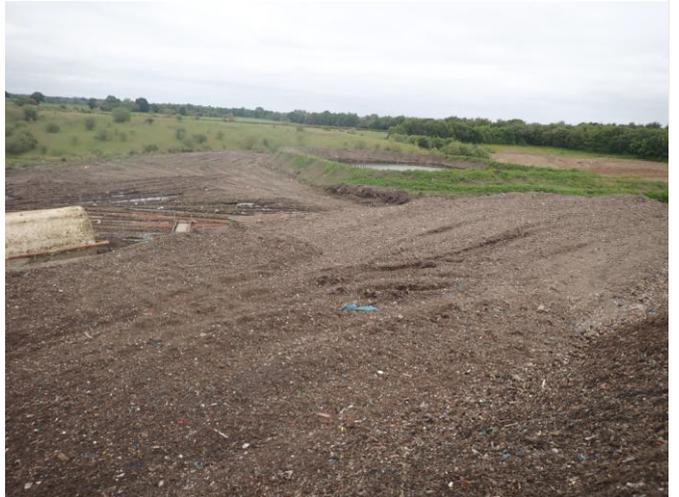
Fig. 18

To the area to the left of the high large pile also appeared to have mixed waste fines stored in an area beyond the impermeable surface (Fig.18). This area was lower than the main pile but also raised above the surrounding ground level. There was a lagoon situated in the southwest corner above the surrounding ground level that was contained within a bund. We did not carry out a close inspection of this area but observed it from the higher waste pile.
