Wrotham Quarry

Annual Report for Western Slope Monitoring

April 2019

Project N° : 190410

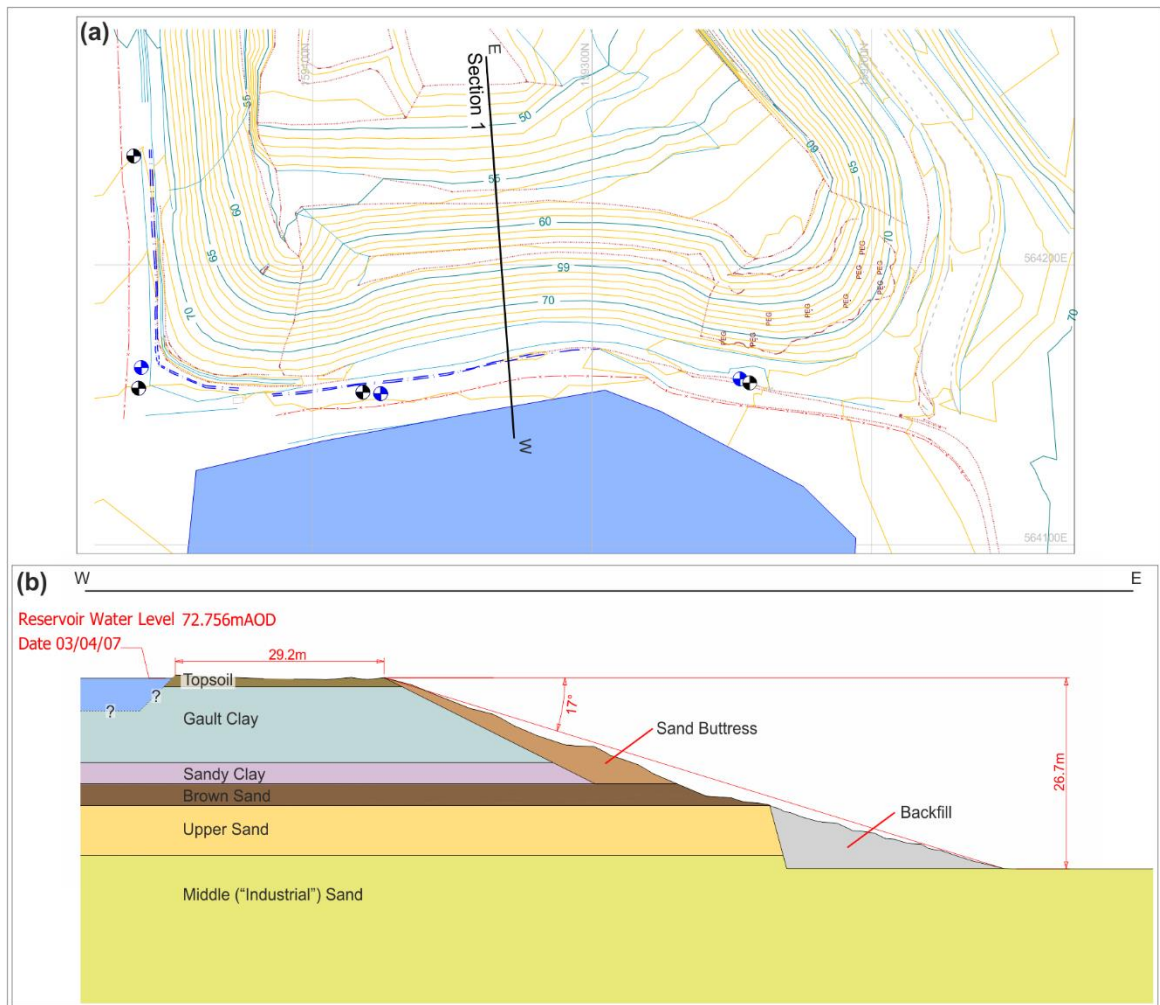
Schematic Cross-Section 1: *Section through the centre of the Western Slope with a plan showing the section location (a) and geological interpretation based on borehole data (b)*

- 3.1.4 Regionally the strata dips 1-2° towards the north-northwest.
- 3.1.5 The Upper Sand within the Folkestone Beds was extracted during the quarrying of the Western Excavation Area. Above the Upper Sand, the remaining part of the Western Slope comprises ~3m Brown Sand, ~3m of a Sandy Clay unit, ~10.5m of Gault Clay and ~1.25m of topsoil.

- 3.1.6 Using borehole data provided by the British Geological Survey (BGS Borehole TQ65NW29 at NGR 564130,159390) and local knowledge on the quarry faces and previous working practices at Wrotham, QuarryDesign have created a geological section through the Western Slope, as provided below in Schematic Cross-Section 1.
