## Ground Stability Report

Proposed Commercial Development

Land off Napier Road, Rockingham

Document no.: STT1234-R01 Rev A

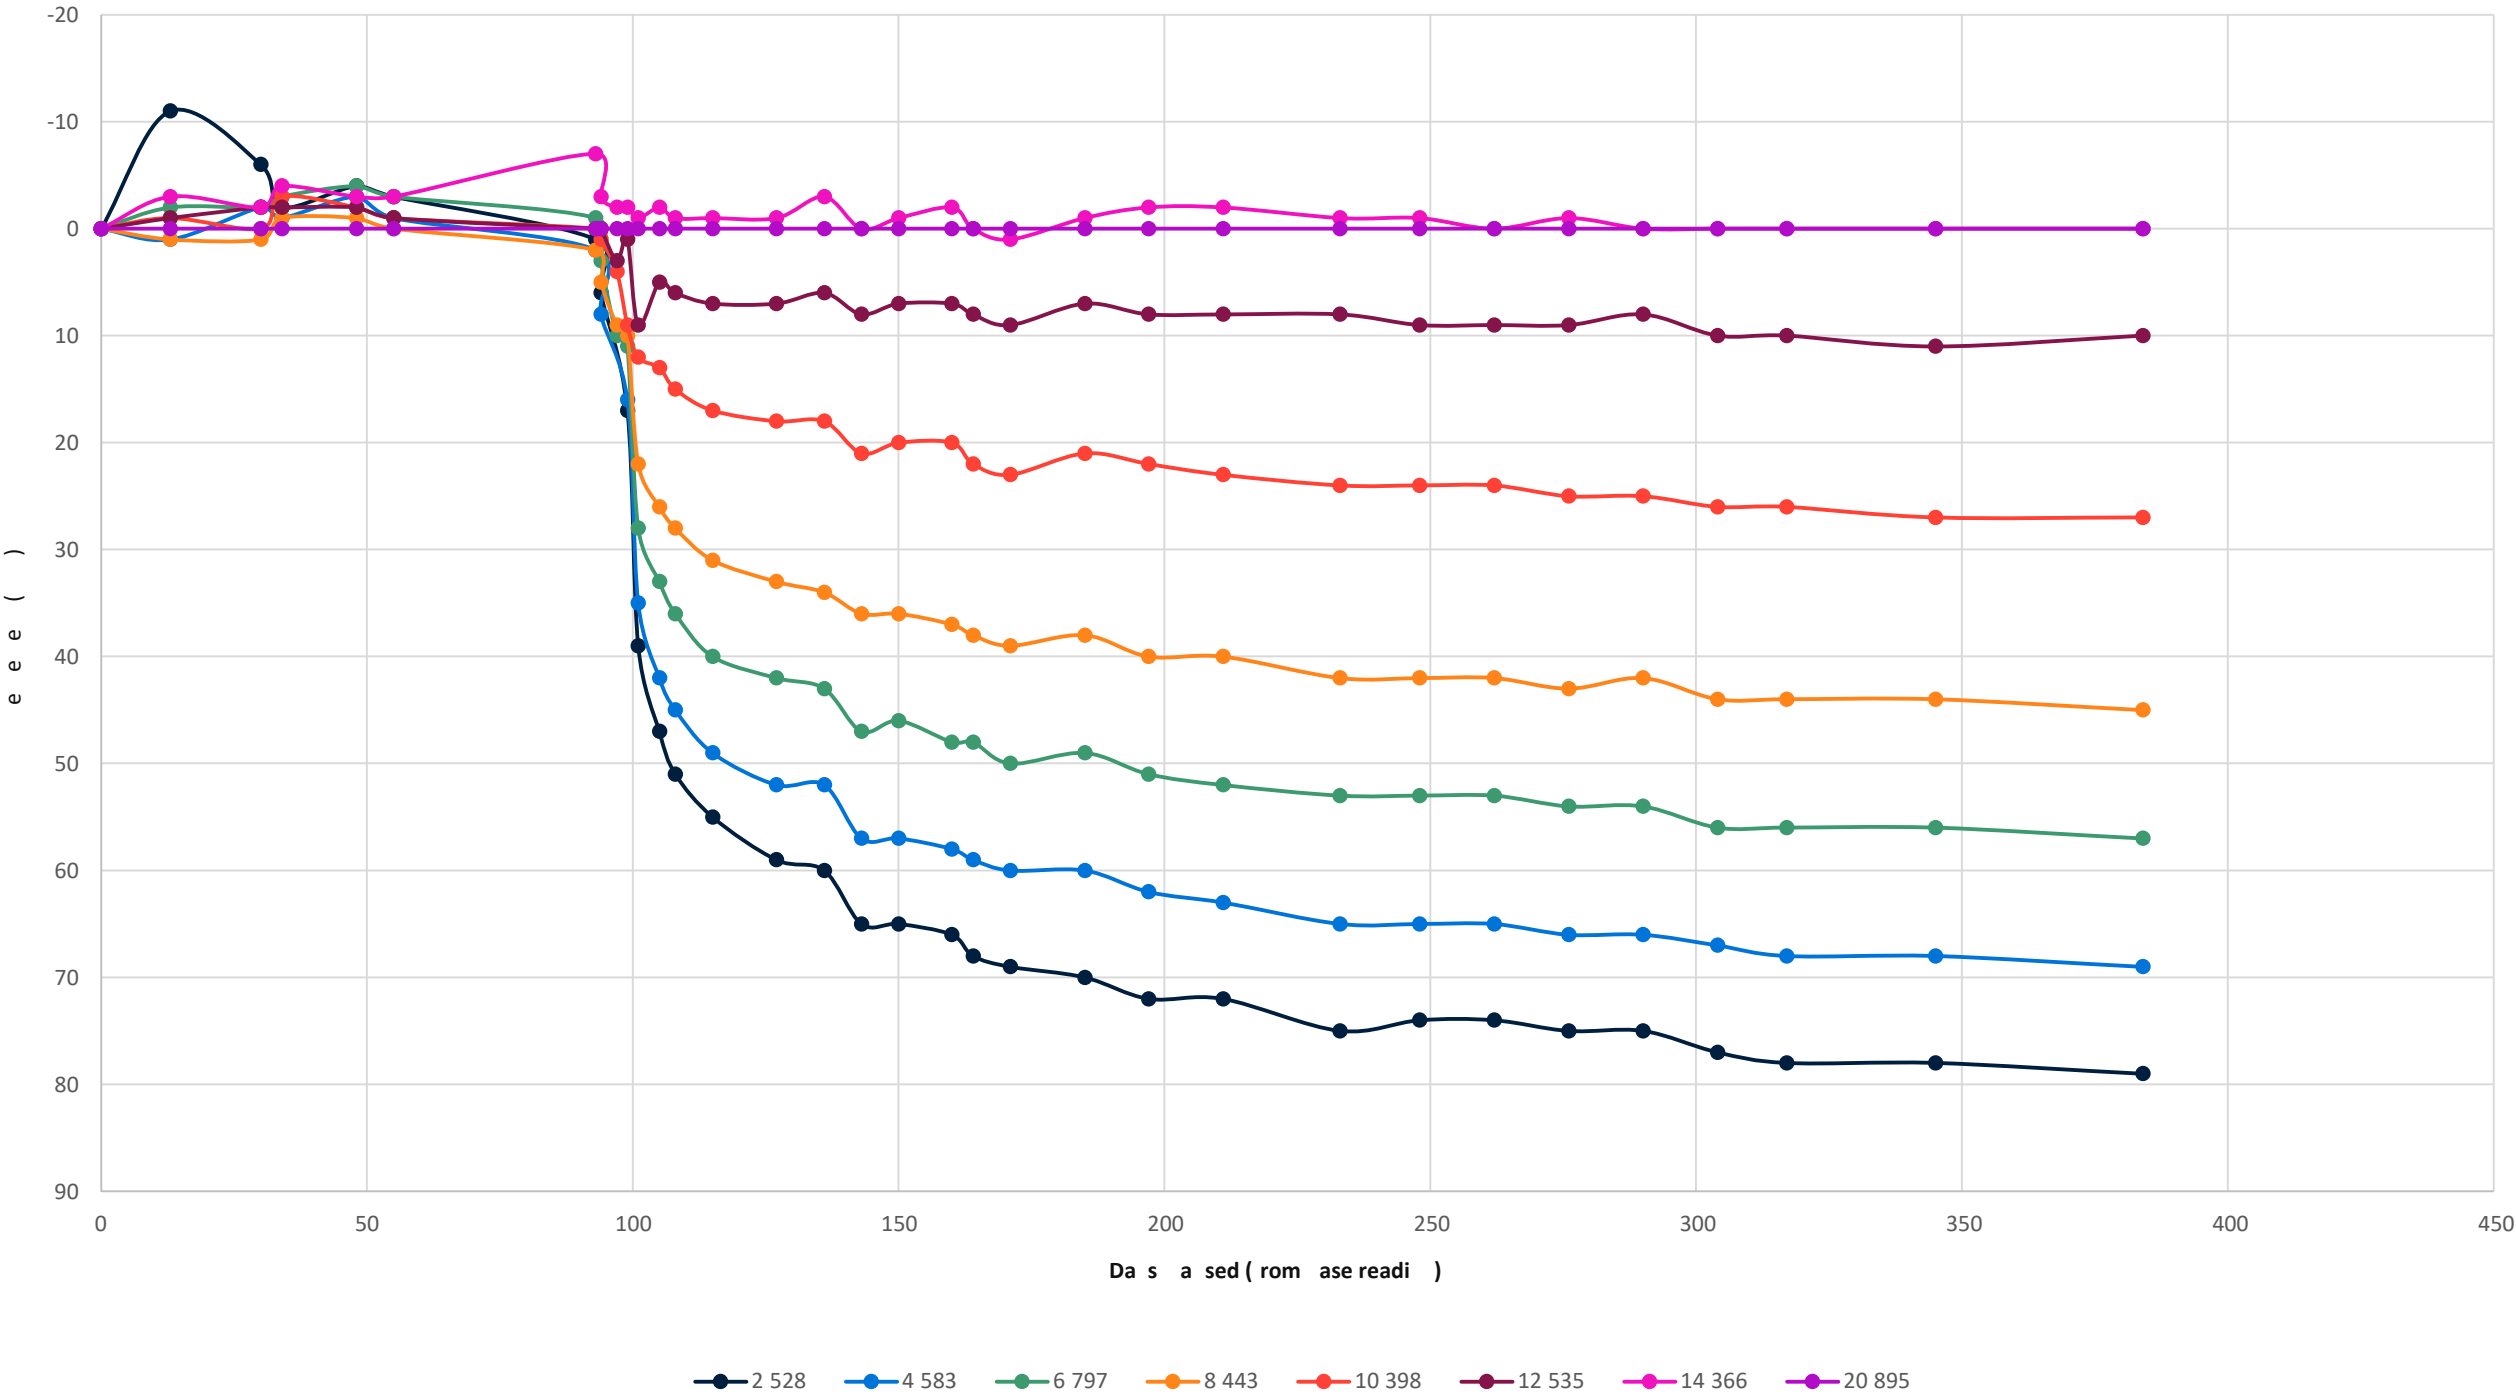
te someters - BH10

- 3.3.4 The interpretation from the extensometers BH103 and BH106 is summarised below alongside BH101 for completeness. It should be noted that settlement values quoted are for the uppermost magnet which is considered to be representative of original ground level.

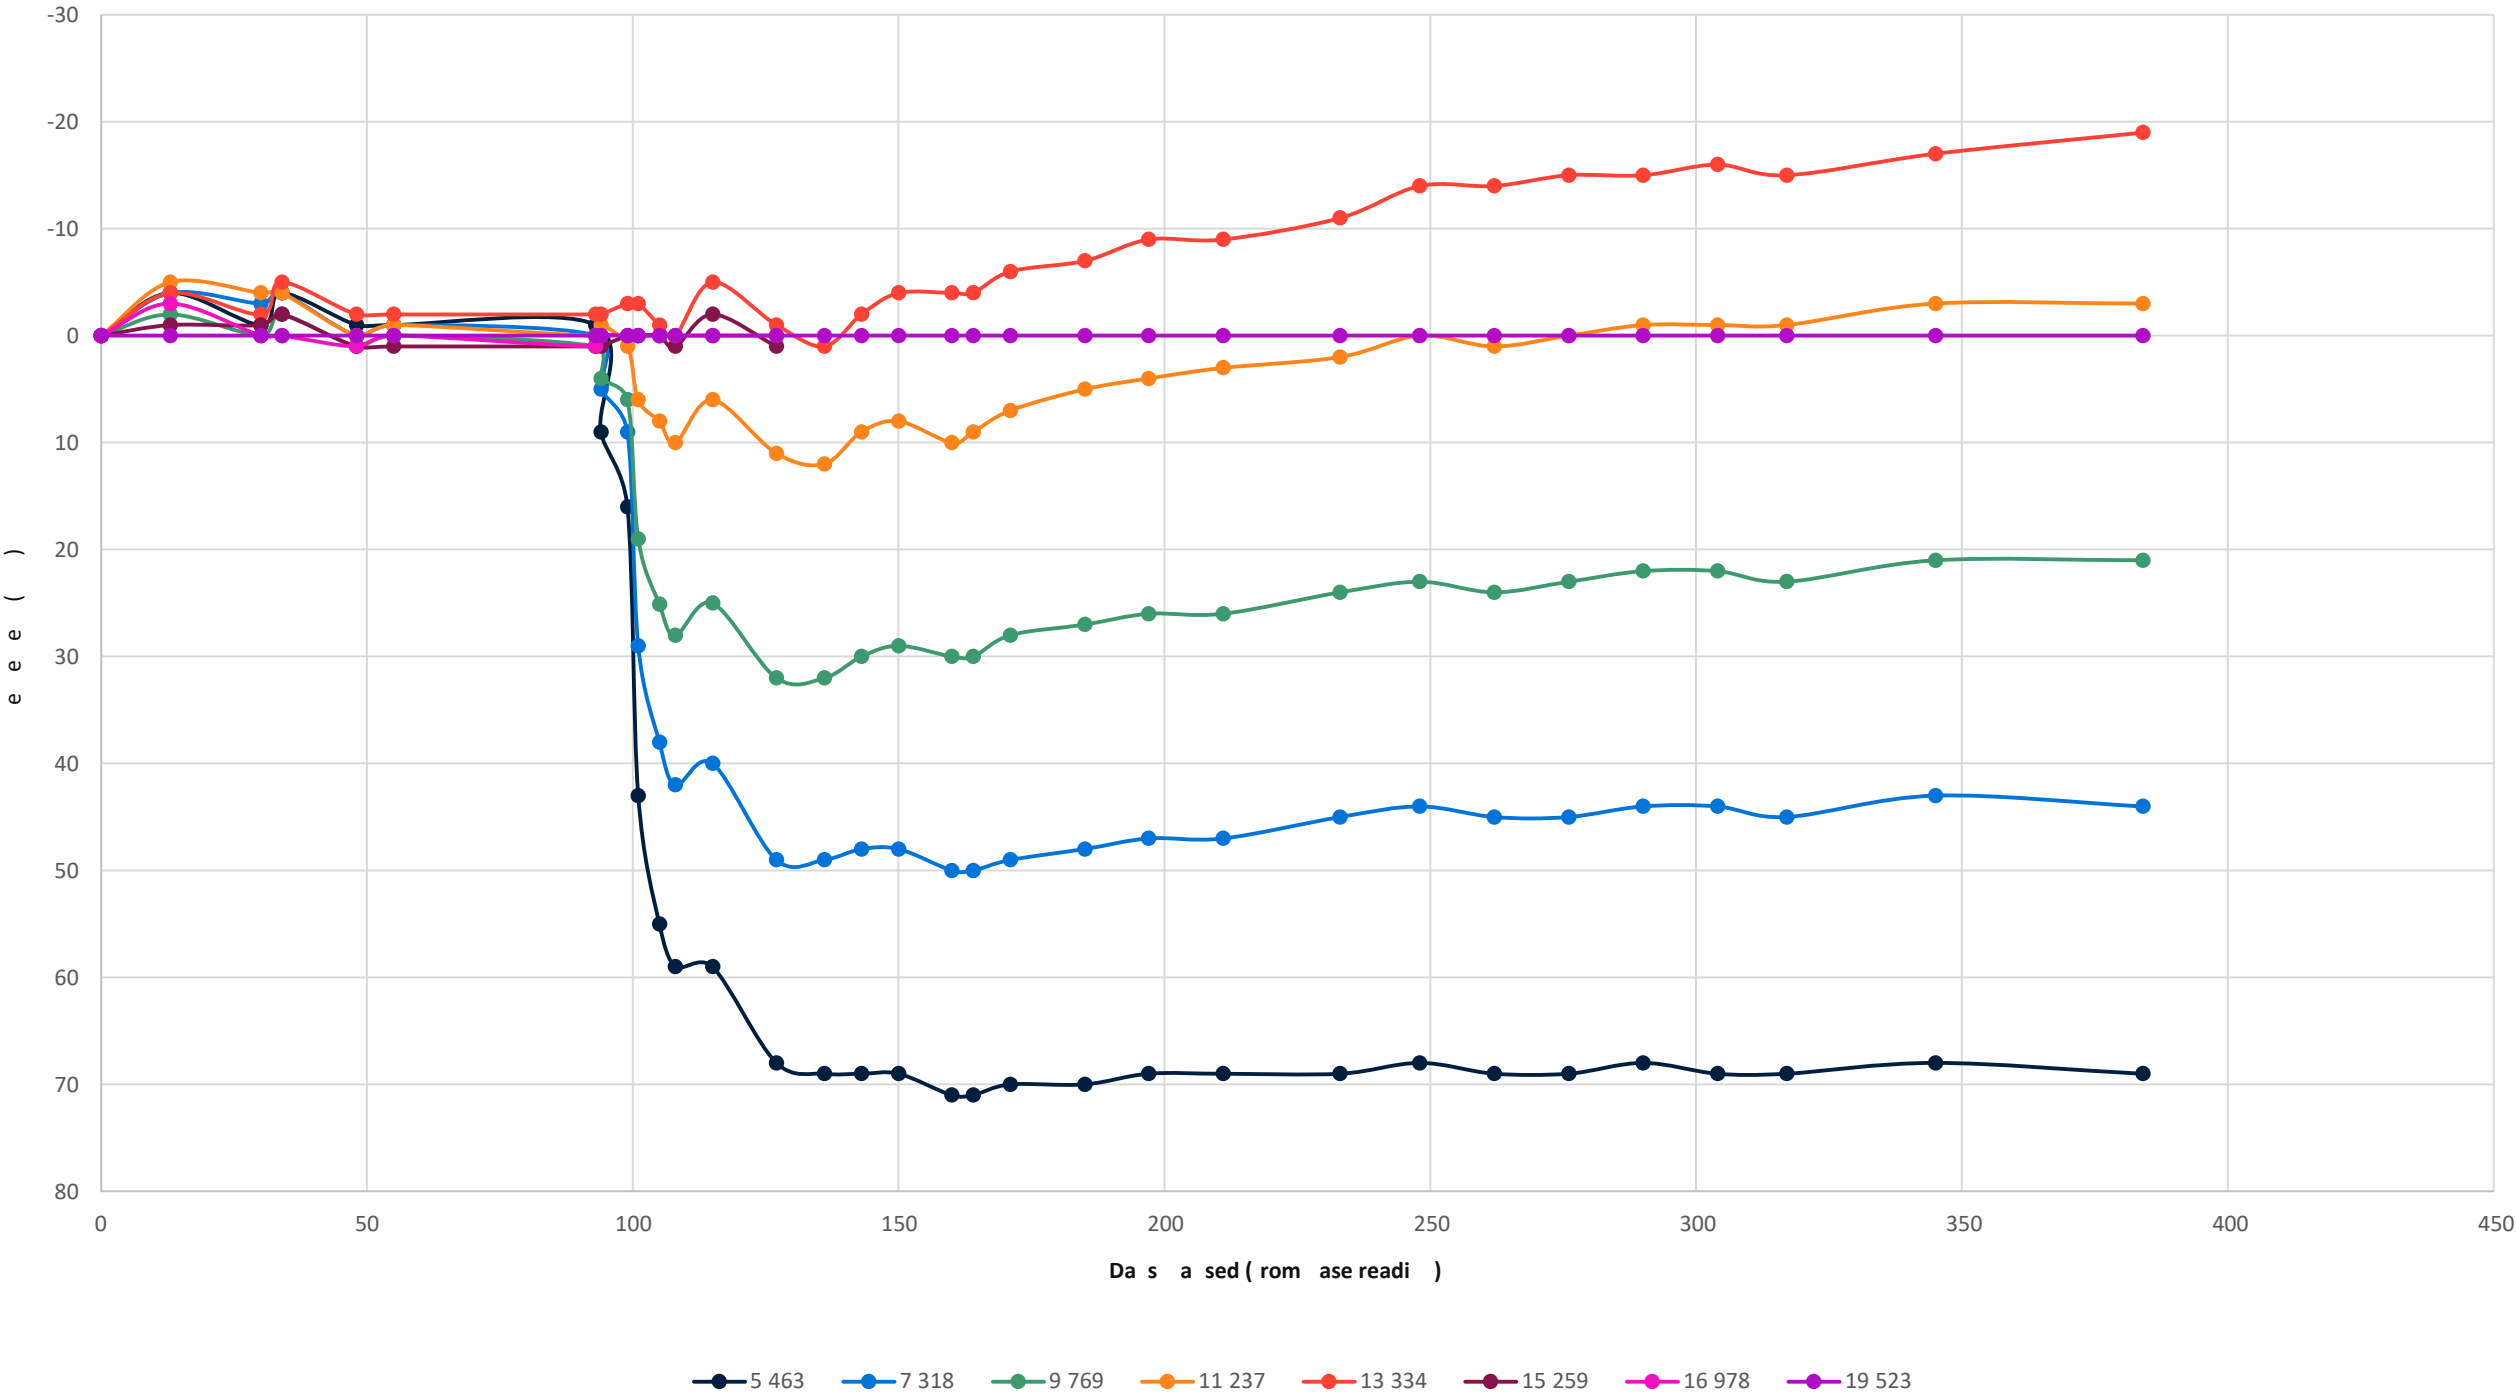
te someters - BH10

- 3.3.5 BH106 became unserviceable below 15.529m BGL after 21/09/2022. The cause is unknown. It was therefore not possible to monitor the datum magnet at the base of the borehole after this date. Normally this would render the installation redundant as movement is calculated by determining the difference between the datum magnet and magnet of interest. However, in order to provide indicative information on the movement of the upper magnets, and as settlement of the base magnet has been stable in the remaining boreholes, the last recorded value of the datum magnet has been used for comparison with higher magnet readings after 21/09/2022 in BH106. These results should be viewed with conservatism.
