Newlay Weir Investigation

Independent review into the failure
of Newlay Weir in January 2021

Final Issue

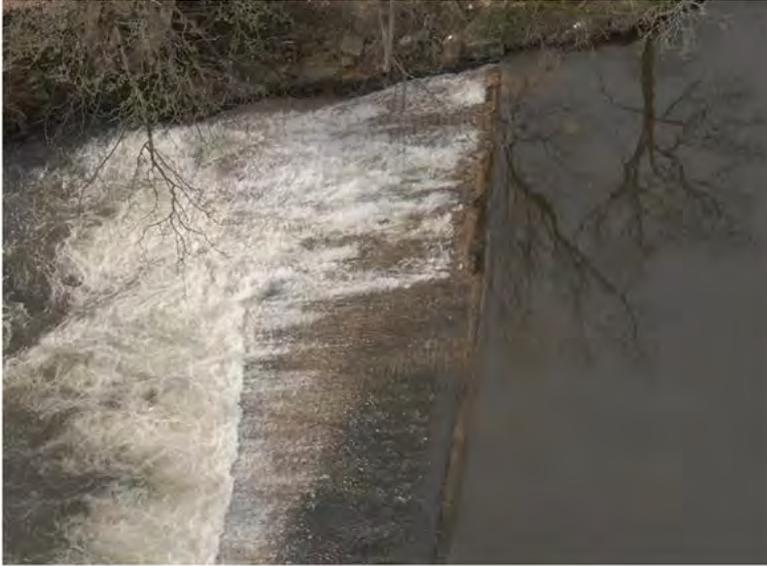
The report highlighted that some of the blocks near the location of the proposed work have been compromised. These blocks appeared to have buckled / displaced from the curved shape of the weir in the location of the fish pass construction area (Figure 12). There were no missing blocks or apparent surface damage or wear on the crest of the weir. There was minimal debris to the top of the weir. A pre-condition photographic survey undertaken by Fishtek^[5] on the right side of weir face shows turbulent flow which indicates irregularities in the surface of the weir, supporting AECOM's observations.

In the location of the proposed fish pass, the slope appeared to be consistent in gradient, and flow over the slope was uniform indicating that the surface was potentially free of surface damage and erosion. However, in the area adjacent and downstream of the buckled weir blocks, the slope surface has been eroded with displaced and missing stone setts. This can be seen in Figure 14 taken by the Environment Agency during the construction works, exposing the buckled weir blocks and missing stone setts mentioned in the AECOM report^[6].

Figure 12 Drone view of right side of weir (21-04-2020)

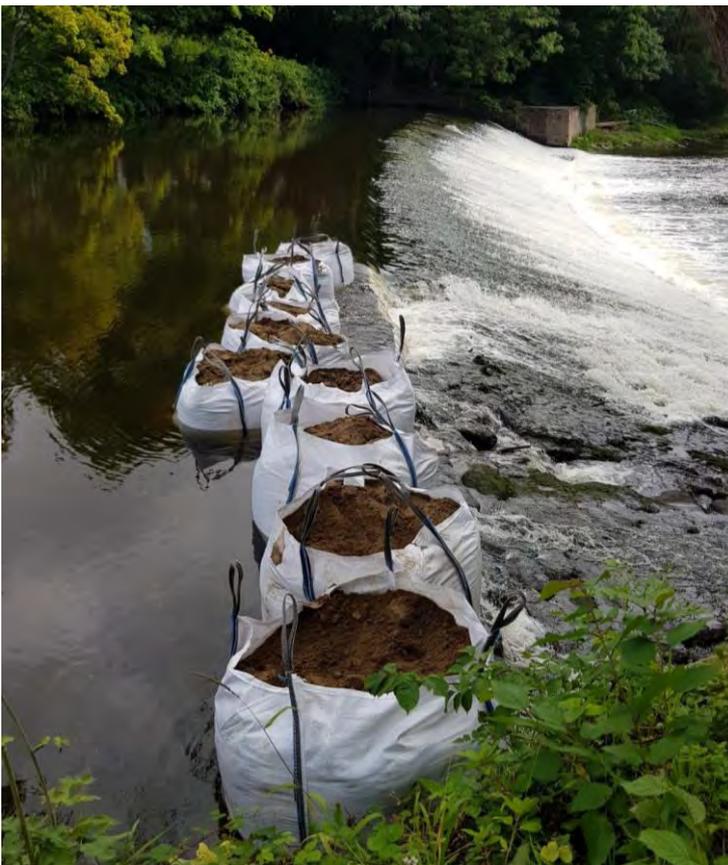
Figure 13 Sand filled bags to allow access to the weir (taken by the Environment Agency)

Figure 13 and Figure 14 show sand-filled bulk bags, placed at the crest of weir to reduce the river flow in the location of the proposed fish pass. The low flow at the time of these photographs reveals detail of the condition of the weir that is not evident from the 2018 AECOM structural inspection or the Fishtek 2020 pre-condition photographic survey.

Masonry stone setts extend to the right bank, but there are missing stone setts on the downstream face between approximately 3m to 8m from the right bank. Concrete infill repair is evident at approximately 4m from the right bank and is thought to relate to historical repairs in 1938. Deterioration of the weir is evident through missing stone setts on the downstream face, approximately 5m from the right bank between the stone setts and the concrete repair. This is in the area mentioned in the Fishtek pre-condition survey. Loss of stone setts at the top of the downstream face is also evident.

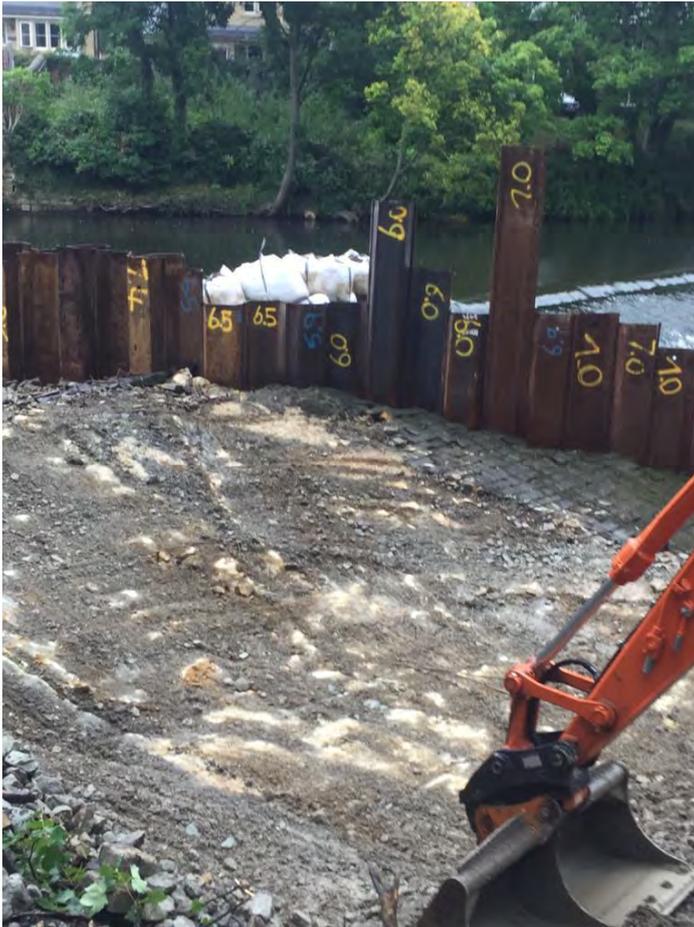
Figure 17 shows the piling installation and Figure 18 shows the installed piles. A boulder platform has been constructed upstream of the weir tying into the weir crest to allow the installation of the piles from the river using a Movax side grip attached to a 30 tonne tracked excavator. The steel piles used were between 6.0m and 7.5m in length long as depicted by the spray paint numbers Figure 18 does not appear to show removal of stone setts prior to installation of the piles.

Figure 18 Installed sheet piles

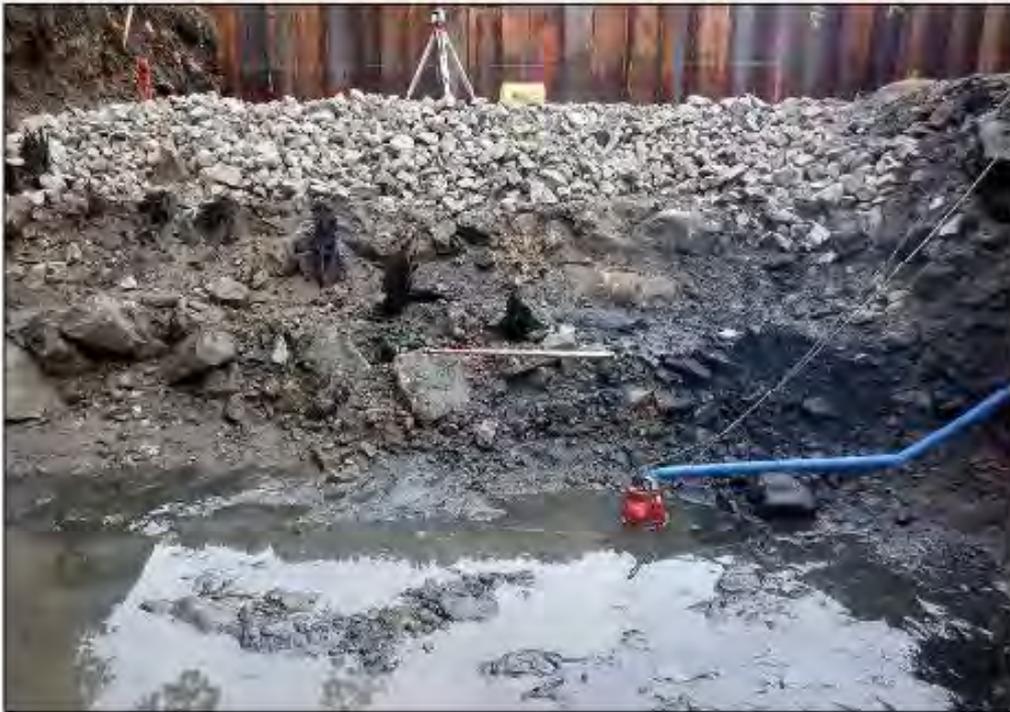
An area of the original weir face was located close to the right bank and measured c. 5m by 5m labelled as 400 as shown in Figure 19 and Figure 21. The sloping weir face was constructed of uniform dressed gritstone blocks, lain in tight rows and had a depth of 0.28m to 0.32m. The remaining surface within the trench was concrete repair labelled as 401, presumed to be from 1938. It was 0.16m to 0.27m thick. Within the concrete, scrap metal pipes had been incorporated to reinforce the surface. No original weir masonry was underlying the concrete repair. A photo of the excavation is provided in Figure 21.

Figure 21 Exposed timber uprights

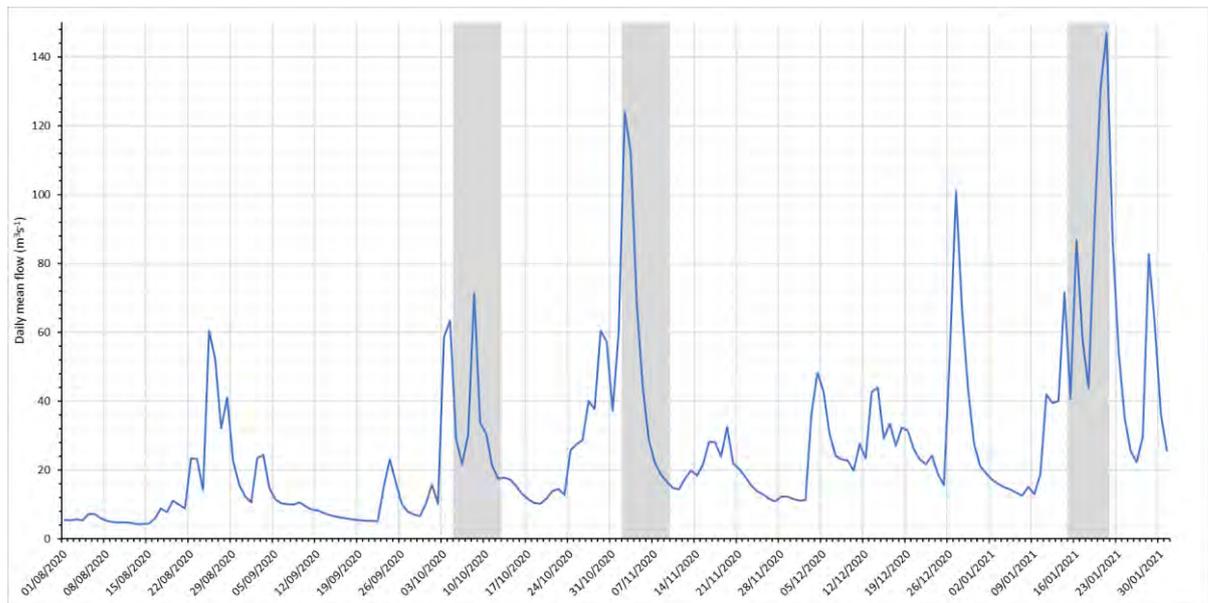
The sheet piled cofferdam was installed in the weir between the 6th and 19th August 2020. Between the installation date and January 21st 2021 when Storm Christoph occurred, high flows stopped construction work on two previous occasions (stopping for approximately a

week each time, commencing 5th October and 2nd November). In addition, prior to the 21st January, work had been stopped for about a week due to high flows. The periods when construction work was stopped due to high flow is shown in Figure 25. Site work was also paused during the Christmas break during which a high flow event occurred on 27th December. This has not been included in Figure 25 because this pause was not a direct result of flow conditions although it is possible that work may have ceased at some point during this period due to a comparable high flow event at the end of December.

Figure 25 Daily mean flow at Armley between 01/08/2020 and 31/01/2021 with periods (in grey) when flow was too high to carry out work on the fish pass

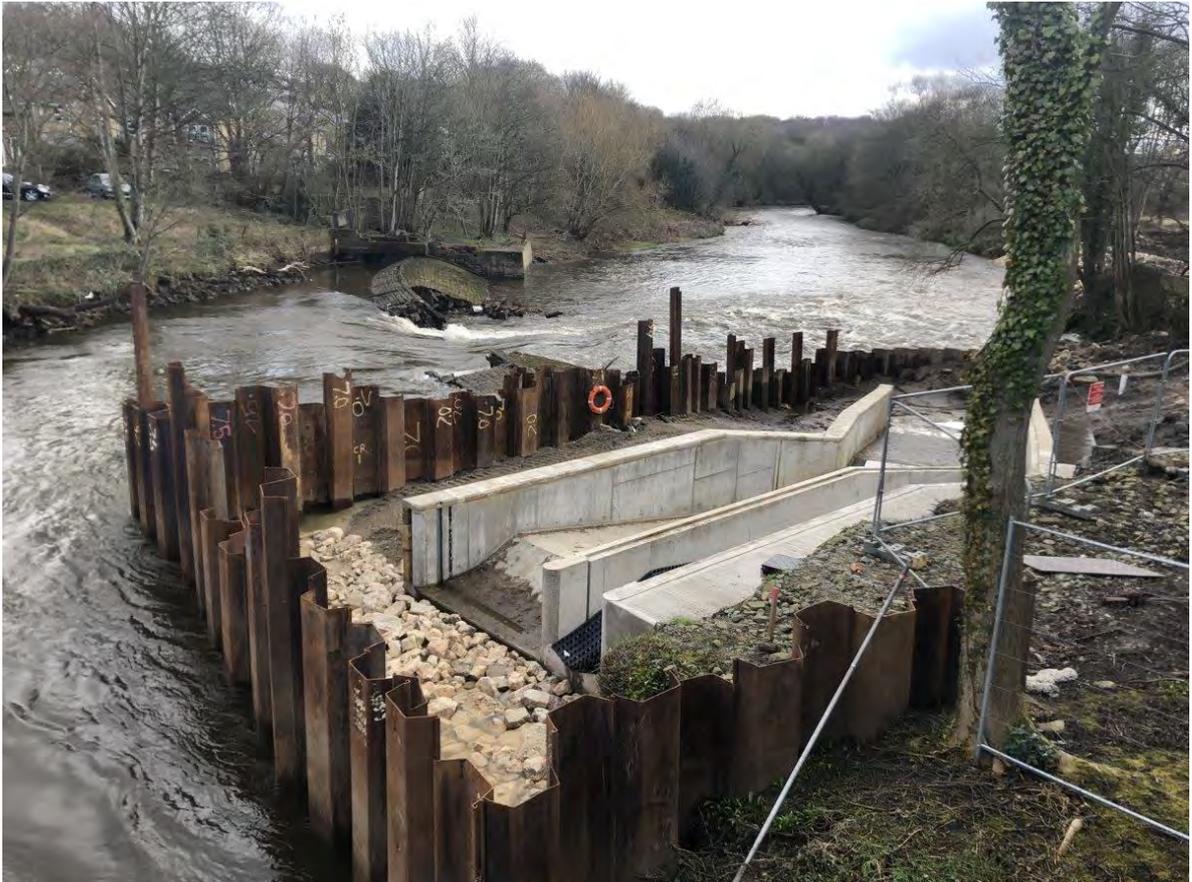
The height of the sheet piles during construction was more difficult to determine as no as-built survey information was provided, but photographs taken whilst the sheet piling was still in position (e.g. Figure 26 allowed these heights to be estimated, by comparing the level of the piles in relation to the height of the fish pass (known to be 1.5m), and the standard height of the Heras fencing on the bank (2m).

Figure 26 The collapsed weir during construction of the fish pass

As can be seen in Figure 26 and Figure 27, most sheet piles were installed to a height greater than the stipulated 600mm below the top of the adjacent bank. It is acknowledged, however, that defining what constitutes as being the “top of bank” is problematic.

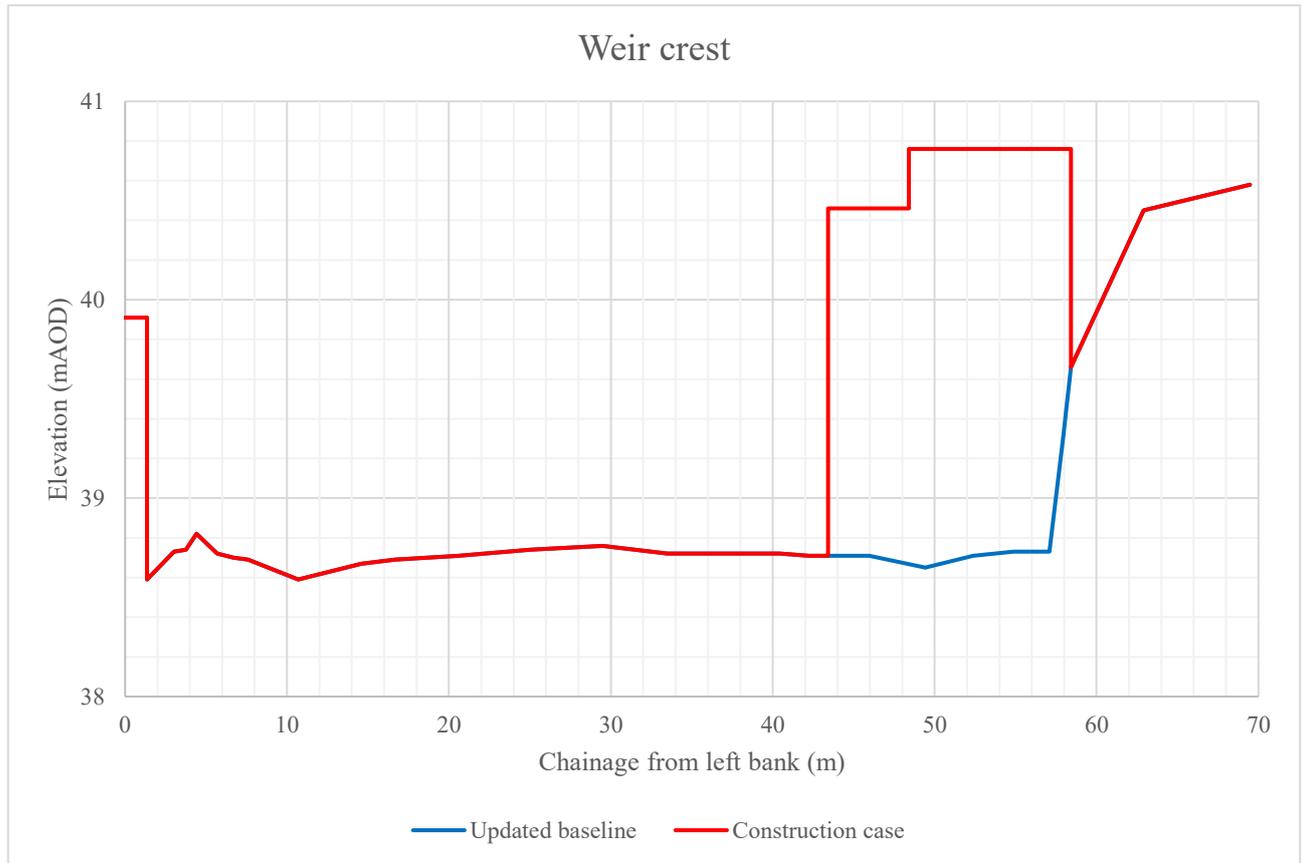
the weir. It was found that the net effect of the sheet piles was to reduce the effective width of the weir crest from 55.7m to 42.1m, a reduction of 25%.

The height of the sheet piles has been estimated based on photography as approximately 1m above ground level on the land side, reduced by 0.3m further in the channel. See Figure 27 for details of how this and the spill profiles are represented in the baseline and construction models.

Figure 27 Comparison of updated baseline and construction case cross-section for the weir crest

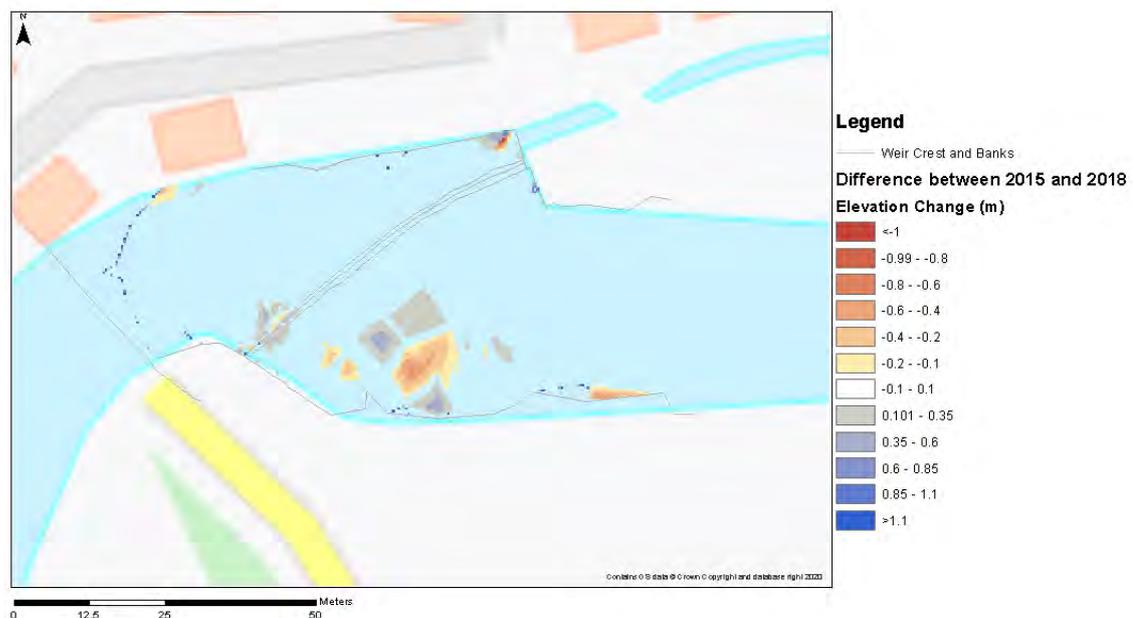
Figure 31 DEM difference plot between 2015 and 2018 surveys

Figure 31 shows that between 2015 and 2018 there was very little change observed in the bed levels both upstream and downstream of the weir. The pool located downstream of the weir deepened by up to 0.8 m at its deepest point with the majority of the pool area deepening by 0.1 m to 0.4 m. There is also some minor accumulation of sediment observed directly upstream of the pool with bed levels increasing by 0.2 - 0.5 m.

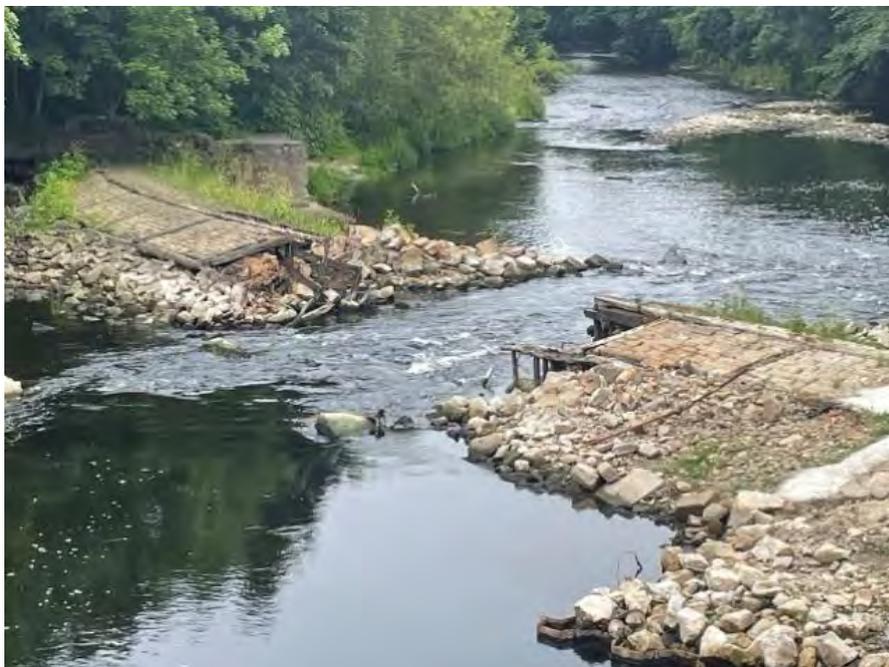
Figure 35 Breached Weir (June 2021)

As can be seen in Figure 35 and the topographic survey data, sediment has accumulated immediately downstream of the weir creating a riffle feature, filling in the downstream scour pool with material likely to comprise mainly of the collapsed weir. Further downstream, a bar has developed (Figure 36), likely to be formed from material entrained downstream during

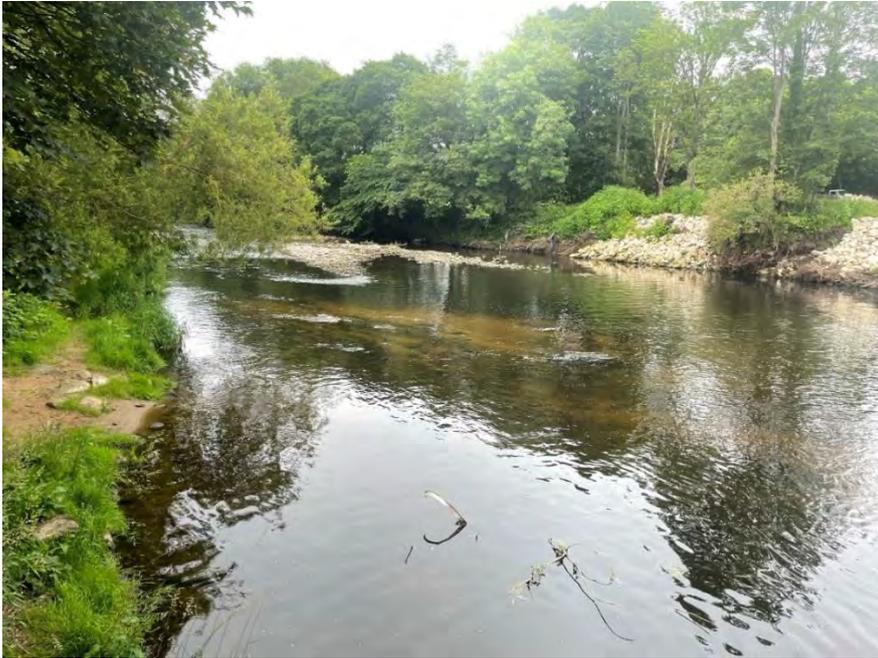
Figure 36 Bar formed downstream of weir

high flows that occurred after the initial breach and/or material from the bank collapse that occurred on the right bank during the high flows after the breach (see lighter colour stone that has been used to repair the failure).

There is also a large area of erosion on the right bank downstream of the weir which again aligns to the main flow of water post-breach. It is likely that the bed immediately in the path of this flow (Figure 39) would have been deeper after the initial breach, but the bank collapsed at this location (reported 08/02/2021) and was repaired (18/02/2021) with stone (as noted in Figure 36) filling in the deeper scour area that would have formed, resulting in the bank collapse.

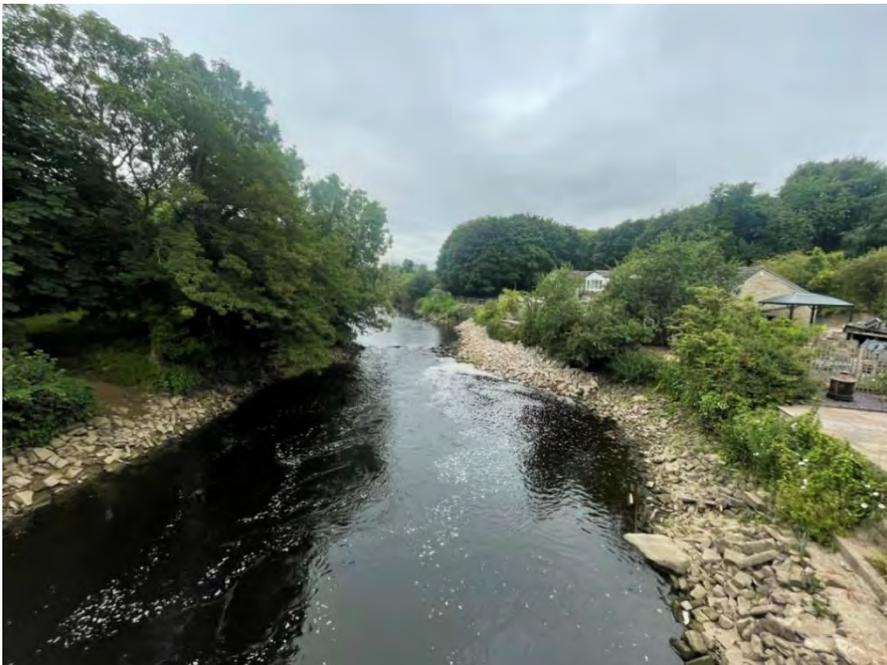
Figure 37 View of the channel upstream of the footbridge

Upstream of the Newlay Bridge (Figure 37) water levels have dropped significantly and are now fast flowing (in comparison to the ponded reach that was present when the weir was intact).

There is still little geomorphological diversity in this reach, apart from the exposed foundations of the Monks Bridge crossing that can be seen in the upstream extent of the photo. The recent stonework on the left bank has been installed to protect the toe of the bank which had been exposed as water levels had dropped, where properties were considered to be at risk.

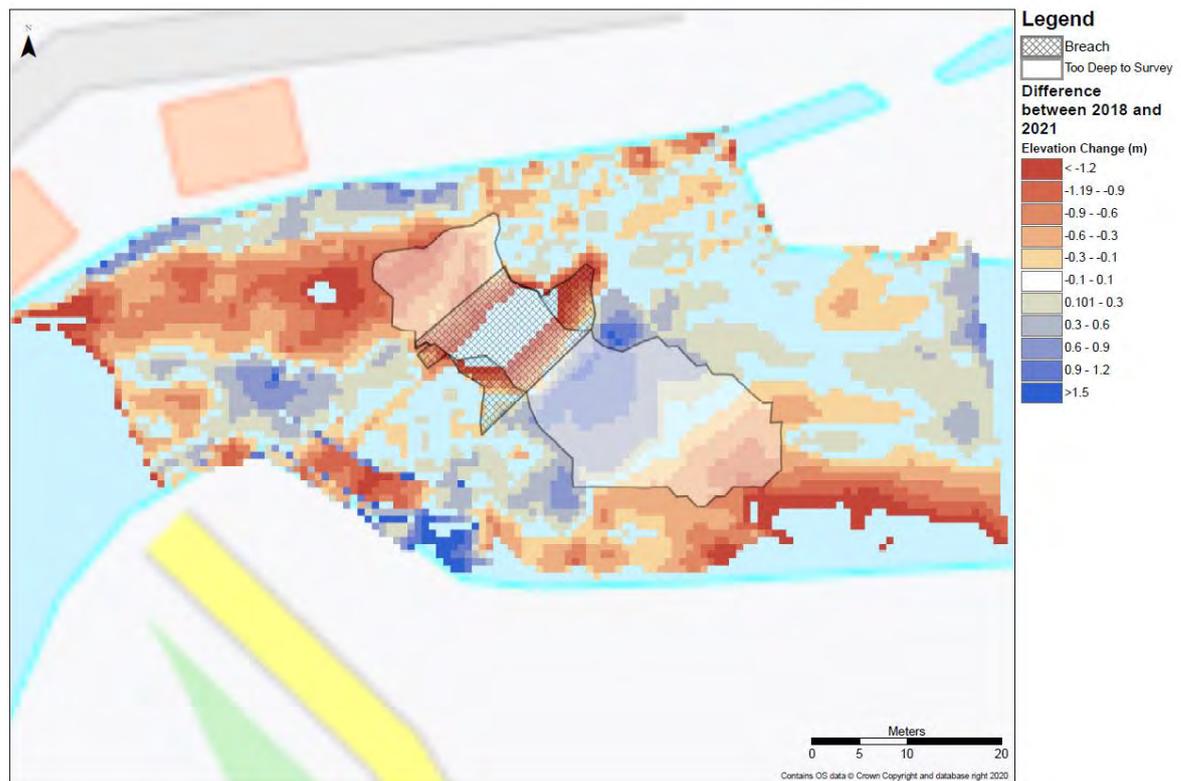
Figure 38 Net elevation loss and gain at Newlay Weir between 2018 and 2021

As observed in the site walkovers and photos, the DEM difference plot shows that following the breach there has been significant change to the channel topography. Firstly, upstream of the weir, erosion of the bed (approximately 1 m lowering) has occurred within the middle of the channel, where the large scour hole under the Newlay bridge, extending towards the weir, was observed in 2015 and 2018. This feature has extended further into the centre of the channel, creating a new thalweg through the breach in the weir. This large-scale scour is likely to have happened predominately during high flows after the initial breach as water levels dropped and the impounding nature of the weir was lost.

Deposition is also evident with the plots within the vicinity of the breach although, as the area where the main flow of water is currently flowing, water levels and velocities meant that the bathymetry of the bed was not directly surveyed in 2021 in the area depicted in Figure 38.

However, the DEM was able to extrapolate levels from surveyed points and provide an estimate of current bed levels, with the exception of the weir itself, allowing an estimate of bed level changes in this area to be made.

As such it is likely (as was observed at lower flows) that the pool identified downstream of the weir in both the 2015 and 2018 topographic surveys has been infilled with a bed level changes of approximately 0.3 m to 0.9 m.

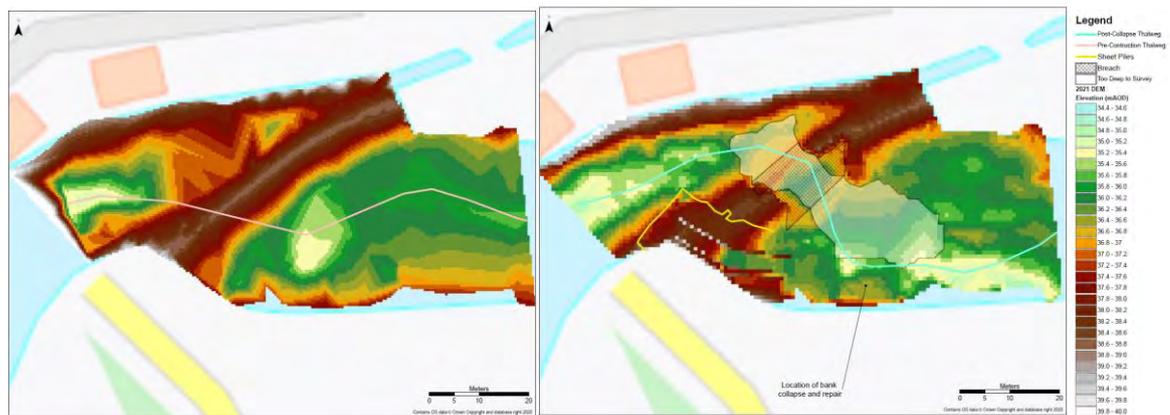
Figure 39 DEM plots from 2018 and 2021 with corresponding thalwegs

Analysis of the DEM outputs and topographic survey allows long profiles to be extracted that show the route of the thalweg both pre and post collapse (Figure 39). The long profile presented in Figure 40 compares the 2015, 2018 and 2021 elevation data along the post-collapse (2021) thalweg, clearly showing how the bed levels have changed since the collapse of the weir and supporting the discussions above.

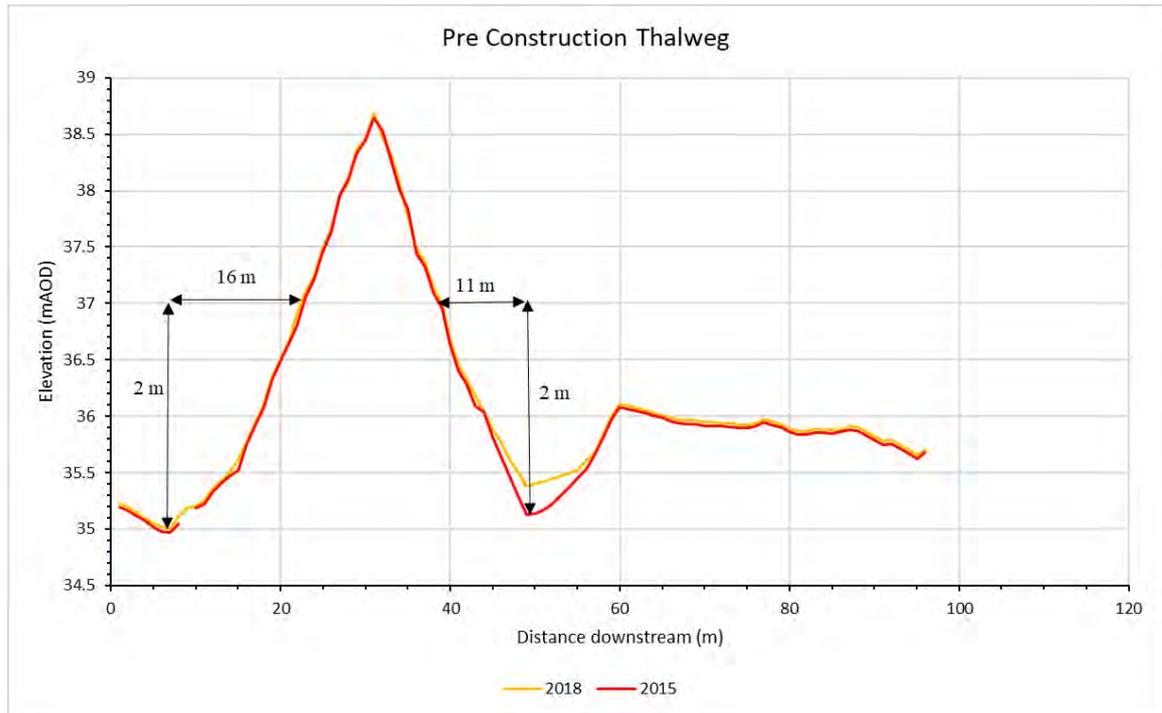
Figure 41 Long profile 2018

The 2018 survey long profile data (Figure 41) shows that the large scour hole under Newlay Bridge was over 16 m away from the toe of the weir (surveyed in at 37 mAOD) with a difference of 2 m from the bottom of the scour hole to the toe of the weir (1 in 8 slope).

Downstream of the weir there is a similar profile and approximately a 1 in 5.5 gradient from weir toe to bottom of scour hole. It is unlikely that the gradient of this profile alone would have resulted in a collapse of the weir without some other influencing factor. Therefore, we need to understand what might have changed and how this may have resulted in the collapse of the weir.

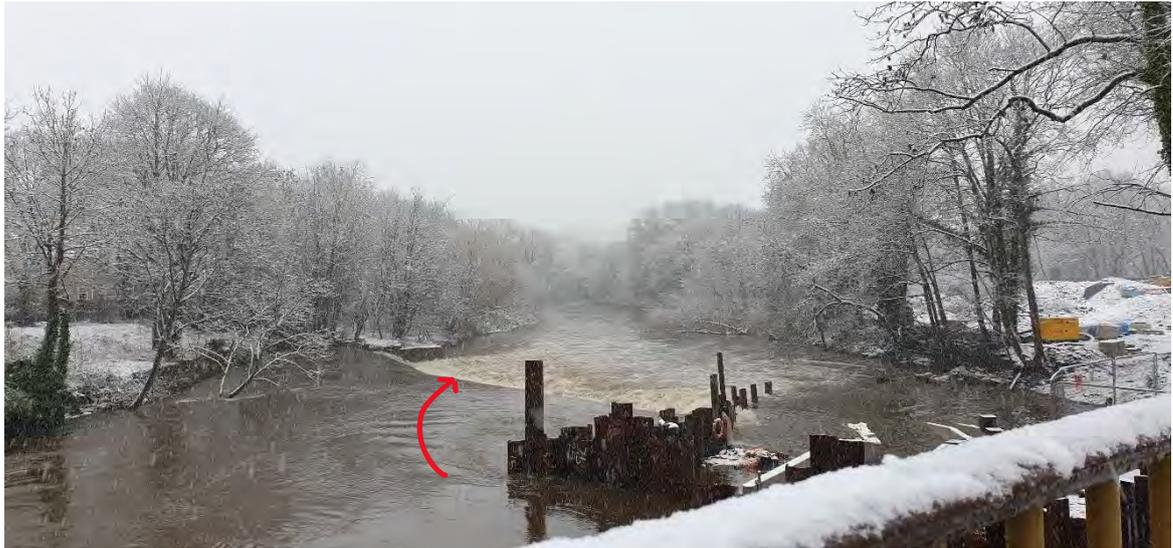
Figure 42 Photos taken on 14th January (public survey photo)

However, during higher flow events, the flow dynamic appears to change with the upstream corner of the sheet piling influencing the flow more as shown in Figure 42, forcing the main flow of the water towards the centre of the weir.

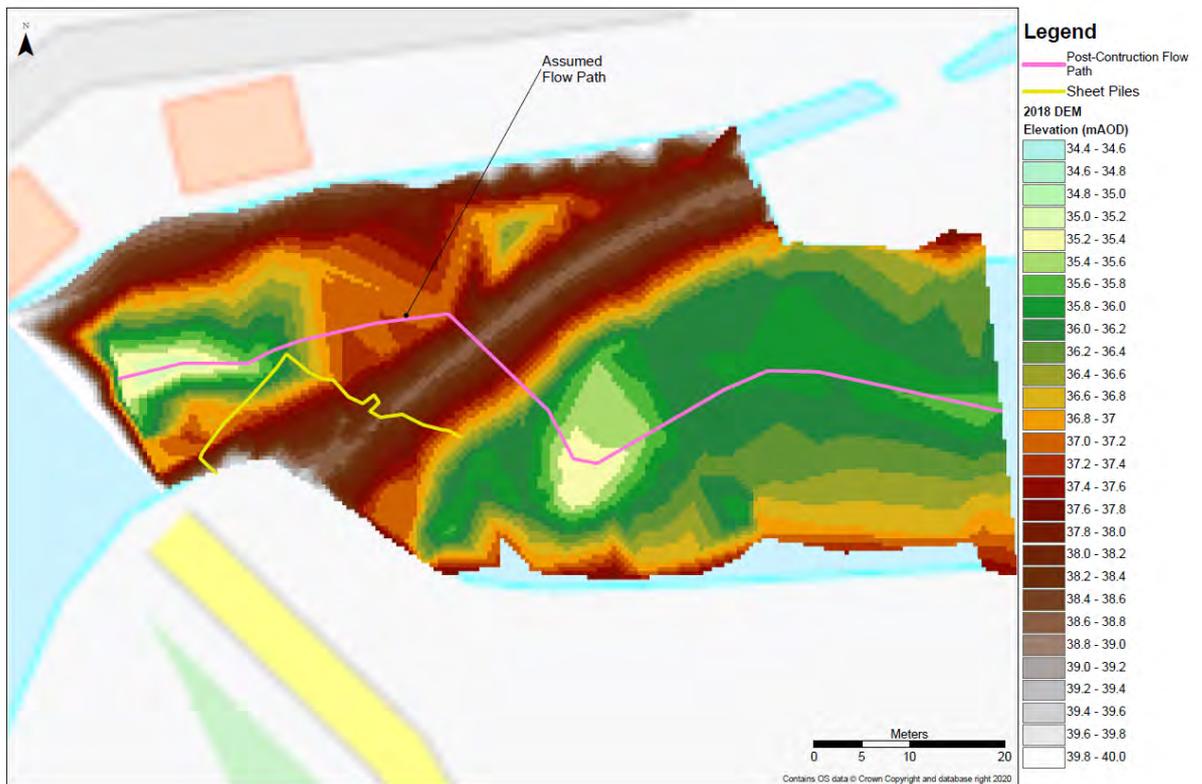
Figure 43 2018 DEM with sheet piles and assumed flow path during construction

With the raking angle of the sheet piles directing the main flow across the face of the weir, as shown in Figure 43, and the reduction in channel functional width by 25%, resulting in an increase in velocity over the front face of the weir of 10% (as detailed in Section 4.2.5) during a 1 in 5 year event; it is possible that these changes have caused erosion at the toe of the front face of the weir resulting in the collapse of weir. The angle of deflection can be observed

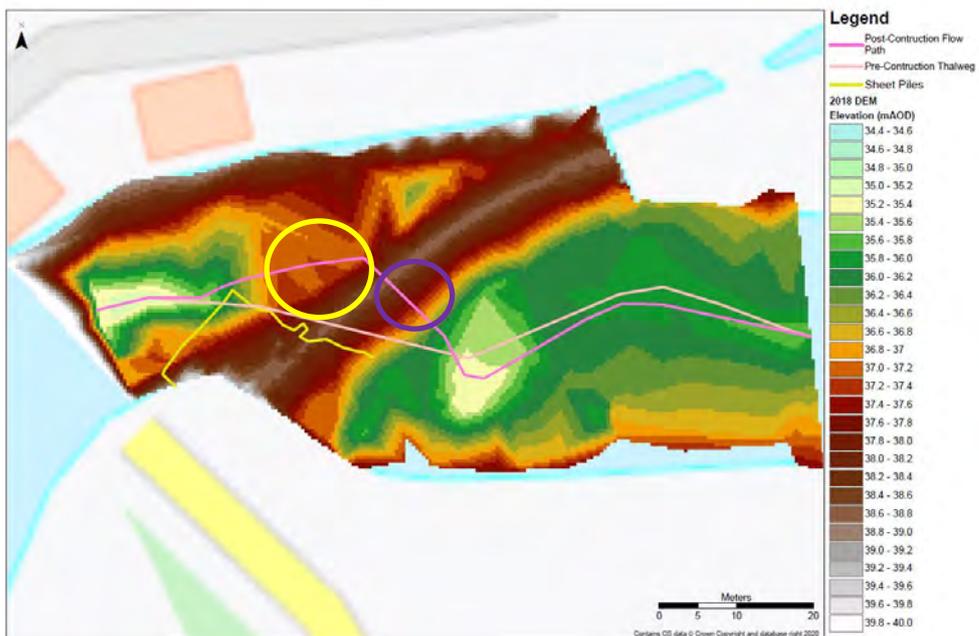
Figure 46 DEM plots 2018 with pre-construction and during-construction flow paths

The morphological response to this change in flow dynamics and increase in velocities can also be interpreted using the images in Figure 46 and the long profile in Figure 47 shows the DEM generated for the 2018 data with two different flow routes for pre-construction and during-construction.

The first flow route (blue line) as expected, follows the deepest part of the channel and flows over the crest of the weir in the general vicinity of the fish pass construction area. Due to the presence of the sheet piling, the second flow route during construction is altered and flow is directed towards the centre of the weir crest. It is difficult, without modelling, to determine the exact route of this flow over the weir crest – but it is likely that it would be drawn towards the deep pool area downstream of the weir and return to a similar flow path as the pre-construction route.

The river bed upstream of the weir, highlighted by the yellow circle on both Figure 46 and Figure 47, and the downstream face of the weir (purple circle) will be the areas with the main focus of the flow and most affected by the changes associated with the restriction in channel width discussed in Section 4.2.5. The locations of these areas of focus are also shown in Figure 48 for both the 2018 DEM and 2021 DEM. These areas are where the initial breach took place, confirming that the restriction in the channel is likely to have had some influence over the failure of the weir.

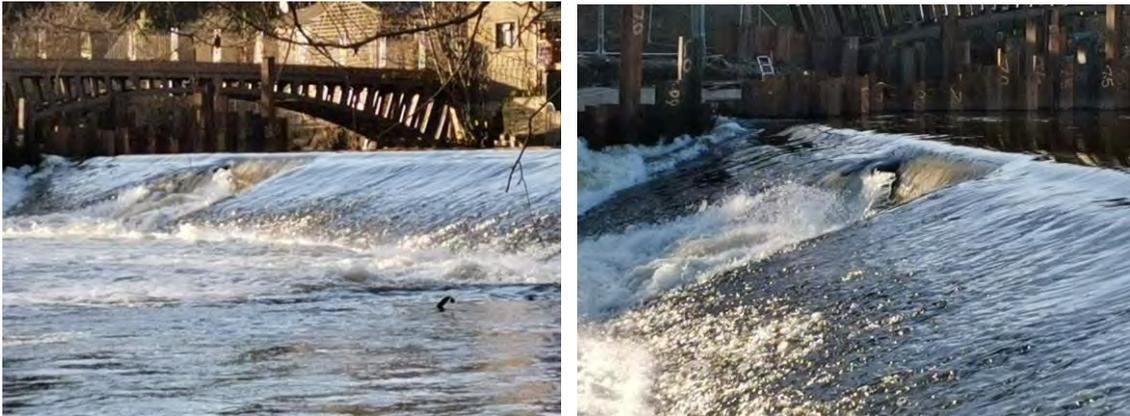
Figure 50 Photos taken on 25th January provided for the purpose of the investigation

The collapse then progressed on 25th January as the river level subsided after Storm Christoph. On this date, the concave depression on the weir is more pronounced. The 25th January is also the initial date when it is understood that a member of the public contacted the Environment Agency to report damage to Newlay Weir.

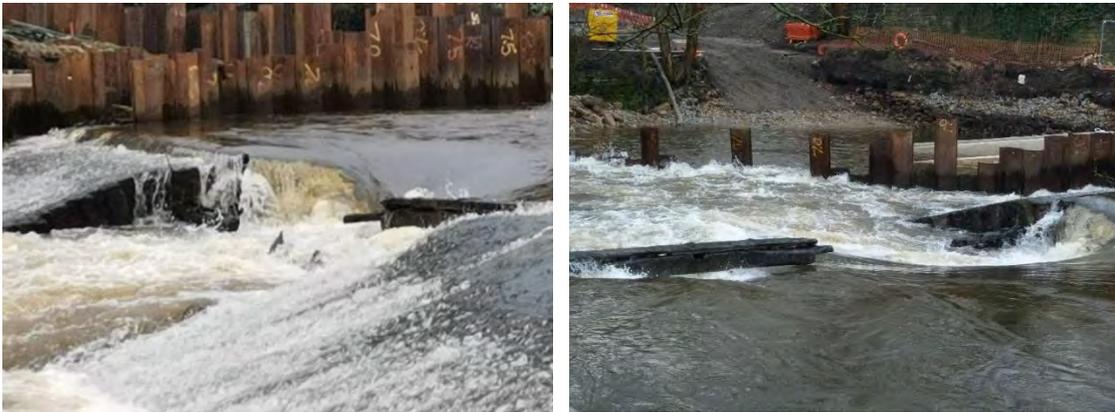
Figure 51 Photos taken on 5th February provided for the purpose of the investigation

On the 5th February, the failure has retreated upstream, breaching the upstream face of the weir, creating an opening in the weir and exposing the weir’s timber frame. Between the 6th and 7th of February, the weir has fully breached with a clear path for the flow to move through.

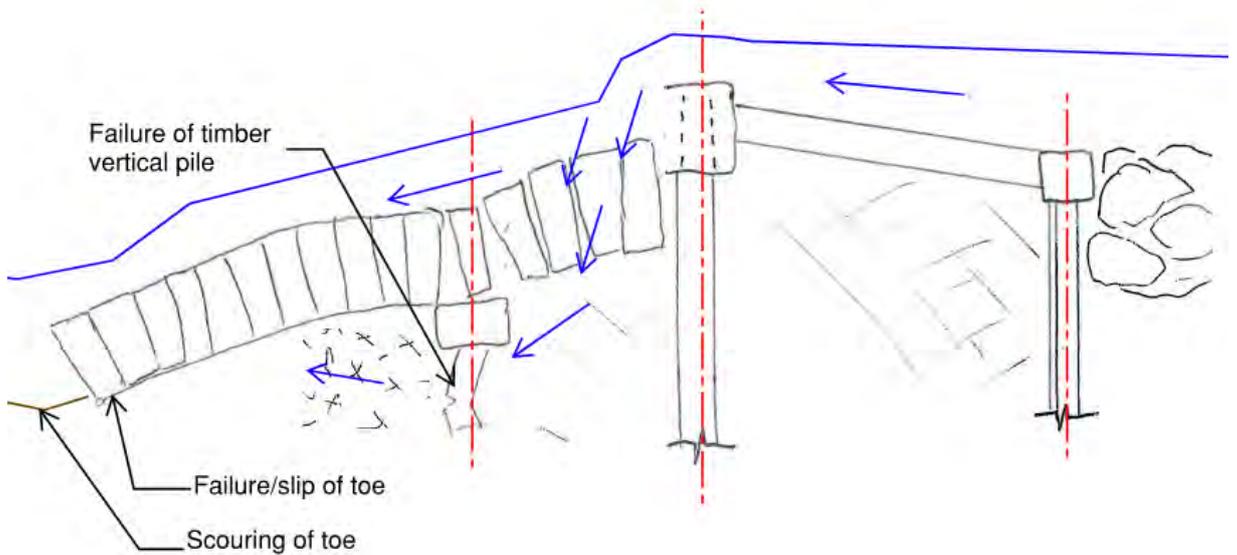
Figure 53 Stage 1 of the Predicted Collapse Mechanism

Stage 1 occurred on the 21st January; the photograph taken by a local resident (Figure 54) shows the front face of the weir has dropped and slipped. This movement then allows water to penetrate the front face of the weir (Figure 53), this will further accelerate the erosion underneath the weir and change the position of the hydraulic jump, further accelerating erosion.

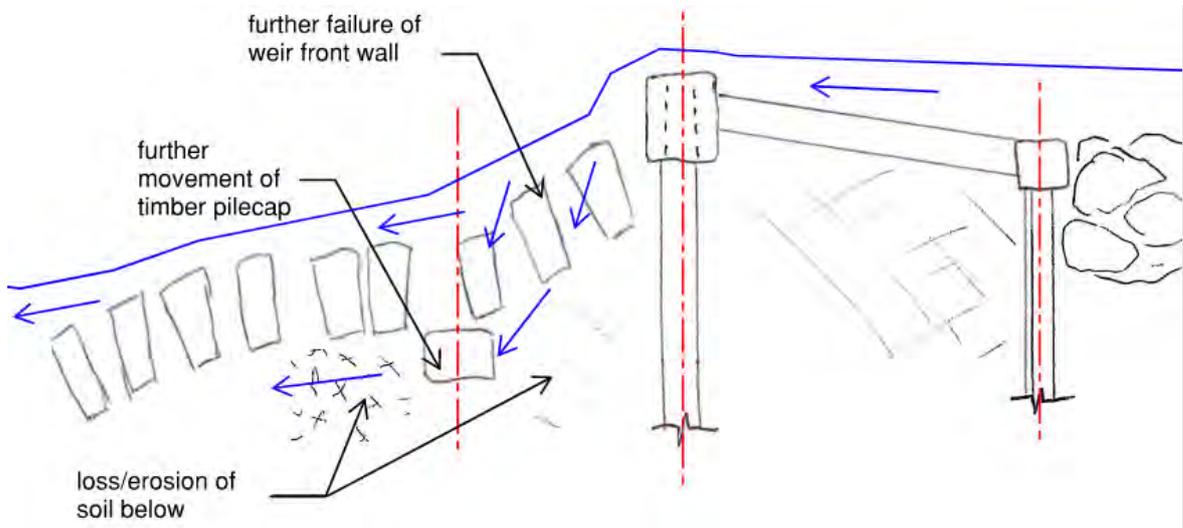
Figure 55 Stage 2 of Predicted Collapse Mechanism

Stage 2 was the process of further erosion to the front face (downstream) of the weir. Due to the gaps created by the toe failure the front face is no longer impermeable, and water can travel underneath the weir. As shown in Figure 55, the water is now weakening the structure by eroding the soil below and damaging the timber substructure underneath.

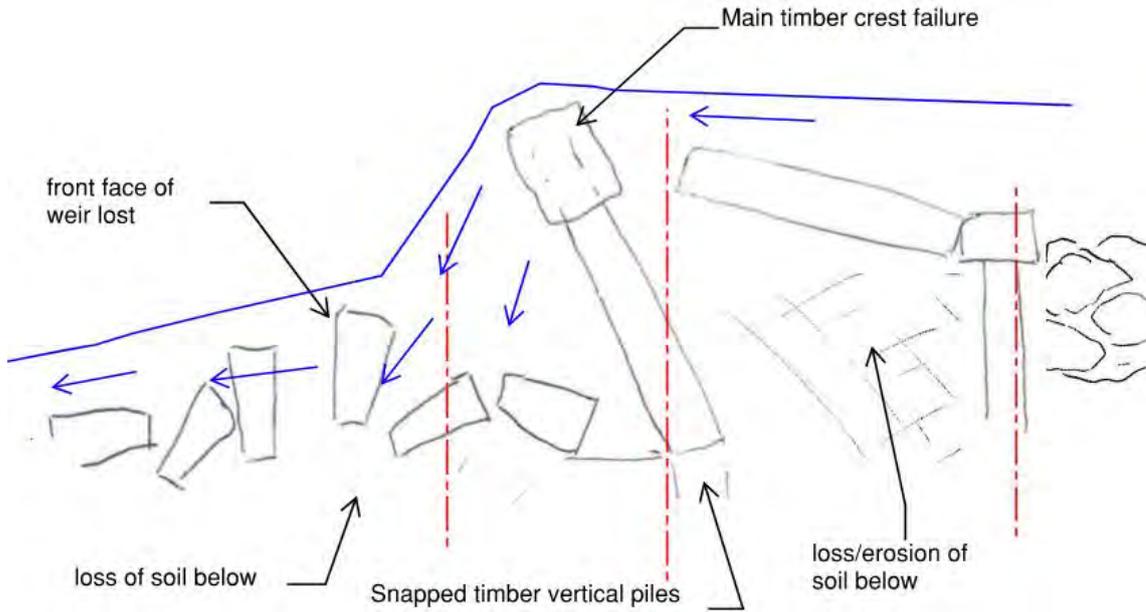
Figure 57 Stage 3 of Predicted Collapse Mechanism

Stage 3 is when the front face of the weir section has been lost due to erosion, and the passive force which was keeping the weir together has been removed. Pre-failure, the passive force for the weir came from the solid material (soil, stonework and deposits) that resists the active water pressure and soil behind the weir crest. The photograph (Figure 58) taken on the 4th

February 2021 shows that the main timber crest and vertical timber piles are the only element which are resisting the active force. The timber substructure for Newlay weir was designed as a composite structure (fill and timber) and therefore does not have enough capacity to resist this force.

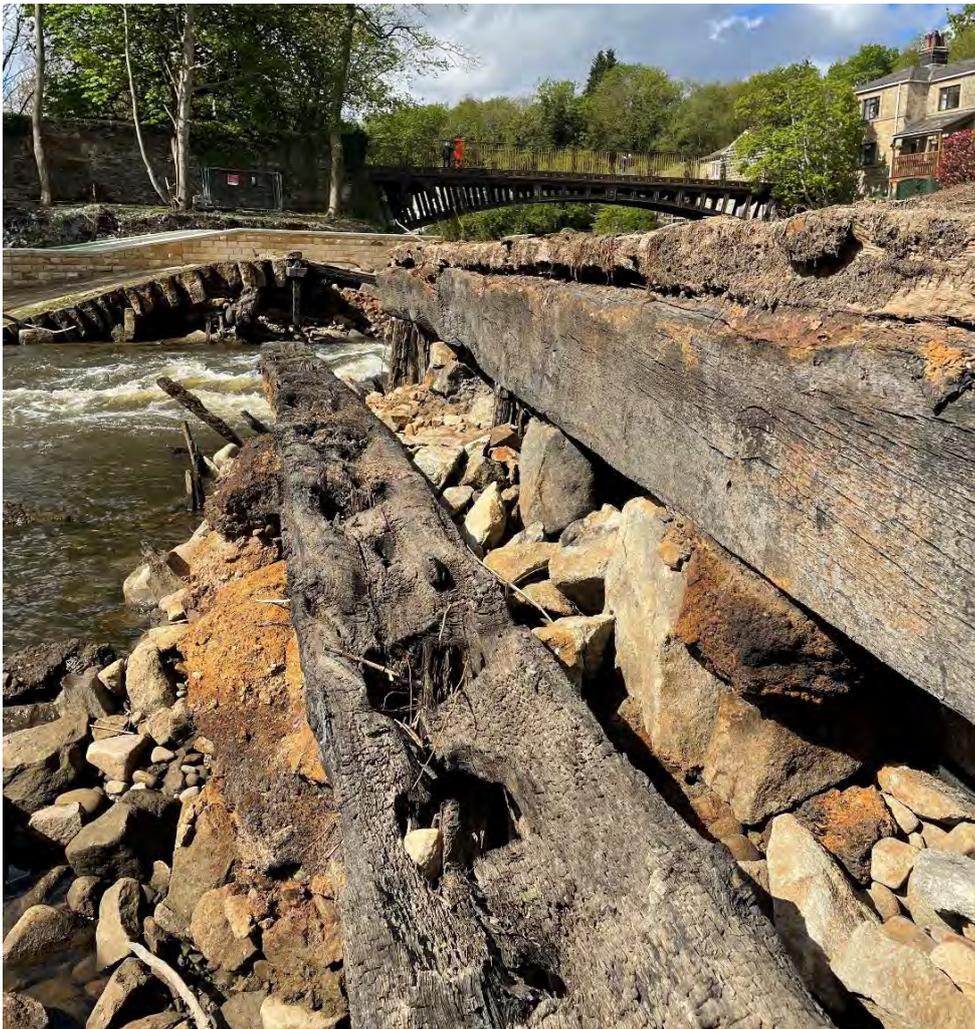
Figure 61 Site visit (11-05-2021)

Stage 5 is the when the weir is breached and the water is now flowing though this breached zone of the weir. This zone will continue to widen and the edges of weir will continue to widen until the river channel finds its natural width. Figure 61 shows the makeup of the weir and shows the zone of the breach on 11th May 2021. Figure 62 shows a plan view of the breach pre 06-02-2021 and post 06-02-2021.

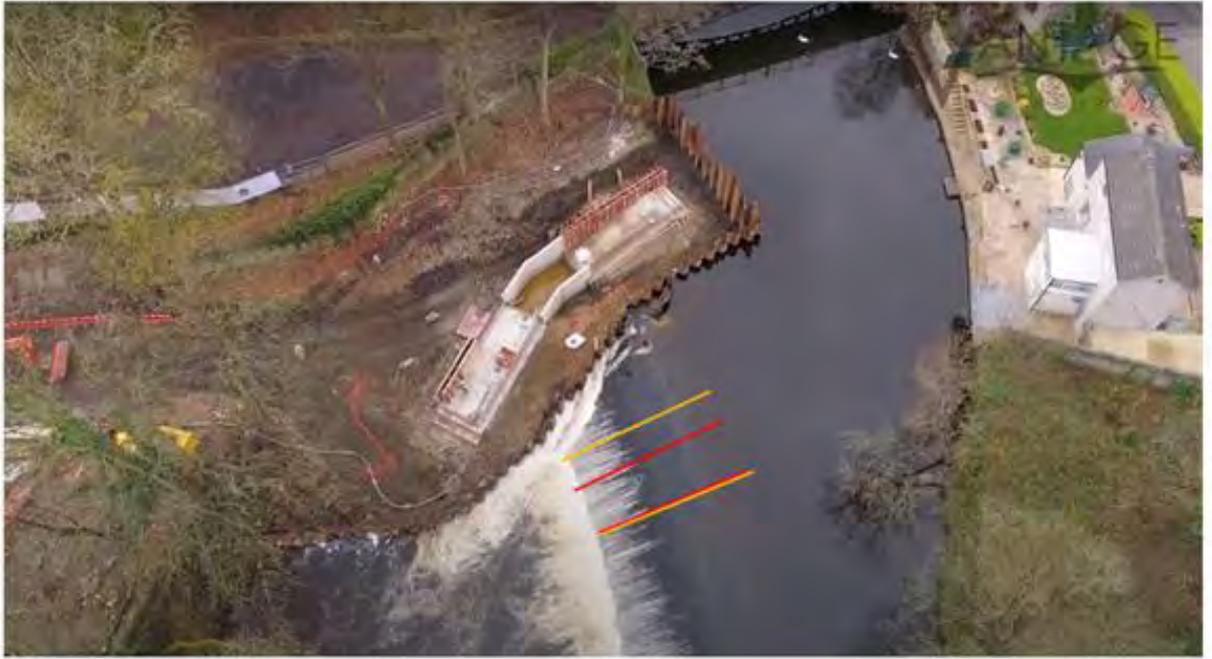
Figure 62 Plan view of breach progression (red = pre 06-02-2021, yellow = post 06-02-2021)

during low flows in relation to the area of collapse, in Figure 62. At low flows, the redirected flow almost reaches the area that the collapse initiated in. At higher flows (and therefore velocities), the zone of influence of the redirected flows would be likely to reach the red line in Figure 62.

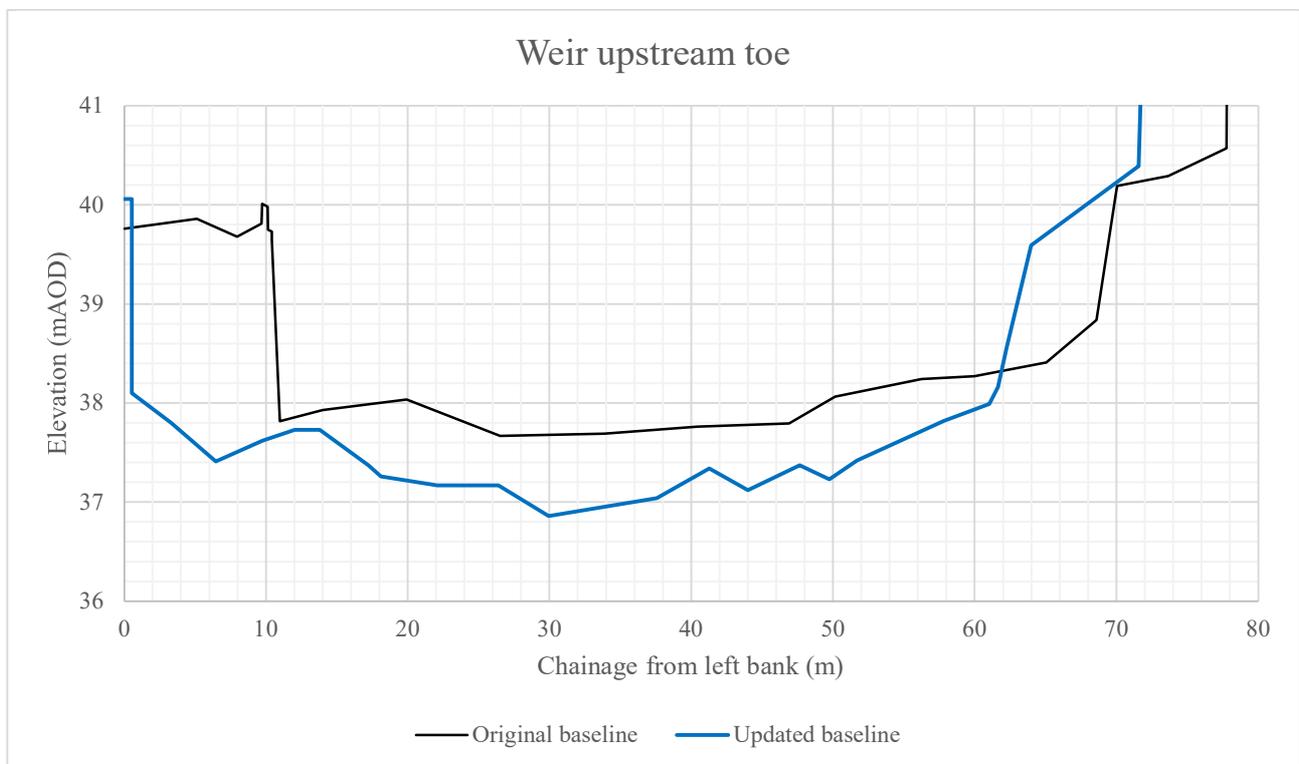
Figure 1 : Model cross-section for weir upstream toe, for original and updated baseline

The cross-sectional data for the weir upstream toe were replaced with those abstracted from the topographical survey, at a point a few metres upstream of the crest. This updated section has a slightly deeper bed level than the previous section, but the width is comparable. See Figure 1 for details.
