Newlay Weir Investigation

Independent review into the failure
of Newlay Weir in January 2021

Final Issue

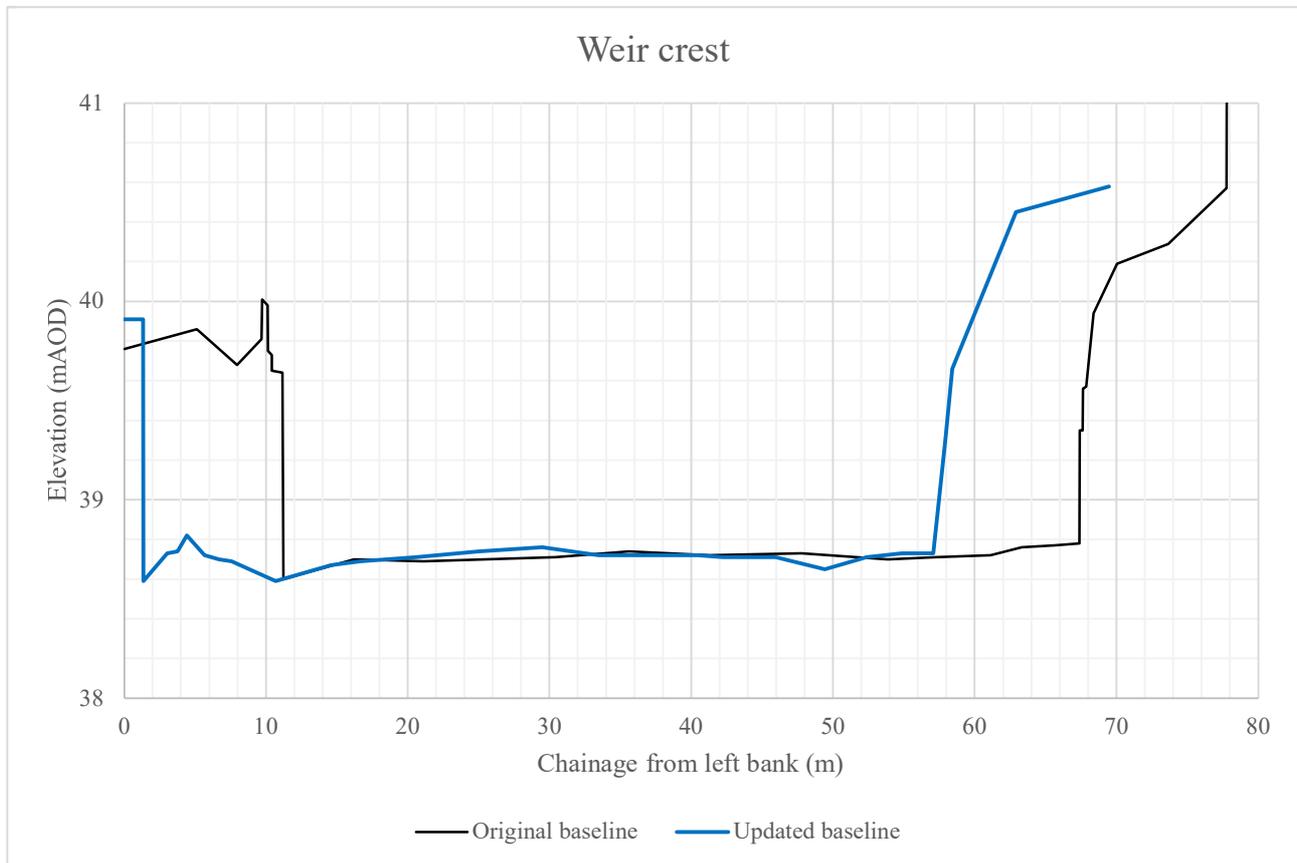
Figure 2 : Model cross-section for weir crest, for original and updated baseline

The cross-sectional data points for the weir crest were replaced with those abstracted from the topographical survey, directly across the weir crest itself. This updated section is very similar to the previous model. See Figure 2 for details.

Following the equations used to define flow across a weir, the expected result is to reduce the head over the weir by 14% for the same flow. This increase in efficiency would increase the velocity at the upstream face of the dam, for the same flowrate.

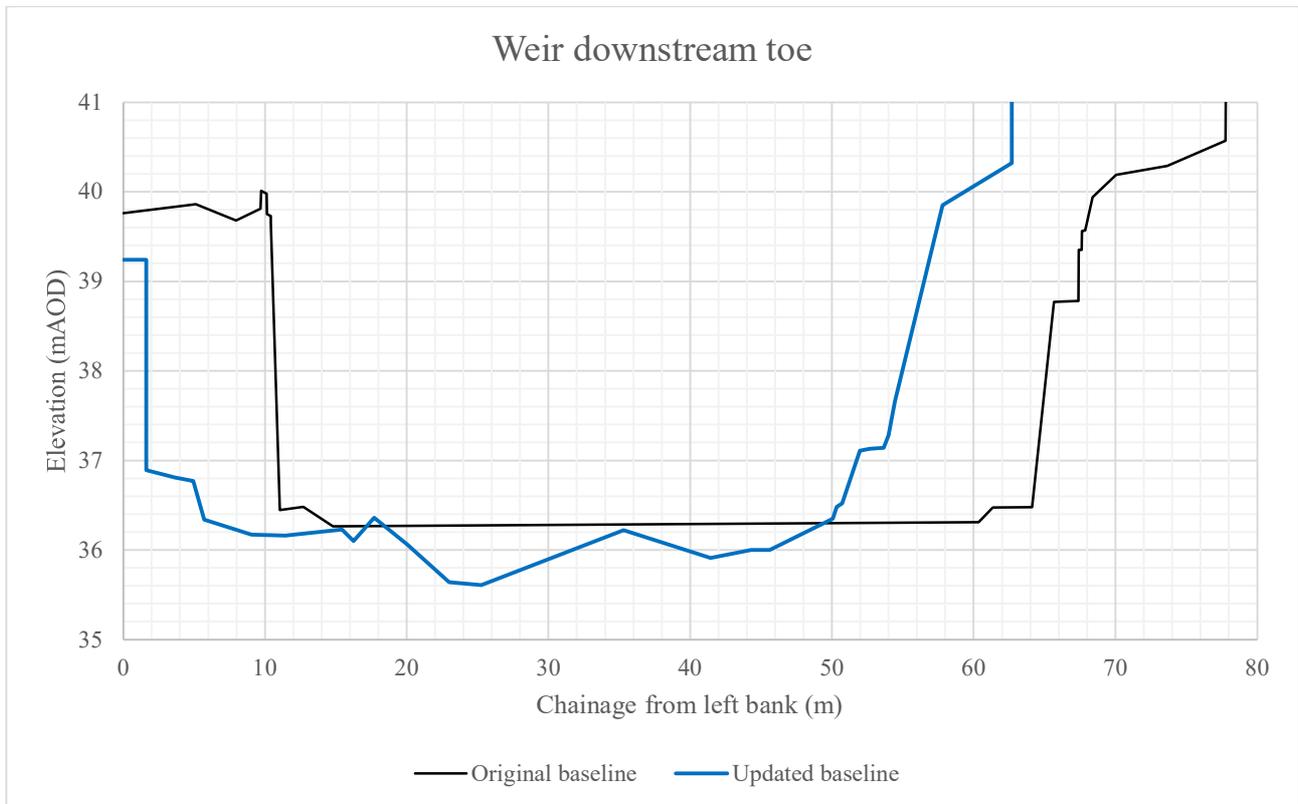
Figure 3 : Model cross-section for weir downstream toe, for original and updated baseline

The cross-sectional data for the weir downstream toe were replaced with those abstracted from the topographical survey, at the first location downstream where consistent level data were available. The bed level is lower than in the original model, but has better spatial definition. Widths are comparable between the two. For details, see Figure 3.

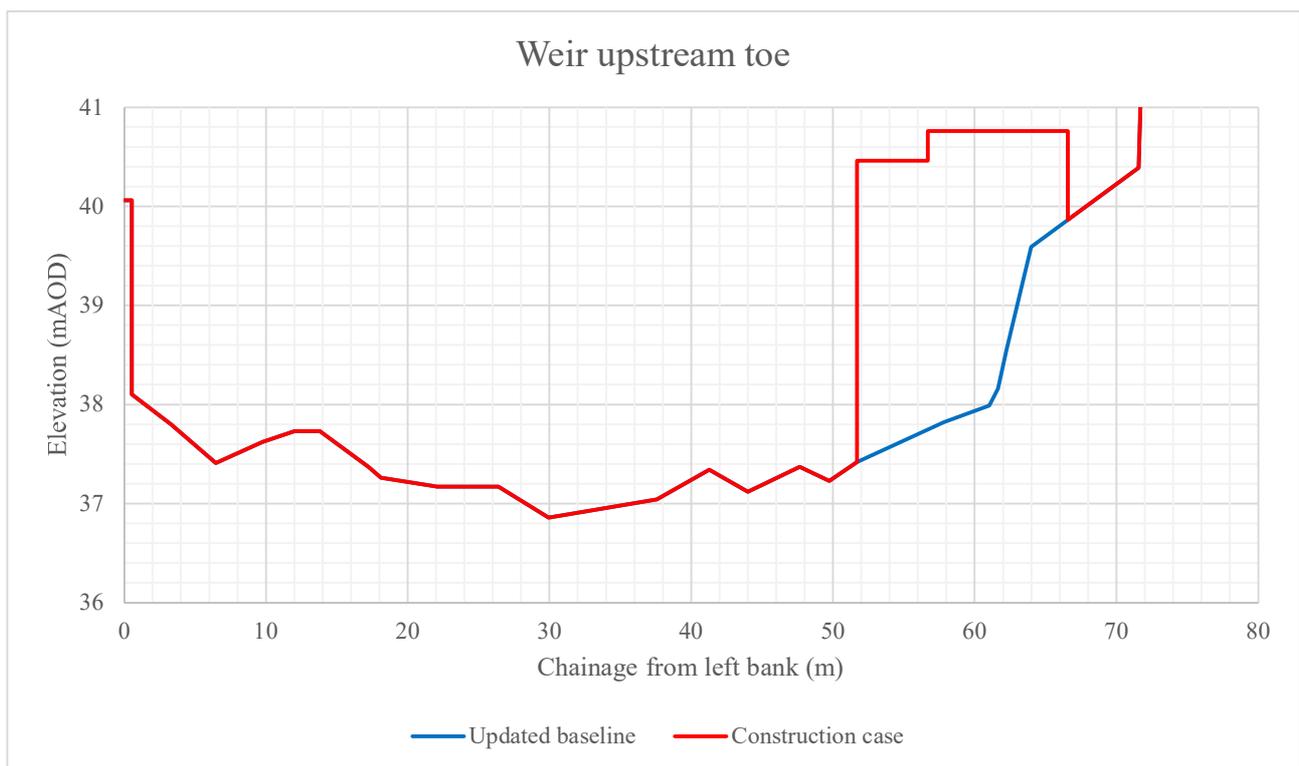
Figure 4 : Comparison of updated baseline and construction case cross-section for the weir upstream toe.

At the upstream toe, the sheet piles block off approximately 15m of the channel towards the right bank. Rather than tying into high ground, they stop adjacent to a tree, leaving a gap to one side through which high water can bypass the coffer dam and pass through the fish pass construction working area.

The height of the sheet piles has been estimated based on photography as approximately 1m above ground level on the land side, reduced by 0.3m further in the channel. See Figure 4 for details.

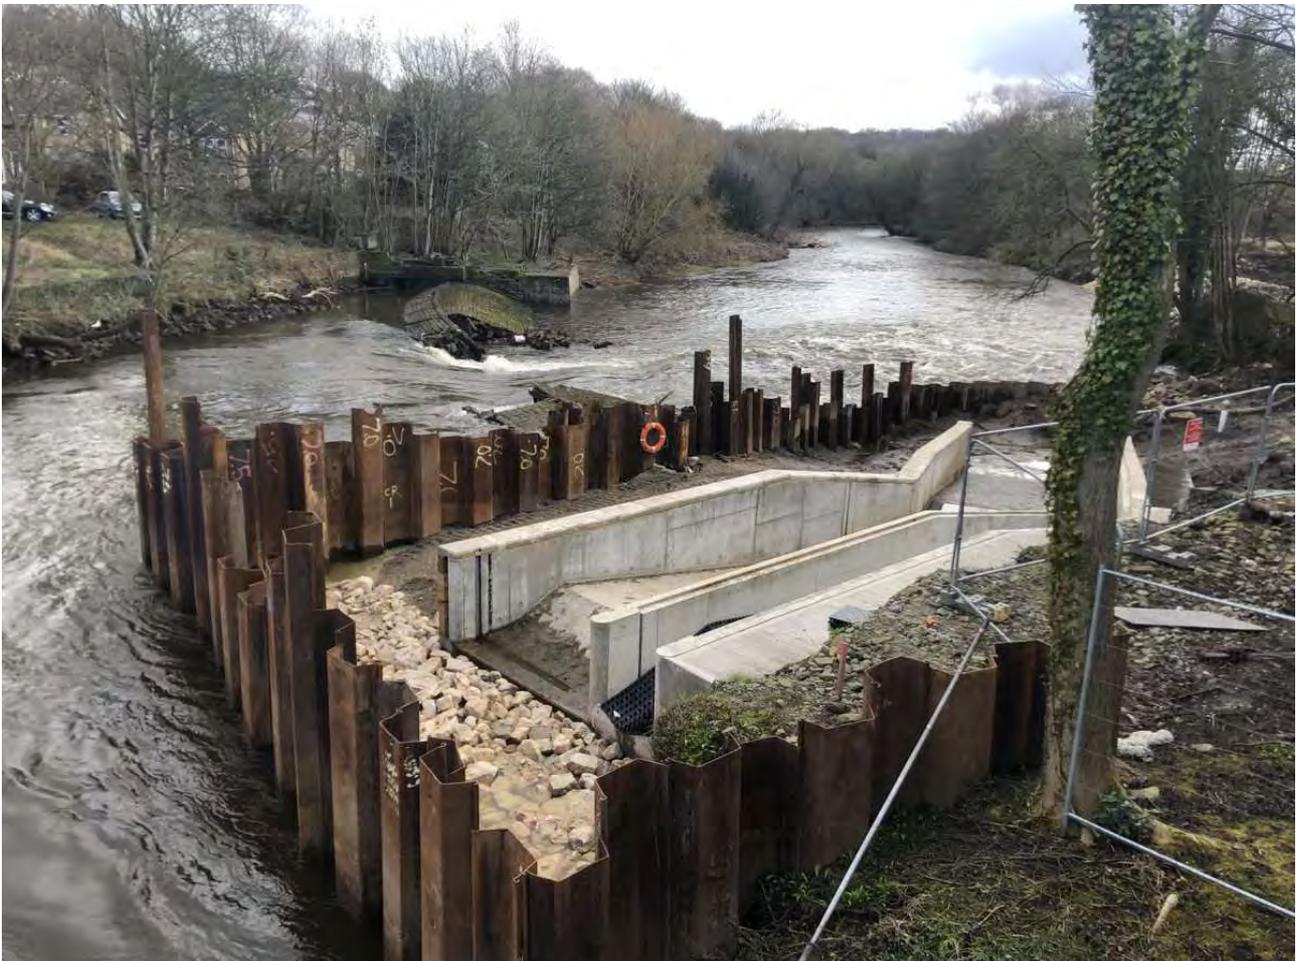
Figure 5 : Photograph showing the collapsed weir during construction of the fish pass.

Figure 6 shows the weir post-collapse but *with* the sheet piles used in the construction of the fish pass. Note the height of the fish pass (known to be 1.5m), fencing (2m), which were used to infer the height of the sheet piles. Note also the exposed shape of the weir; this was used to suggest the modifications to the weir definition in the model.

The net effect of the sheet piles is to reduce the effective width of the weir crest from 55.7m to 42.1m, a reduction of 25%. According to the equations predicting flow over a weir, this indicates that for a similar flow, the head over the weir would be increased by approximately 21%.

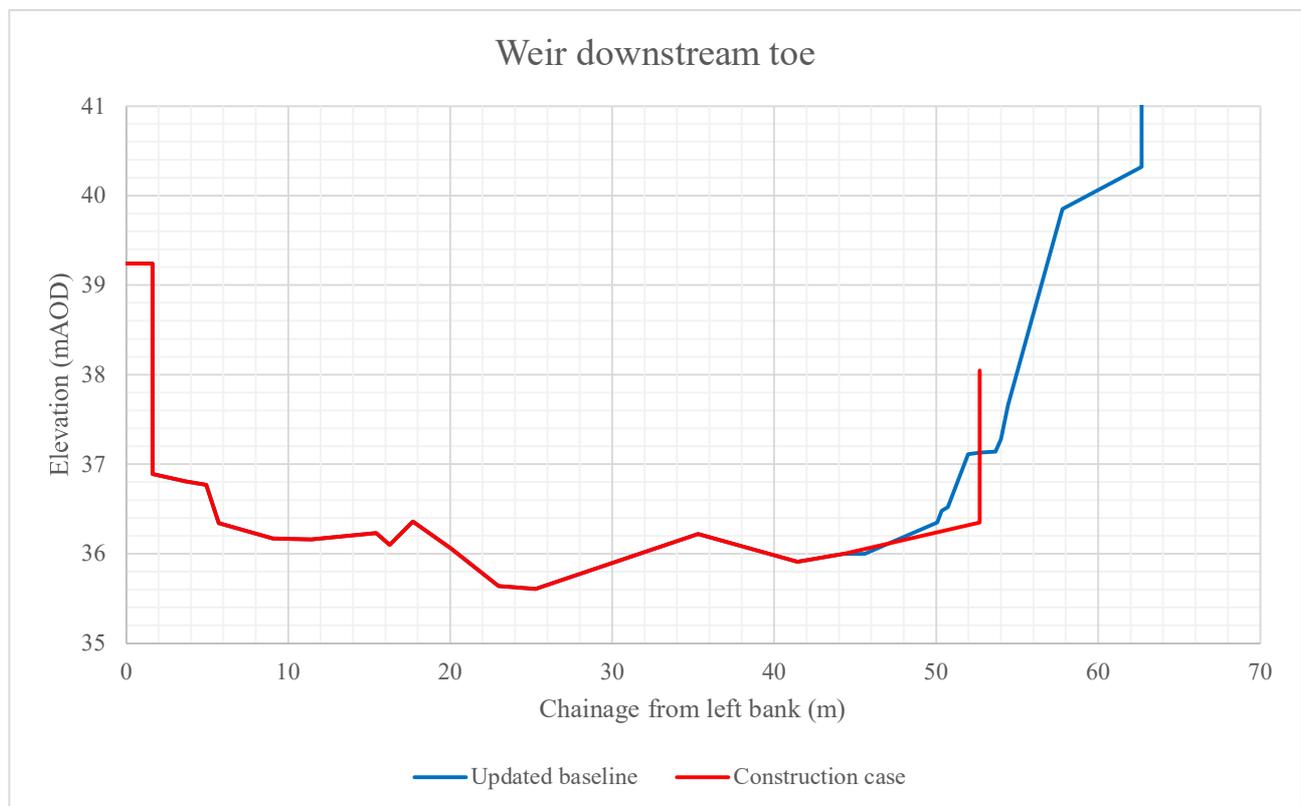
Figure 6 : Comparison of updated baseline and construction case cross-section for the weir downstream toe.

Approximately 10m of river flow area at the weir downstream toe is taken up with the sheet piles. The cross-section is reduced in width from the original right bank location by 10m to reflect the area protected by the piles. See Figure 6 for details.

Several metres downstream of the downstream toe, the full flow width has been restored. Consequently, the cross-section has been replicated 10m downstream, but without the curtailment 10m from the right bank. For completeness, this replication of the weir downstream toe cross-section has also been incorporated into the baseline case.

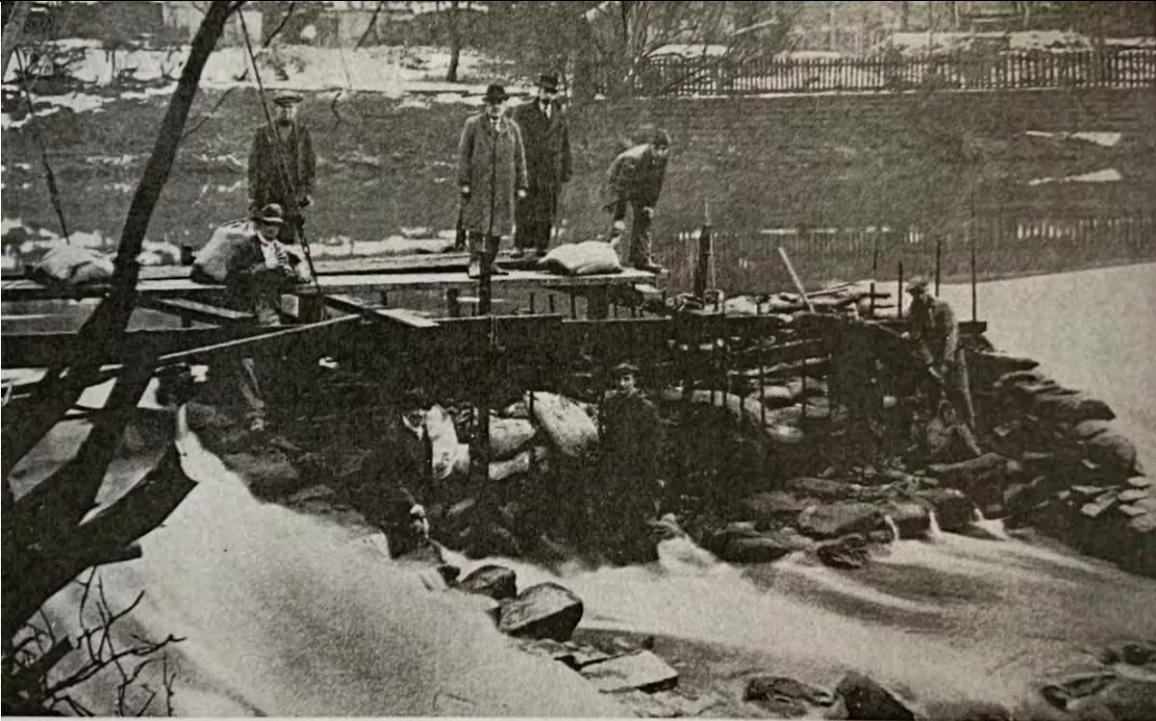
<p data-bbox="618 938 1317 970">11. The Weir at Newlay under repair, December 1938.</p> <p data-bbox="689 986 1240 1018"><i>Acknowledgement: GKN (Kirkstall Forge)</i></p> <p data-bbox="385 1034 808 1066">Repairs at Newlay Weir in 1938.</p> <ul data-bbox="434 1074 1928 1136" style="list-style-type: none"> • An archaeological report (conducted in 2020) also found evidence of 20th century repairs through concrete across the weir face.
1947	<p data-bbox="385 1150 658 1182">Historic Flood Event</p> <ul data-bbox="434 1190 1917 1326" style="list-style-type: none"> • 20/03/1947 "The floods in the West Country subsided after 20 March, but rivers continued to rise in eastern England. The Wharfe, Derwent, Aire and Ouse all burst their banks and flooded a huge area of southern Yorkshire. The town of Selby was almost completely under water. Only the ancient abbey and a few streets around the market place escaped inundation. 70 percent of all houses in the town were flooded.....⁴"

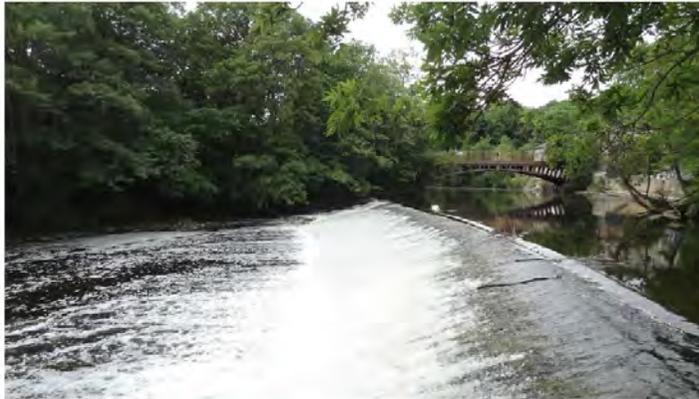
Photograph 4.1 : General view of Newlay Weir

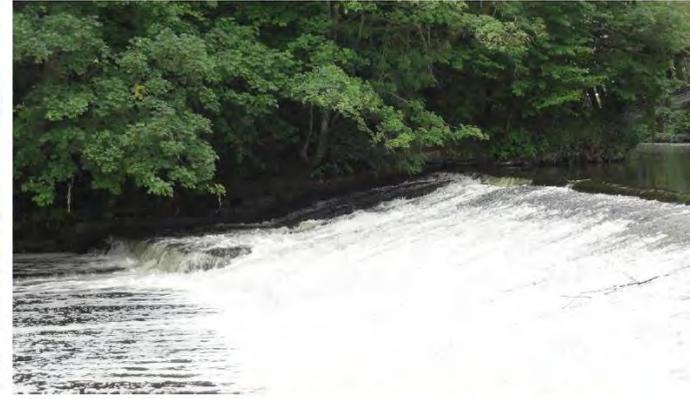
Photograph 4.3 : View of right hand bank to receive proposed fish pass

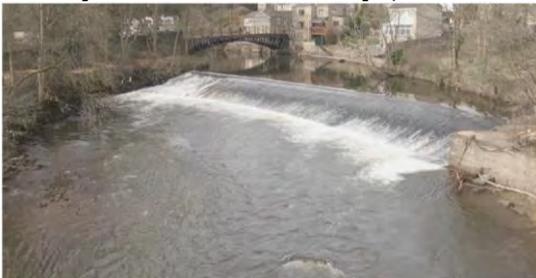
- “Unfortunately, due to the high flow conditions on site at the time of the survey, it was not possible to assess the condition of the weir. However, using a still from drone camera footage taken a few days beforehand, it can be seen that the section of weir to be worked on and the section immediately adjacent seem to be in a moderate condition. From another still of this footage, the extent of the collapsed river wall can be seen.”

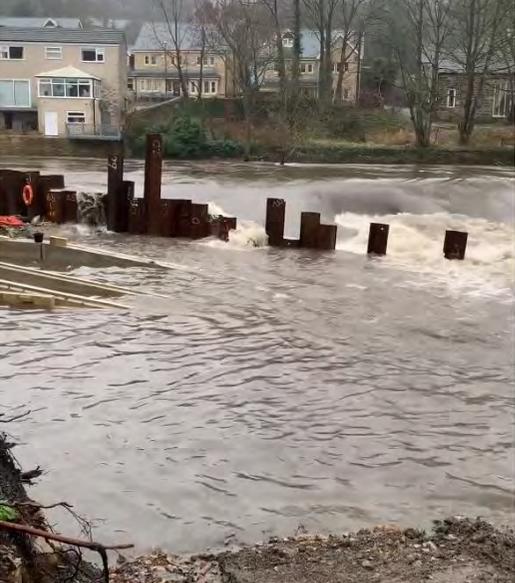
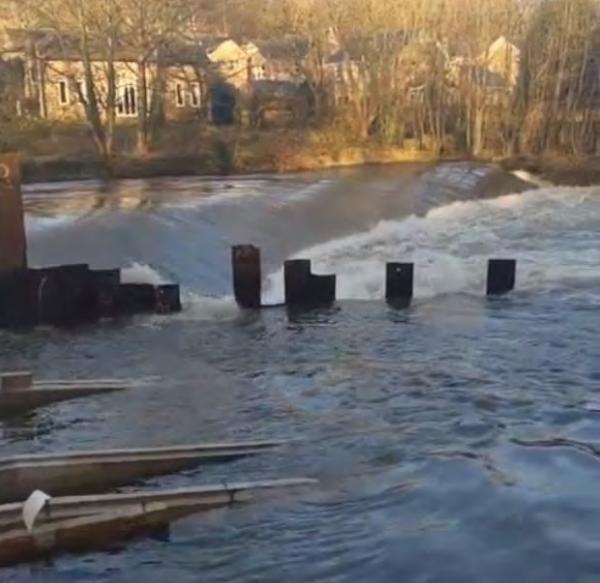
21/01/2021	Initial Collapse begins						
21/01/2021	<p data-bbox="383 300 584 336">Storm Cristoph</p> <ul data-bbox="434 341 1910 408" style="list-style-type: none"> <li data-bbox="434 341 1910 408">• In January 2021 there was a storm event within the catchment. The peak river flow and level values recorded at Armley were: <table border="1" data-bbox="387 411 1480 624"> <thead> <tr> <th data-bbox="387 411 763 515">Events</th> <th data-bbox="770 411 1081 515">Peak River Level (m)</th> <th data-bbox="1088 411 1480 515">Peak Flow (m³s⁻¹)</th> </tr> </thead> <tbody> <tr> <td data-bbox="387 520 763 624">21/01/2021 – Storm Cristoph</td> <td data-bbox="770 520 1081 624">3.279</td> <td data-bbox="1088 520 1480 624">168</td> </tr> </tbody> </table> <p data-bbox="383 660 1552 695">*Data obtained from EA historic flood record⁵ and from the National River Flow Archive⁶.</p>	Events	Peak River Level (m)	Peak Flow (m ³ s ⁻¹)	21/01/2021 – Storm Cristoph	3.279	168
Events	Peak River Level (m)	Peak Flow (m ³ s ⁻¹)					
21/01/2021 – Storm Cristoph	3.279	168					
21/01/2021	<p data-bbox="383 702 1664 738">Stills from a video captured by a member of the public showing the initial collapse taken at 8:45am:</p> <div style="display: flex; justify-content: space-around;">

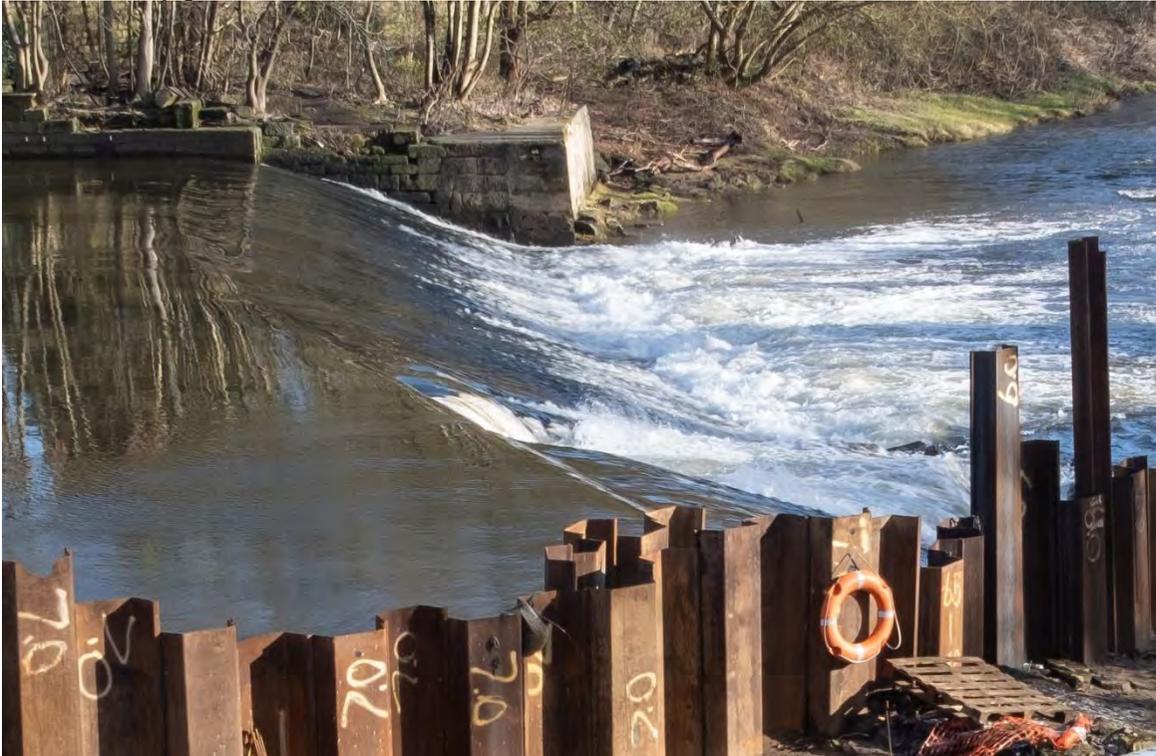
Late 01/2021	Local residents contact the EA emergency helpline after noticing that “a small section of the weir had been dislodged on the downriver side, yet no action was taken by the EA” – Newlay Weir collapse letter from local residents
01/02/2021	Public survey photo:

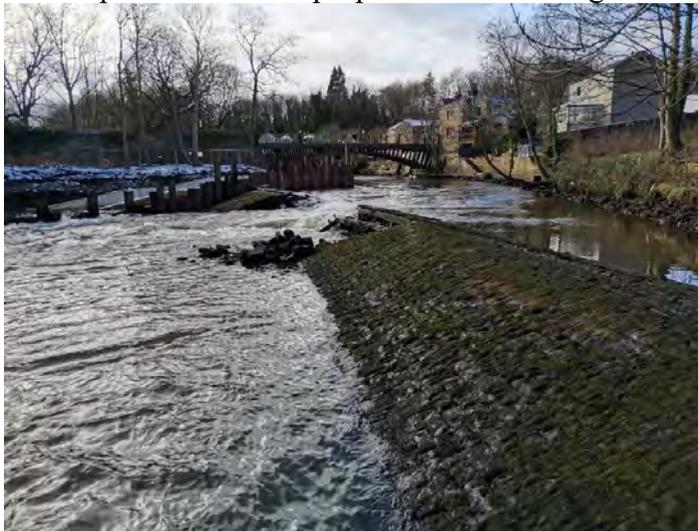
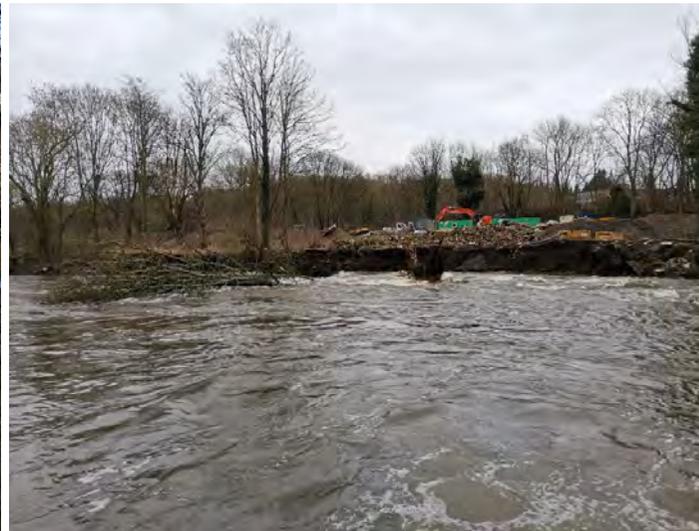
07/02/2021

Full collapse
