# Contract No. 1MC13

# Pool Wood Embankment: Ground Gas Risk Assessment – Sub Lot 5 South

Document Number: 1MC09-BBV\_MSD-EV-RIA-NS04\_NL10-100006

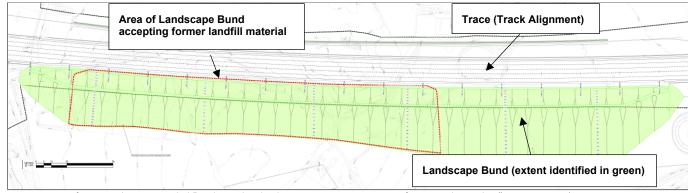
Figure 4: Location of Site Boundary

Source: extract from HS2 drawing entitled "Pool Wood Embankment, Approximate Extent of Permitted Boundary", January 2024 (1MC09-BBV\_MSD-CV-DPP-NS04\_NL10-219402)

The location of Pool Wood Embankment and the extent considered in this report is shown on Figure 1, which comprises the land within the Limit of Deviation (LoD) and the Land to be Acquired and Used (LLAU). Figure 2 shows the footprint of the embankment (highlighted in green) and Figure 3 shows an aerial image of the area. The section of the landscape bund (hereafter referred to as the Site) subject to the placement of material sourced from Middle Bickenhill landfill is shown in Figure 4 and Figure 5.
