## Application for Permit Variation

### Permit N° 53997 (New Tip)

**Restoration of the existing “New Tip”**

**METHOD STATEMENT FOR  
THE RESTORATION  
OF THE “NEW TIP” AREA**

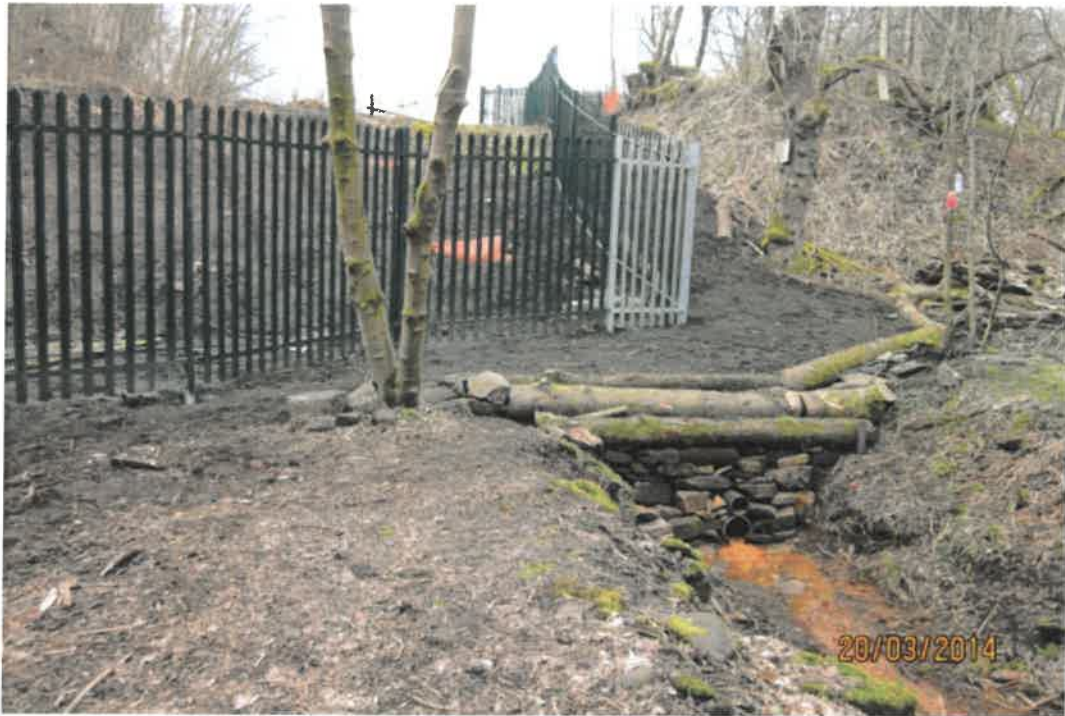
**Picture 3:** New headwall with realigned footpath and fencing.

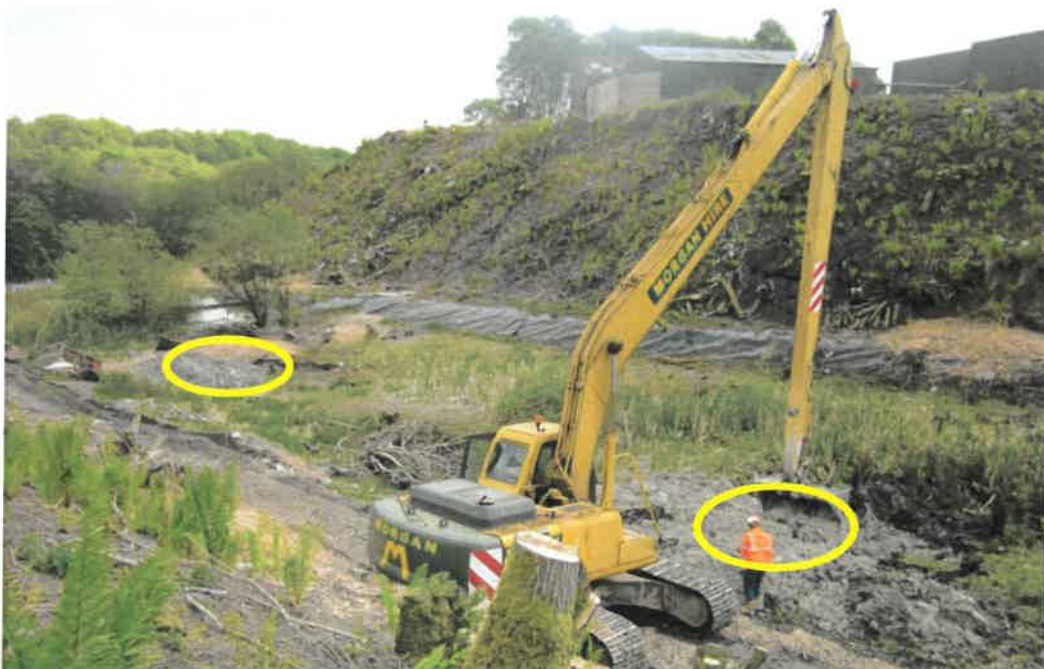
- Samples of paper pulp from the New Tip were taken on 19<sup>th</sup> May 2014 from two locations at depth (from 2m to 3m) and transported by dumper to a location adjacent to the Old Tip where they were placed into 2 skips and their respective “fresh and agitated” leachate’s collected for chemical comparison with the quarterly monitoring findings.

**Picture 4:** Pulp sample locations.

Findings from the recent “Pulp Skip Tests” (19<sup>th</sup> May 2014 see Picture 4 on p16) it appears that the pulp at the eastern end contained less water and presented as firmer allowing vertical sided excavation down to 2.7m, (though only for a limited time period) whereas that pulp to the western end kept slumping to around 45° sides. Taking these observations into account we will try to bulk the wetter materials up at the western end and allow more Leachate to fall out onto the liner.

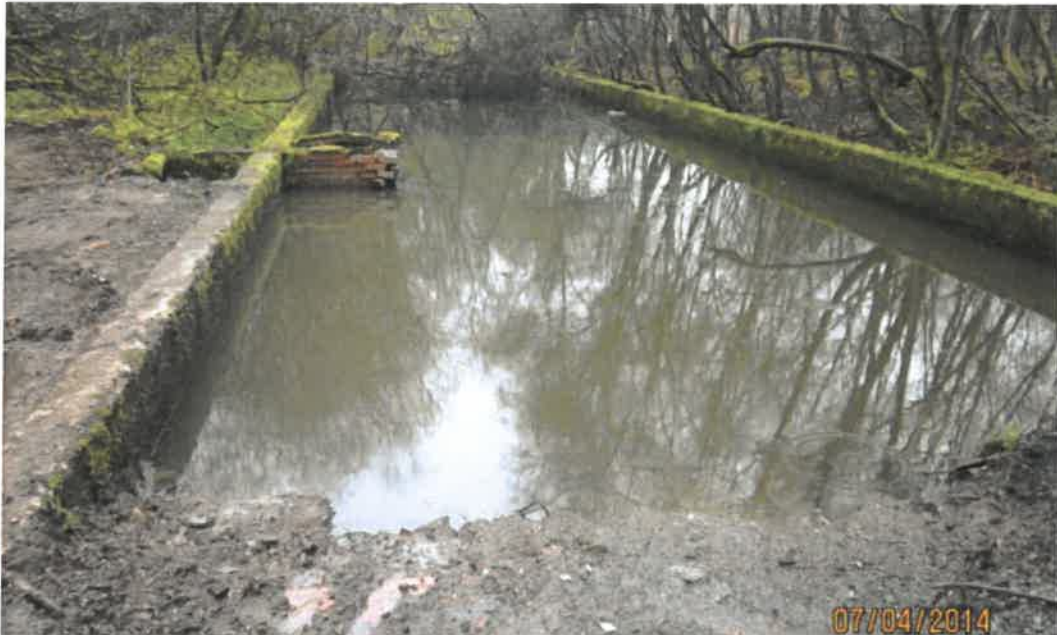
- The existing old filter beds will be refurbished and totally cleared of deleterious materials in anticipation of receiving both the runoff from the whole restoration area and the Leachate from within the new tip liner. This refurbishment will now include the installation of a monarflex liner to ensure there are no accidental discharges or leaks.

Picture 5: Existing filter beds.

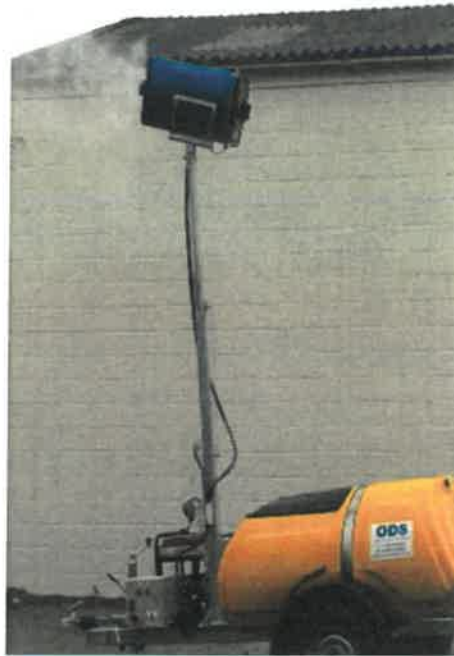
odour emission will be stopped and advice will be sort from Smith Grant and if necessary a propriety odour “Mobile Atomiser” spray (40 micron) will be brought to site to neutralise and break down the smells.

Picture 6: Typical Mobile Atomiser

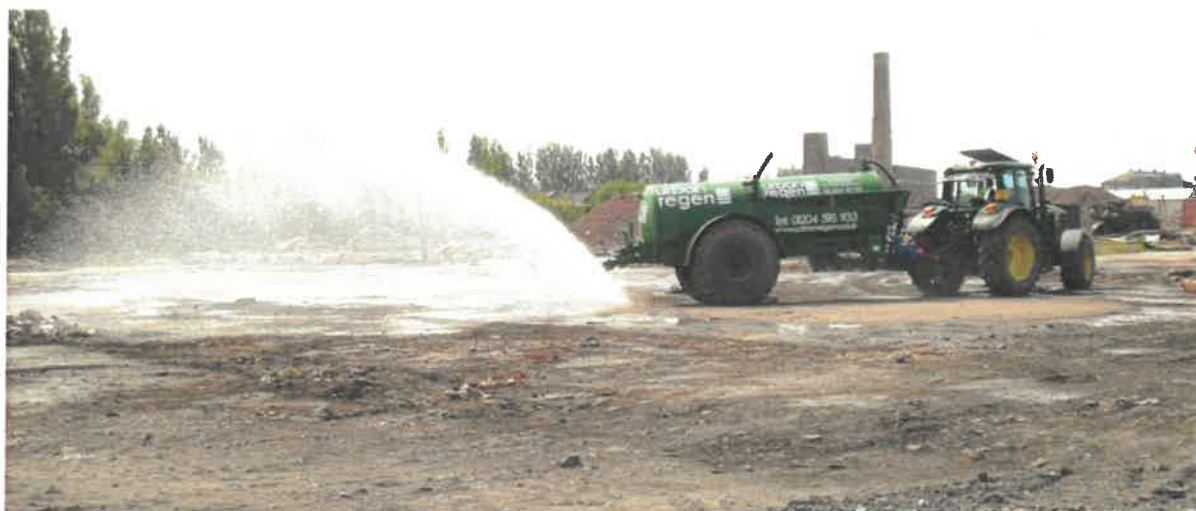
Should any of these works produce the potential for dust generation then damping down measures will ensue by means of a tractor and vacuum tank which will spread water onto the affected areas. An all-weather supply of water for dust suppression is readily available at the site.

Picture 7: Tractor and vacuum tank.

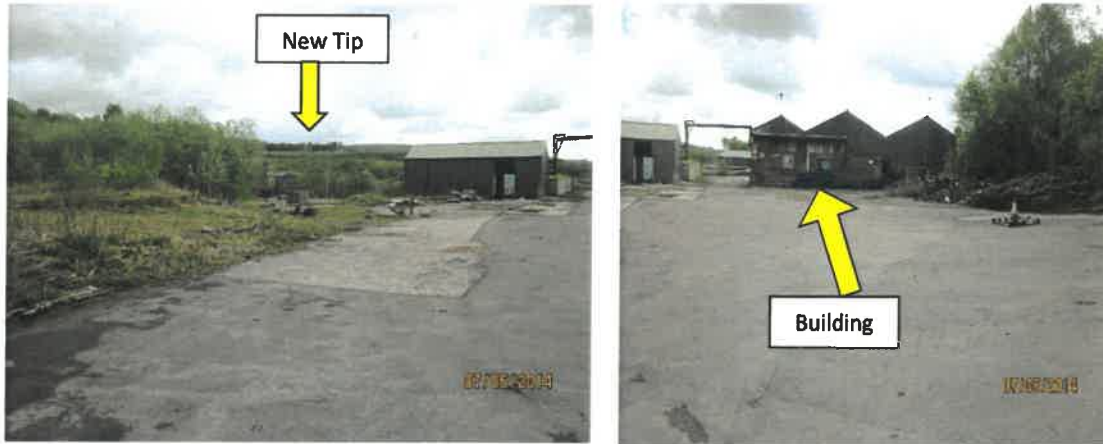
Picture 8: Vegetation treatment building.

The vegetative materials will be placed in windrows inside the building shown which has been chosen due to its internal dimensions, smooth (dense & impermeable) concrete floor and lack of internal drainage gullies or channels.

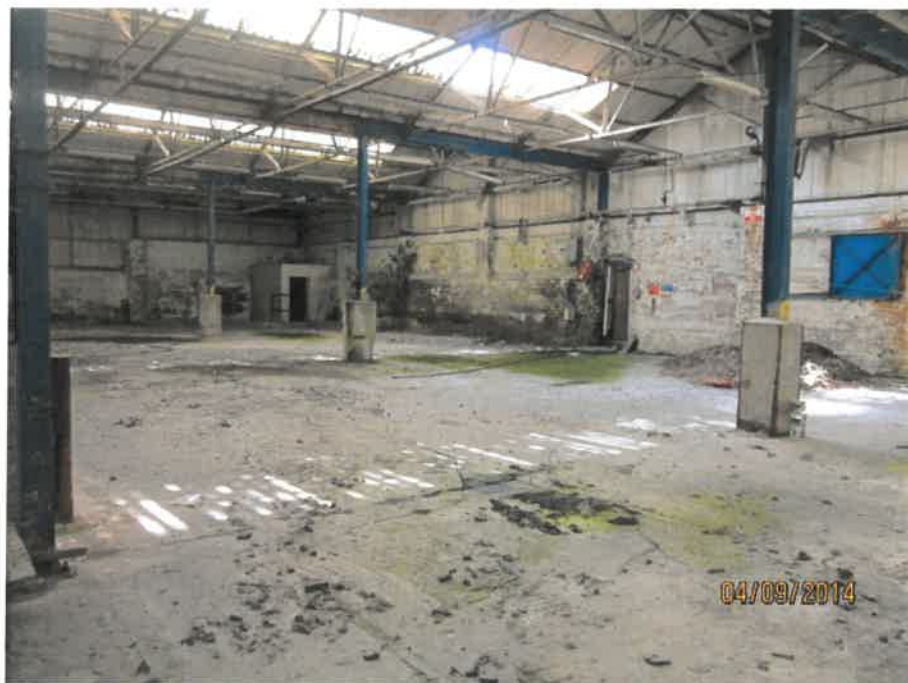
Picture 9: Inside vegetation treatment building.

This building has been successfully used previously in 2012 for small scale pulp and wood chip mixing trials utilising a 15t excavator and remains in good condition.

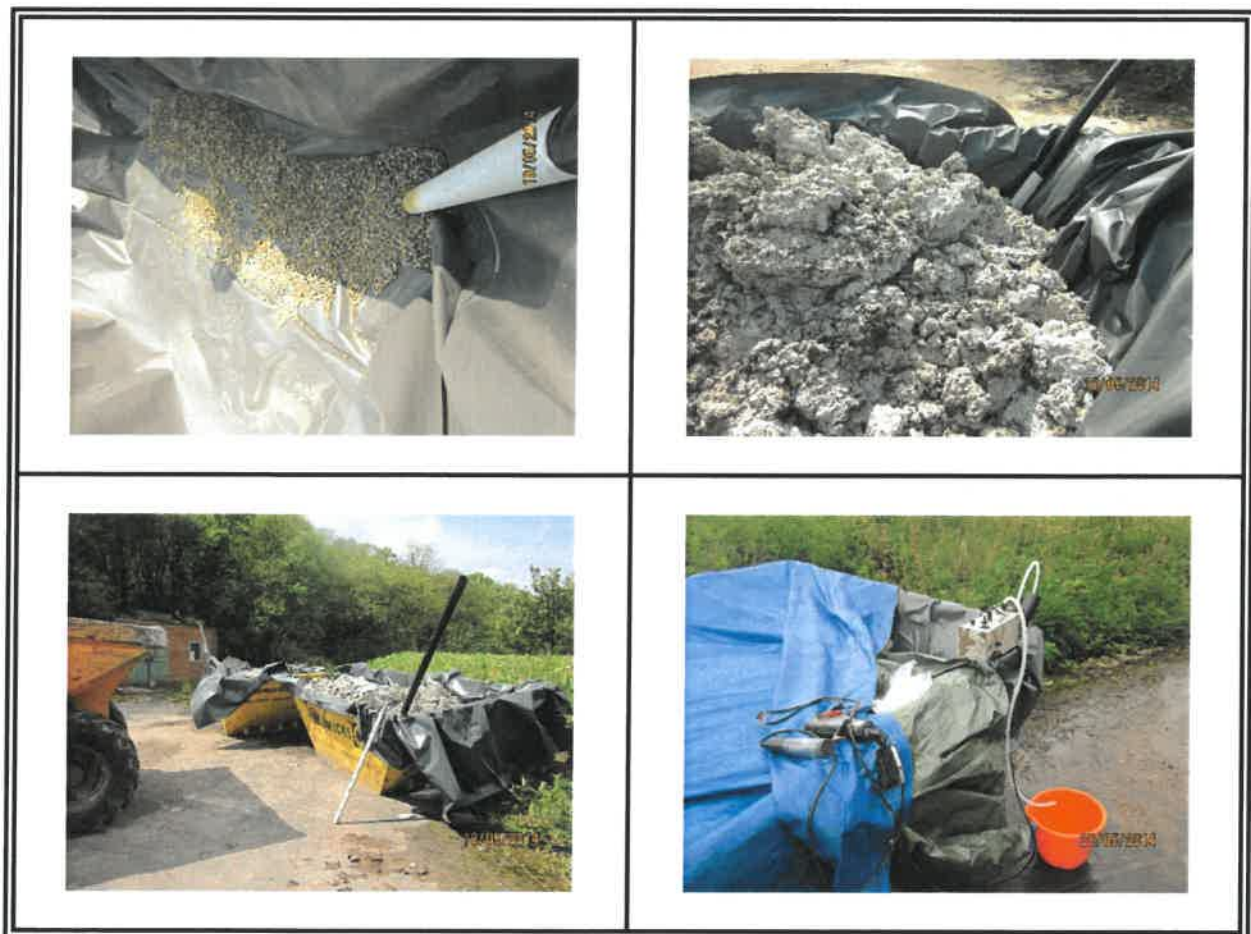
The results of leachate testing (photos above) of these freshly disturbed pulp samples (see 9.1 and Smith Grant R1635-R08-v3 Closure Plan) exceed the existing permitted leachate discharge consent limits and it is intended that this temporarily “higher strength” leachate will be pumped to the “water treatment facility”. This will be lined (monarflex or similar) and sub divided (similar to an interceptor) such that any necessary treatment can be monitored and tested on reduced and separated volumes.

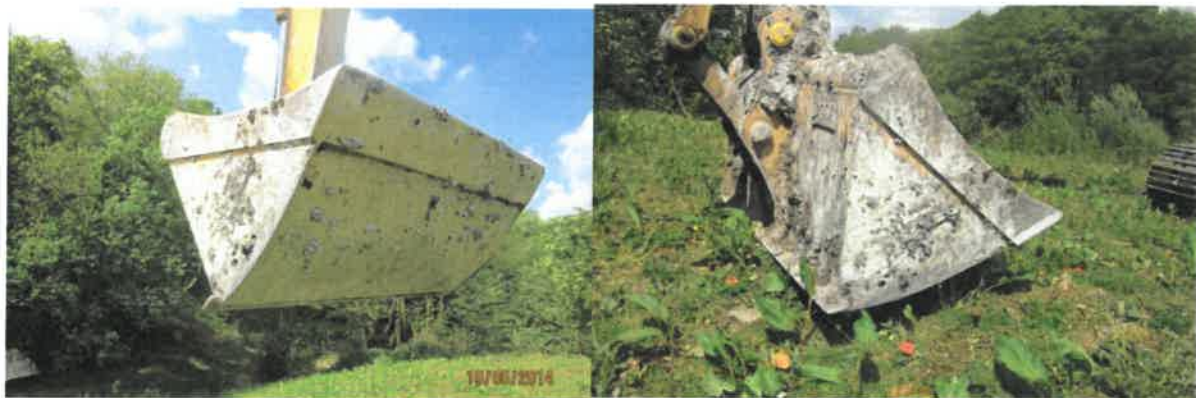
We propose to commence excavations in the New Tip around the existing Leachate pump and sump as this will be the lowest point within the tip liner and from there we will be able to deal with any Leachate or surface water runoff. We would carefully excavate using a smooth bucket (long reach machine as used successfully for obtaining samples for the Leachate skip tests) and intend to empty the area to the eastern end whilst retaining the integrity of the liner around the sump to collect leachate.

Picture 10: Smooth edged bucket.

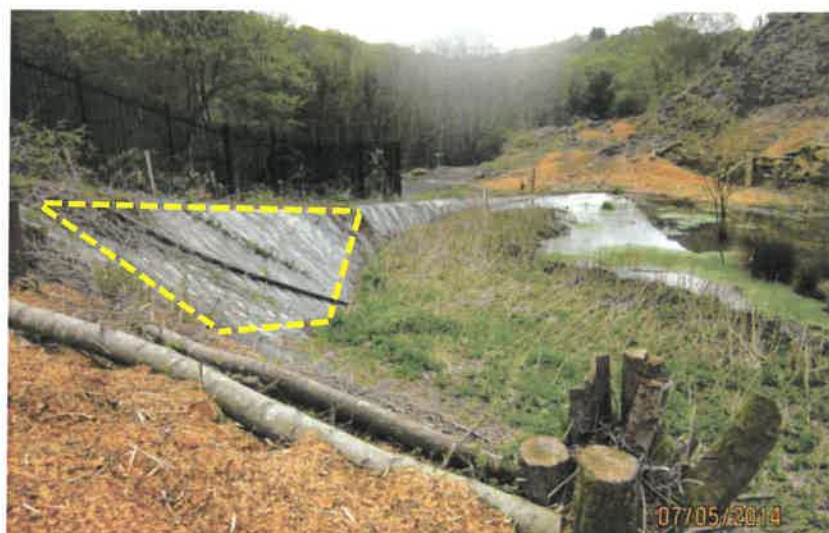
Picture 11: Potential source for repair patches.

Should the liner become damaged during these works (or existing damage be exposed) Urbanspringside will have available a suitably wide double-sided adhesive tape to initiate a temporary repair using patches cut from an area of liner currently above the current pulp level as shown below.

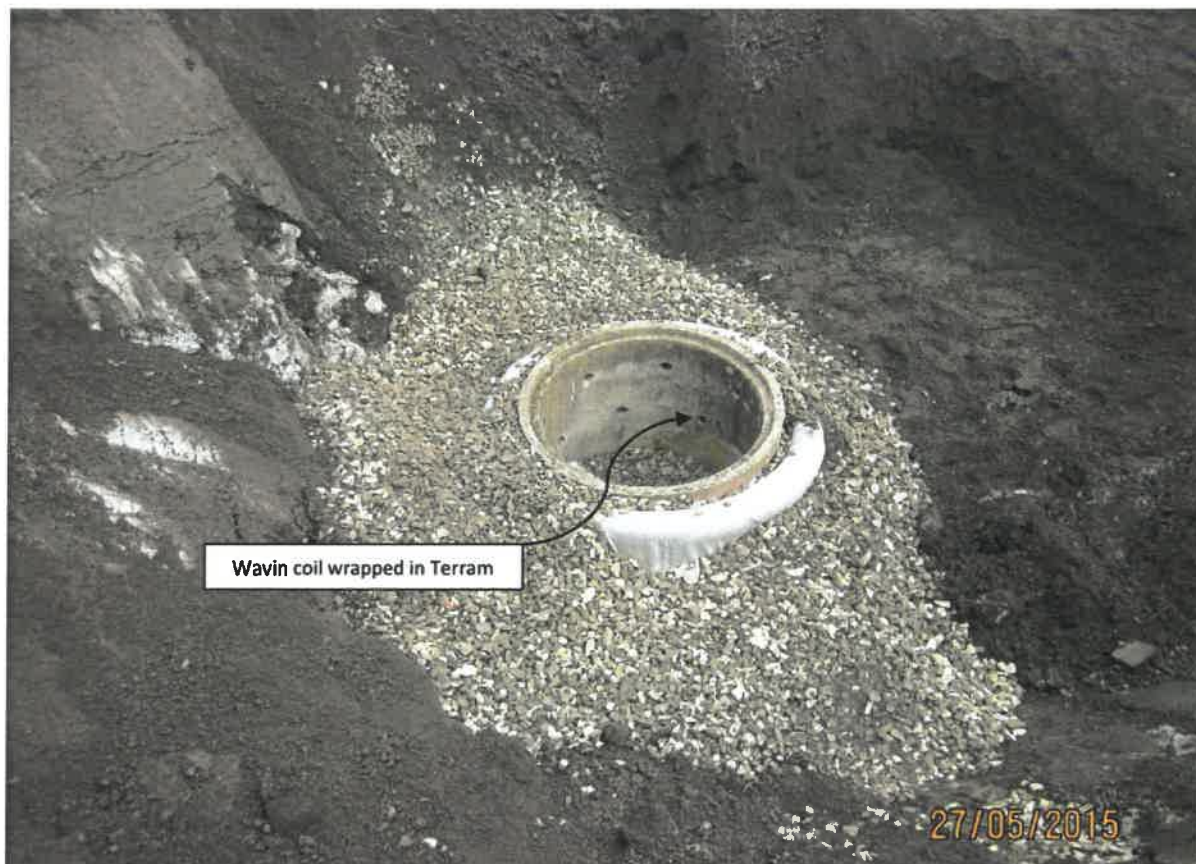
**Figure 2.1.1 – Lower section of the new leachate chamber.**

In May 2015, a new leachate chamber was installed using concrete ringed sections. A drainage surround was constructed around this chamber using a combination of a 150mm dia' perforated 'Wavin Coil' (wrapped around the chamber to increase the collection volume and functioning leachate surface area) and 60mm single size clean stone enclosed by a porous Terram membrane. This was then surrounded with coarse ash recovered from adjacent to the 'New Tip' (see Figure 2.1.1). This structure replaced the existing leachate chamber and surrounding 75-100mm stone which had become clogged.

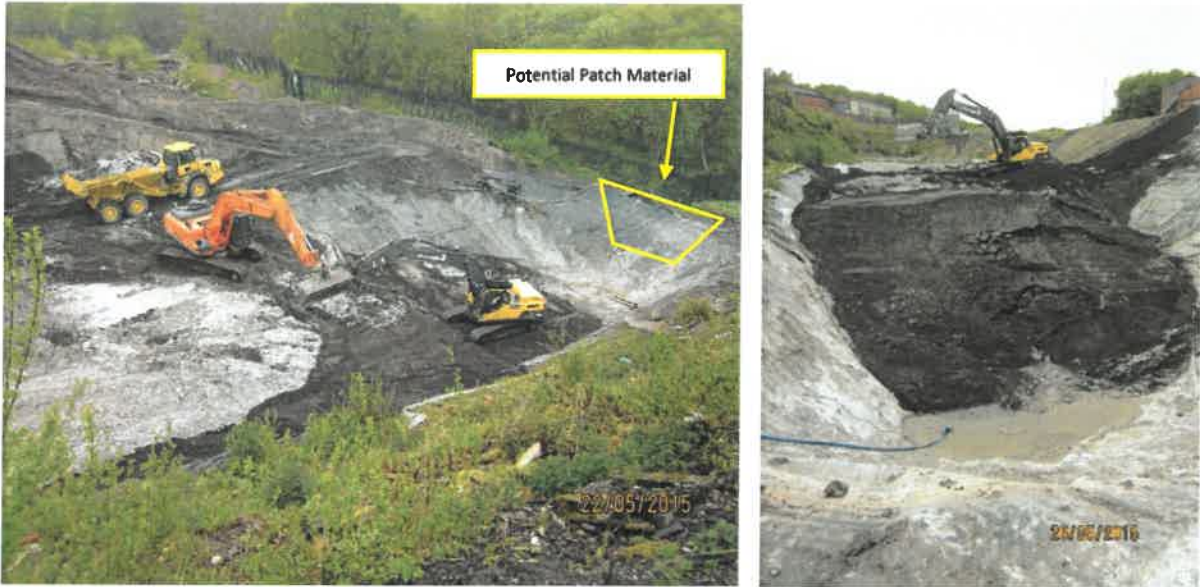
Figure 2.1.3 – Initial ash partition installation and paper pulp removal works.

To enable the new leachate chamber to be constructed an ash partition was installed to the west of the existing chamber. A 360° excavator systematically removed the paper pulp (casting it to the west) along the alignment of the partition and replaced the material with site derived ash. This operation continued in a southerly direction until the partition extended across the full width of the 'New Tip' truncating the eastern 15m (see Figure 2.1.3).

In the event that damage was caused to the liner excavation works were to cease and the damaged area cleaned. A repair would then be affected by utilising a section of liner salvaged from above the fill line at the extreme eastern end of the 'New Tip' (see Figure 2.1.3). All excavation works were supervised, and records kept by the Urban Springside Ltd. Project Manager.

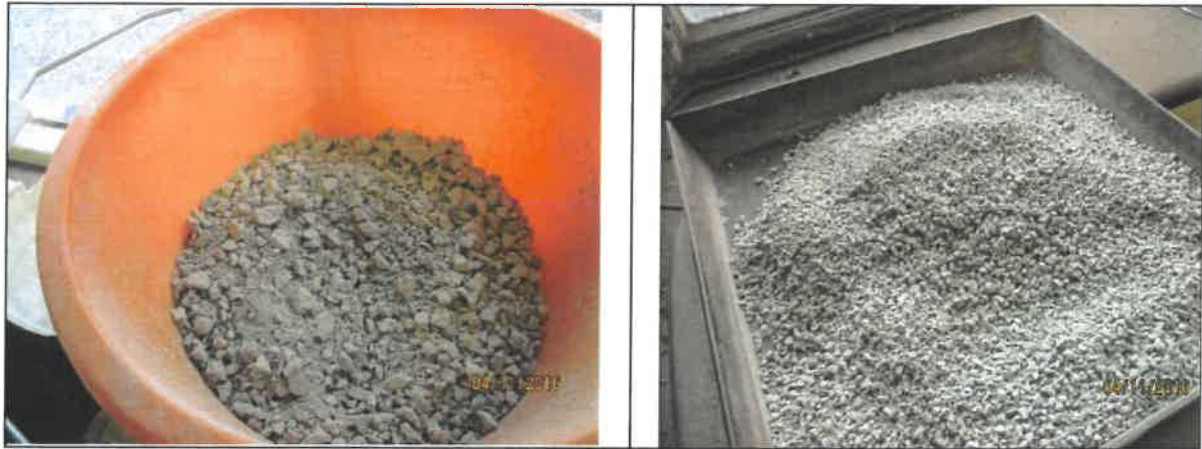
**Fig 2.2.1 Treated 'New Tip' paper pulp sample**

Suitable samples were prepared (see Figure 2.2.1) and tested accordingly with the results compared against a potential substitute 'non-waste' material by SGP. Subsequently SGP compiled '*Review of Testing on Cement Stabilised New Tip Waste Sludge*' (R1635-L08/afs dated 17/01/25). This was duly issued to the Environment Agency for information and comment (17-01-26).

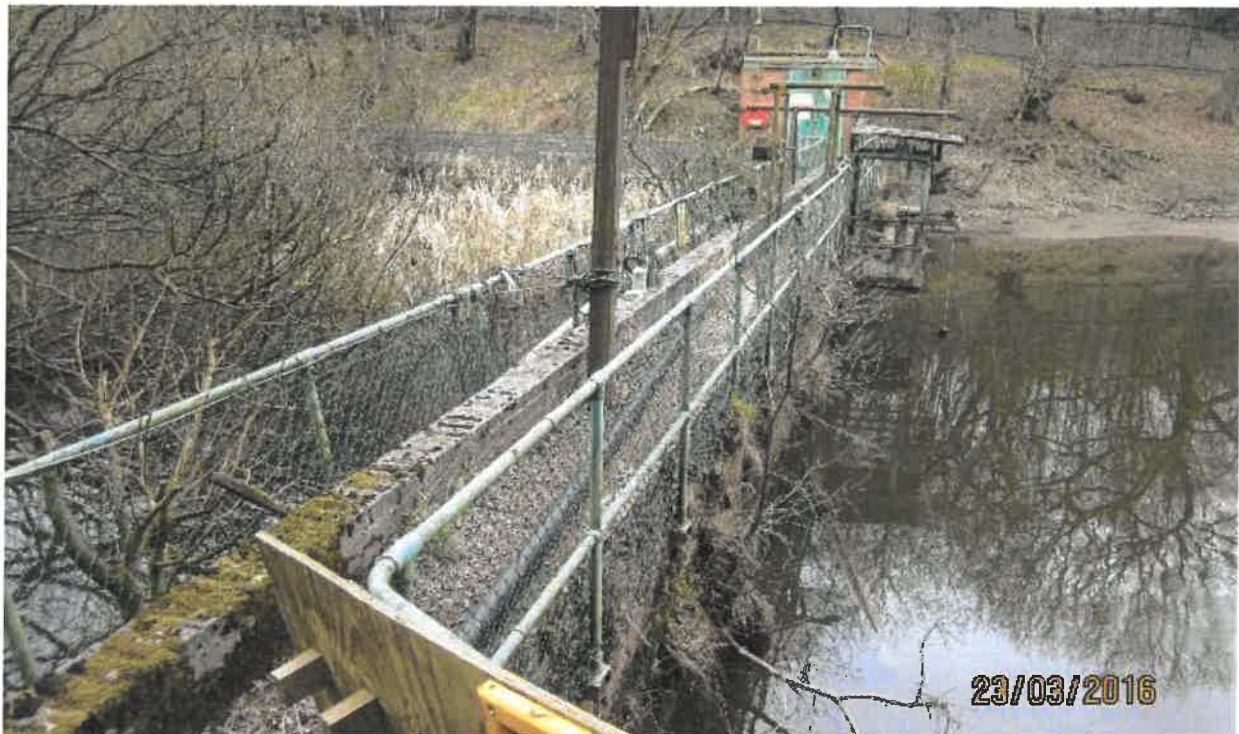
**Figure 2.6.1** The concrete dam (the 'Old Tip' is located to the left).

The existing concrete dam (see Figure 2.6.1). has been inspected by a structural engineer (Reid Jones Partnership) who concluded that it was generally in a good overall condition, being plum and level along its length with no visible signs of distress or movement. However, it was recorded that there was a degree of seepage from the 'Old Tip' through the upper brickwork which was bedded on top of the lower concrete structure. It was recommended that the vegetation be removed, the brickwork re-pointed, and the hand rails replaced. It should be noted that the top of the concrete normally remains approximately 300mm above the normal dry weather water level.

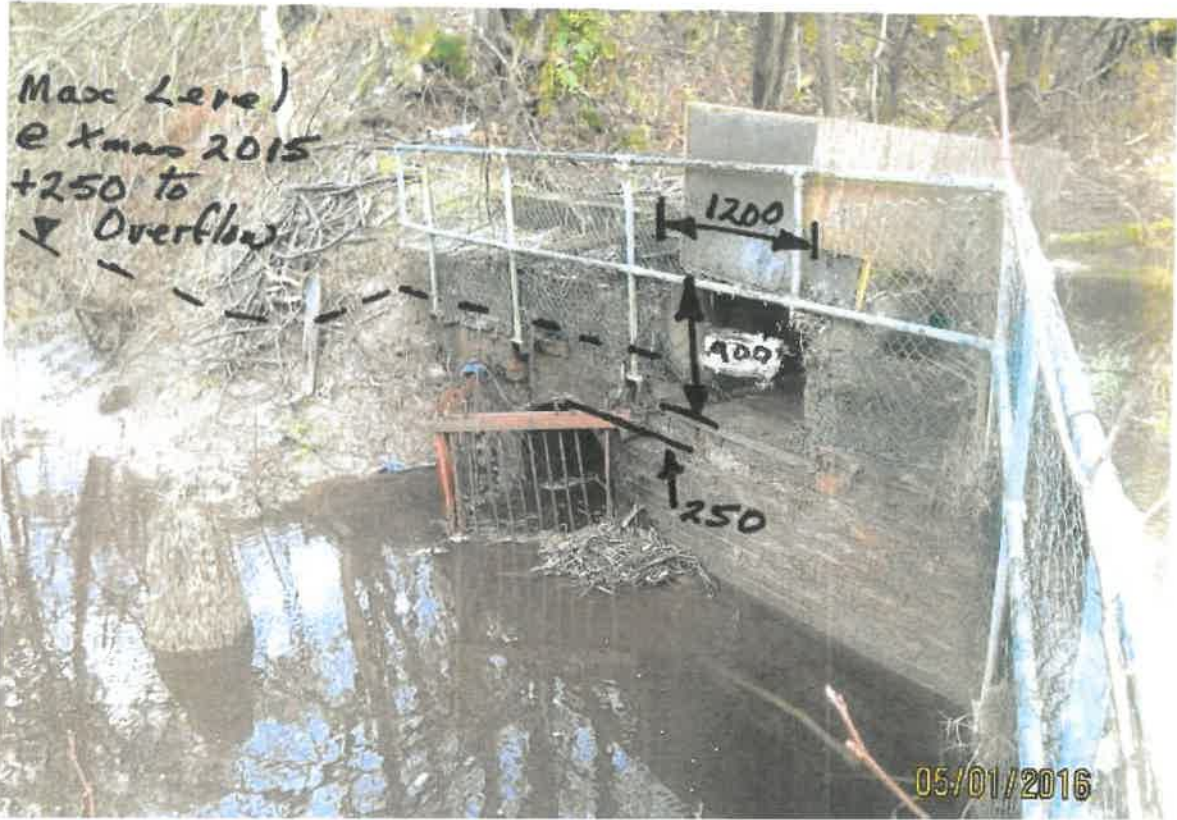
**Figure 2.6.3 Existing lodge overflow arrangement.**

The existing culvert and overflow arrangements (see Figure 2.6.3) associated with the concrete dam are to remain, with the trash screen being refurbished in accordance with a flood risk engineer’s comments. All drainage designs associated with the culvert including its discharge into Eagley Brook will be subject to approvals from the Local Authority Drainage Department.

The remedials advised by Reid Jones Partnership are superfluous to the current designs for the concrete dam as the intention is to remove all the brickwork and form a gently sloping edge into the lodge water (see Figure 2.6.2). Large rocks are to be placed either side of the concrete dam. These are to be topped off with 75-100mm clean rocks for erosion protection which will be extended 300mm above the flood level recorded during the extreme conditions experienced at the site on Boxing Day 2015 (see Figure 2.6.3).

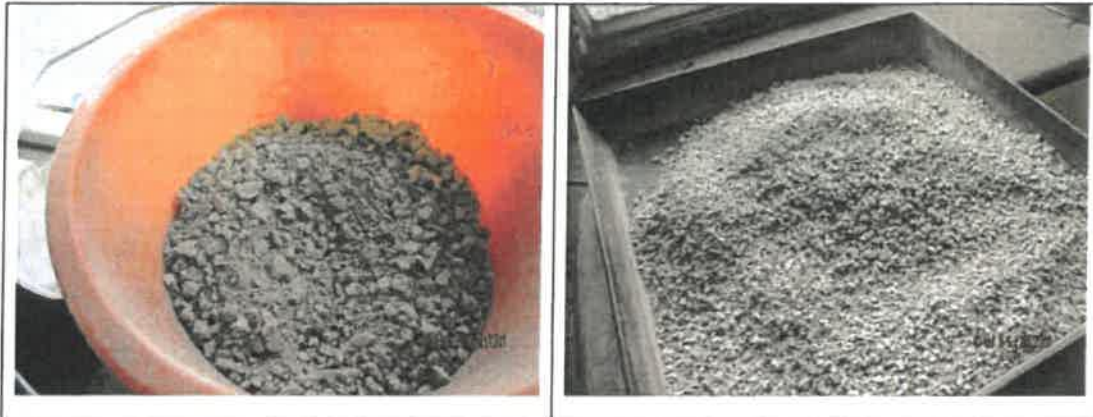
- 2.1. A representative sample of fresh New Tip sludge (~ 5 kg) was collected by Urban Springside for cement stabilisation using cementing agent provided by treatment specialists United Retek. The sample was prepared by mixing in fresh state with additive at a ratio of 10 waste:1 cement and was allowed to air dry and cure for 1 week. The treated material formed a granular mass with particle size ranging from fine gravel to cobble size. The treated material was then ground to a fine gravel (maximum 4mm particle size) for testing purposes (see photos).

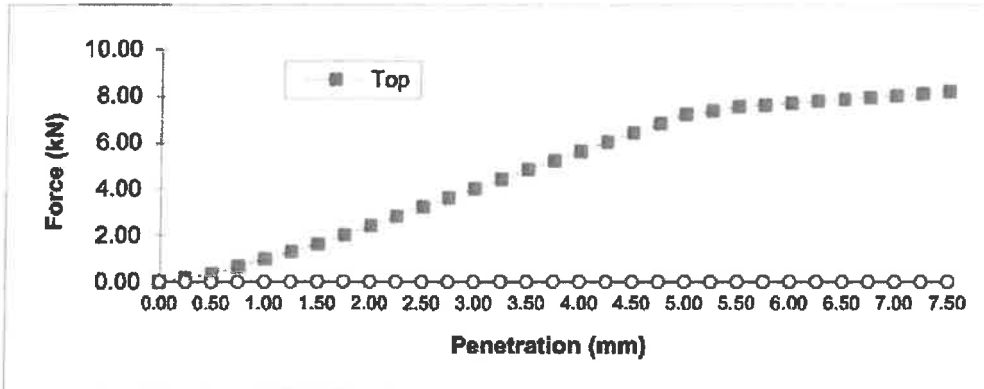
COMPACTION METHOD	Recompacted at as received moisture content using the 2.5kg rammer		
TEST CONDITION	0 Day Cure	SURCHARGE MASS	2.00 kg
PROVING RING No.	1155-9-18608	CALIBRATION	0.008011 kN/div
BULK DENSITY( Preparation)	1.04	DRY DENSITY (Preparation)	0.91 Mg/m3
BULK DENSITY( At time of test)	1.04	DRY DENSITY (At time of test)	0.91 Mg/m3

AGE OF SPECIMEN AT TEST	0 Day	CURING TIME	0 Day
CURING CONDITIONS	Sealed 20 °C	SOAKING TIME	N/A

CBR value 35.0 %      Moisture Content 15 %
