Section Inspection - 25/06/2024 - RWP2X

Town or Village:	Bentham	Inspection Direction:	Upstream	Upstream Node:	RWP2
Road:	Station Road	Inspected Length:	12.34 m	Upstream Pipe Depth:	
Location:	Other pedestrian area	Total Length:	12.34 m	Downstream Node:	S27A
Surface Type:		Joint Length:		Downstream Pipe Depth:	
Use:	Surface water	Pipe Shape:	Circular		
Type of Pipe:	Gravity drain/sewer	Dia/Height:	100 mm		
Flow Control:		Pipe Material:	Vitrified clay pipe (i.e. all clayware)		
Year Constructed:	Not Specified	Lining Type:	No Lining		
Inspection Purpose:	Routine inspection of condition	Lining Material:	No Lining

Section Inspection - 11/08/2022 - S27AX

Town or Village:	Bentham	Inspection Direction:	Downstream	Upstream Node:	S27A
Road:	Station Road	Inspected Length:	28.79 m	Upstream Pipe Depth:	
Location:	Other pedestrian area	Total Length:	28.79 m	Downstream Node:	S27
Surface Type:		Joint Length:		Downstream Pipe Depth:	
Use:	Surface water	Pipe Shape:	Circular		
Type of Pipe:	Gravity drain/sewer	Dia/Height:	150 mm		
Flow Control:		Pipe Material:	Vitrified clay pipe (i.e. all clayware)		
Year Constructed:	Not Specified	Lining Type:	Cured in place lining		
Inspection Purpose:	Post co

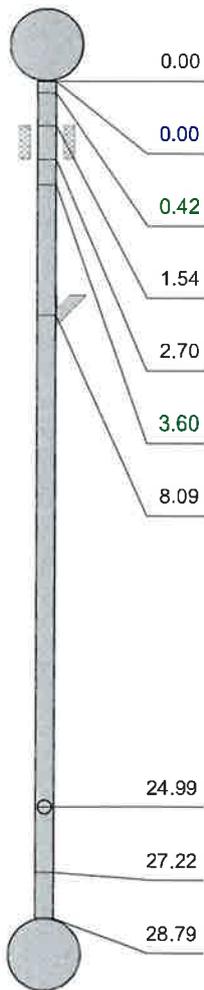
Depth: m
S27A

0.00	MH	Start node, manhole, reference: S27A	00:00:00	
0.00	WL	Water level, 5% of the vertical dimension		
0.42	LR	Line deviates right: Medium	00:00:12	
1.54	S01	RPL	Point repair, localised lining from 12 o'clock to 12 o'clock, start: Patch repair	00:00:15
2.70	F01	RPL	Point repair, localised lining from 12 o'clock to 12 o'clock, finish: Patch repair	00:00:18
3.60	LR	Line deviates right: Slight	00:00:20	
8.09	JN	Junction at 10 o'clock, diameter: 100mm	00:00:25	
24.99	JN	Junction at 12 o'clock, diameter: 100mm	00:00:48	
27.22	RPL	Point repair, localised lining from 12 o'clock to 12 o'clock: Patch repair	00:00:50	
28.79	CPF	Finish node, catchpit, reference: S27	00:01:02

S27
Depth: m
