Technical design note

Project name	Land Adjacent Haldens Parkway, Thrapston, Northamptonshire		
Design note title	Environmental Risk Assessment to support a Deposit for Recovery Permit Application		
Document reference	Report Reference 23880-HYD-XX-XX-RP-GE-5003-S2-P01		
Author	Eric Cooper MSc C.Geol. SiLC		
Revision	02		
Date	8 August 2023	Approved	✓

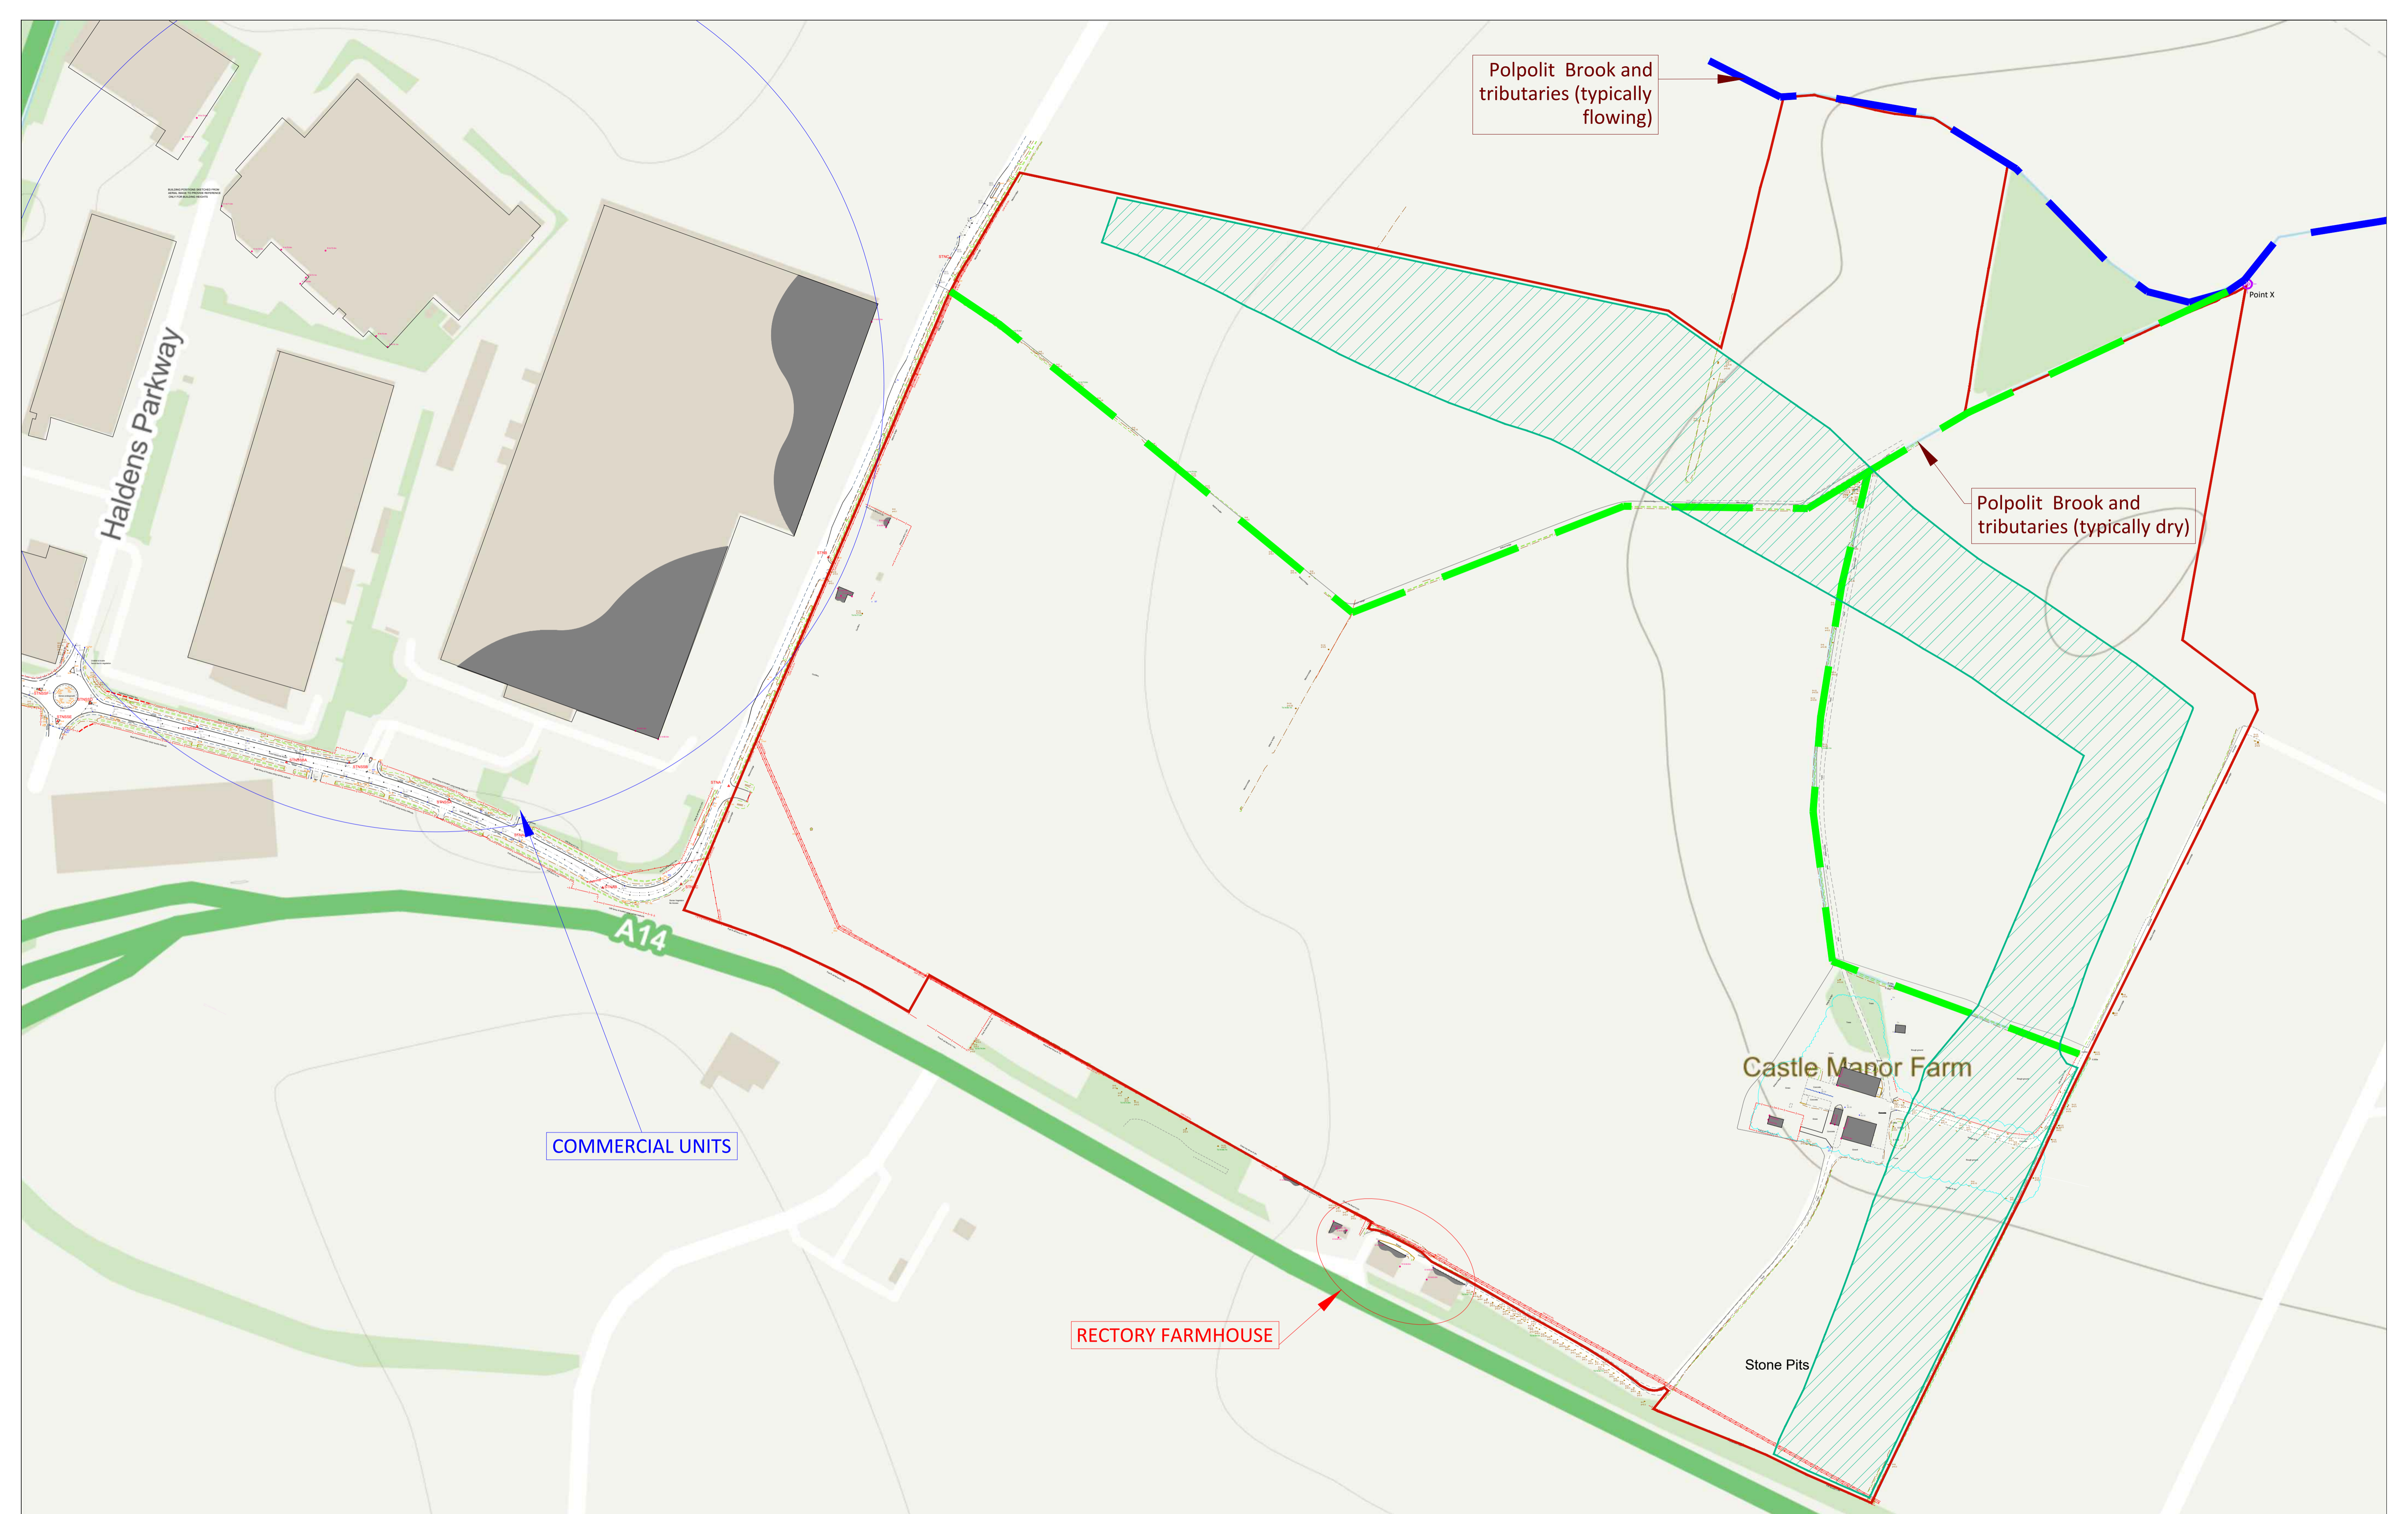
Appendix A Receptors Plan

Potential receptors are shown on Drawing 23880-HYD-XX-ZZ-DR-GE-1026 at Appendix A. The relationship between hazards and receptors is summarised in Table 3.1 below:
