STABILITY RISK ASSESSMENT TONG QUARRY, BACUP

Prepared for: Bacup Clay Company Limited

Project Reference 213036/SRA

ASL Report No. 114-21-610-13 R1

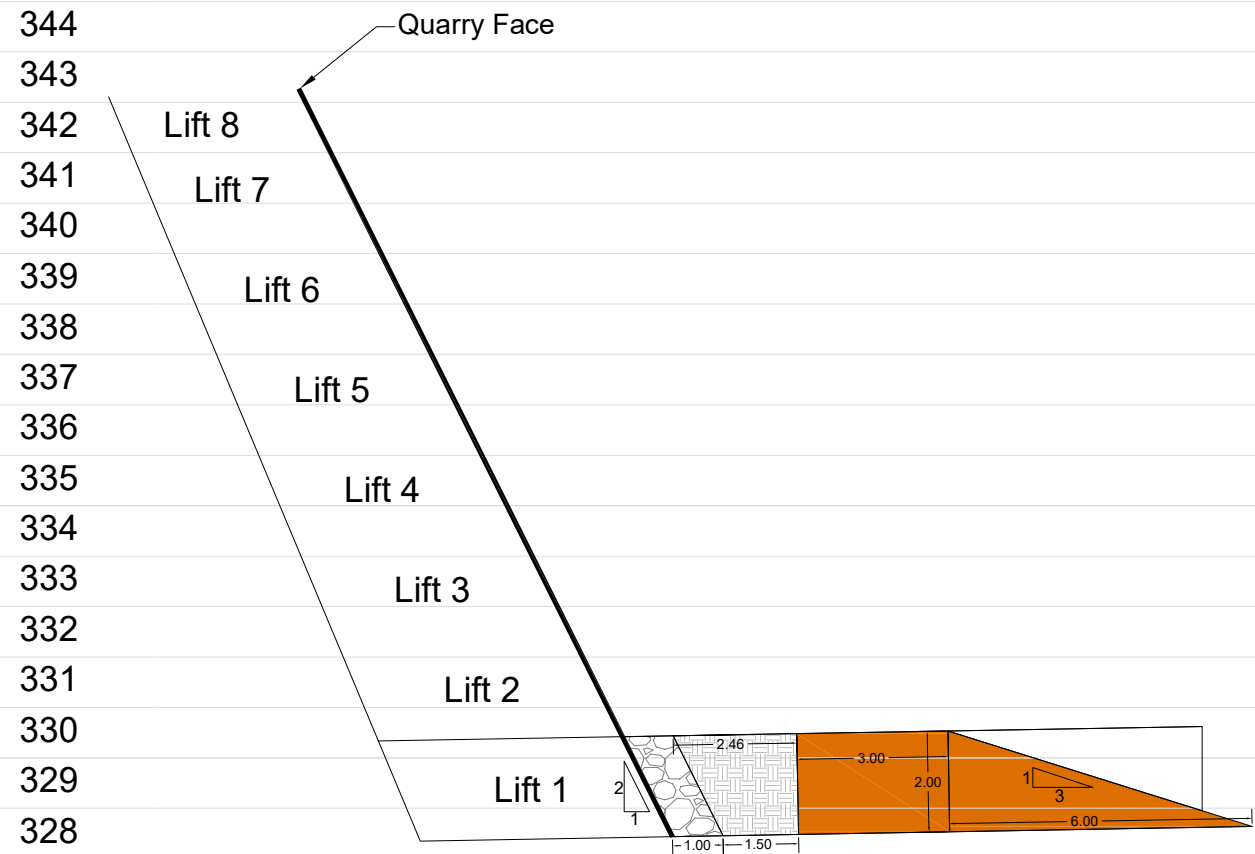
- Key:**
- Waste
 - Compacted Clay Liner
 - Granular Drainage
 - Attenuation Fill
 - General Fill Compacted to S.H.W Series 600
 - Topsoil / Gravelly Clay
 - Pennine Lower Coal Measures (Shale / Mudstone)
 - Lower Foot Mine Coal Seam
 - Lower Coal Seam
 - Sandstone
 - Deep Groundwater Level (06/02/2021)

- Notes:**
1. The Conceptual Site Model has a vertical exaggeration is 2:1 and a horizontal exaggeration of 1:1.
 2. The engineered side wall diagram has a vertical and horizontal exaggeration of 1:1.
