# **Environmental Permit Variation Application**

Eales Farm Landfill, Tamar View Industrial, Saltash

**Environmental Setting and Site Design Report**

Report: GCE00692/2020/ESSD

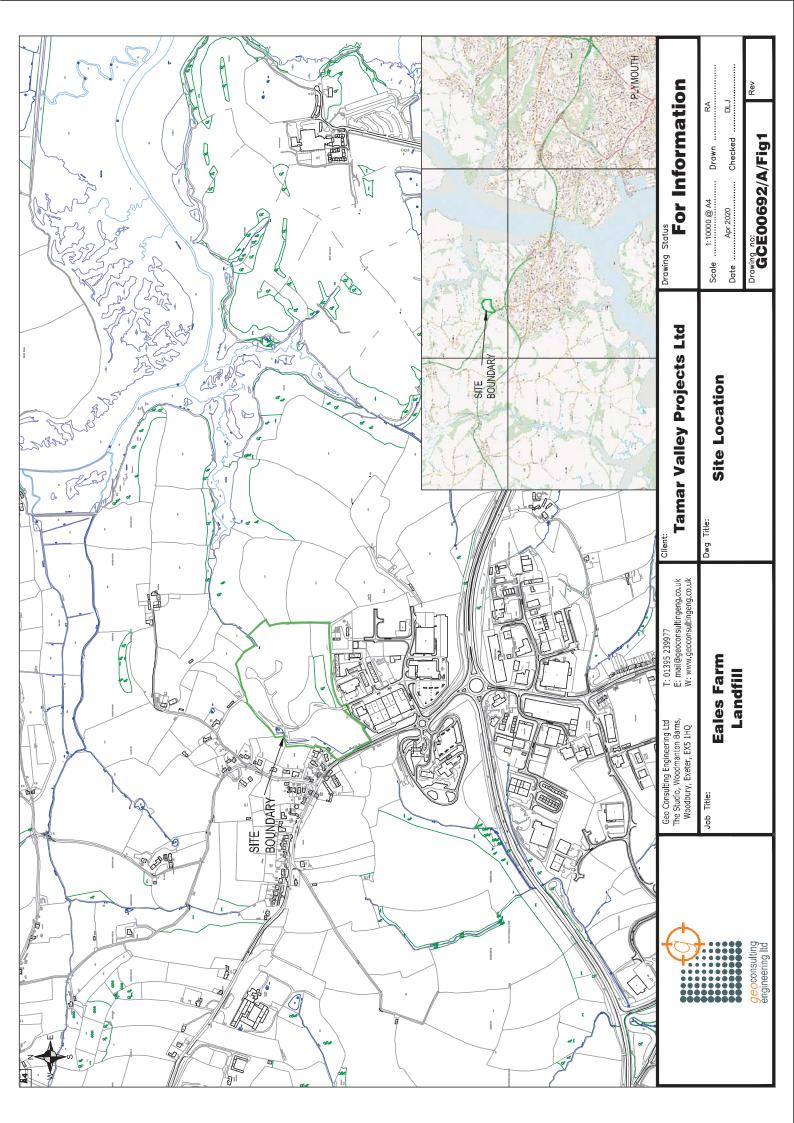
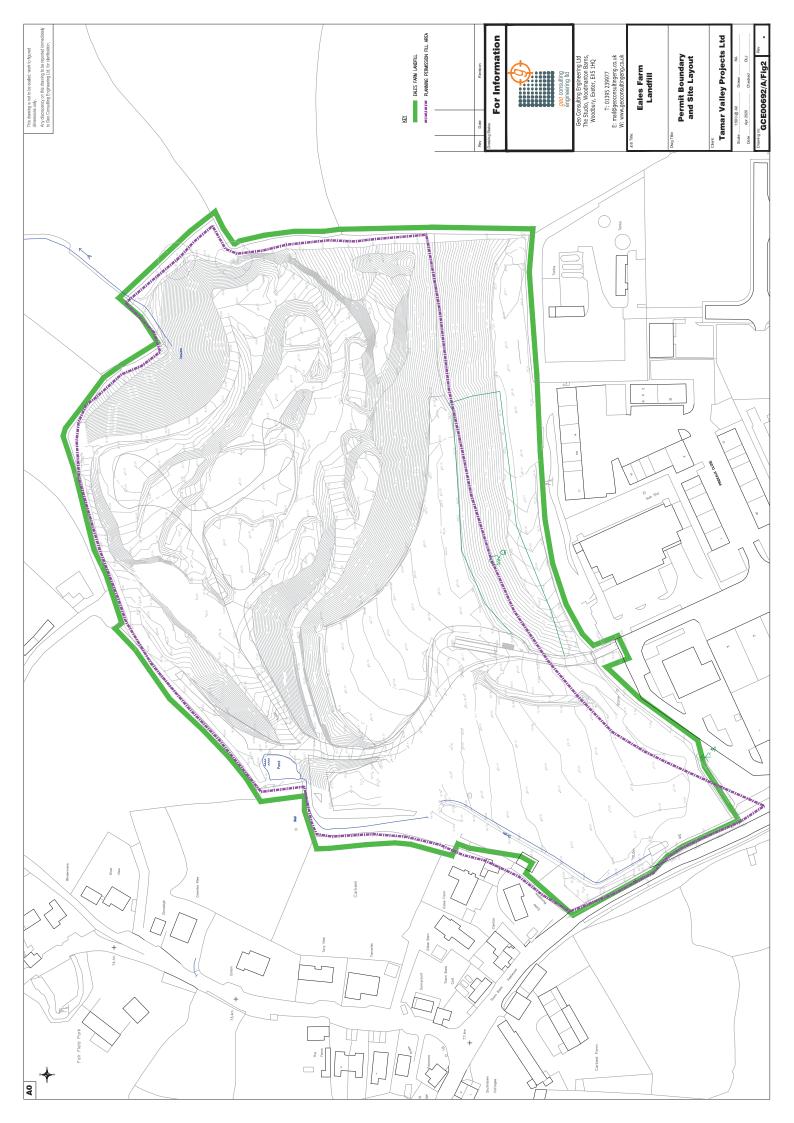
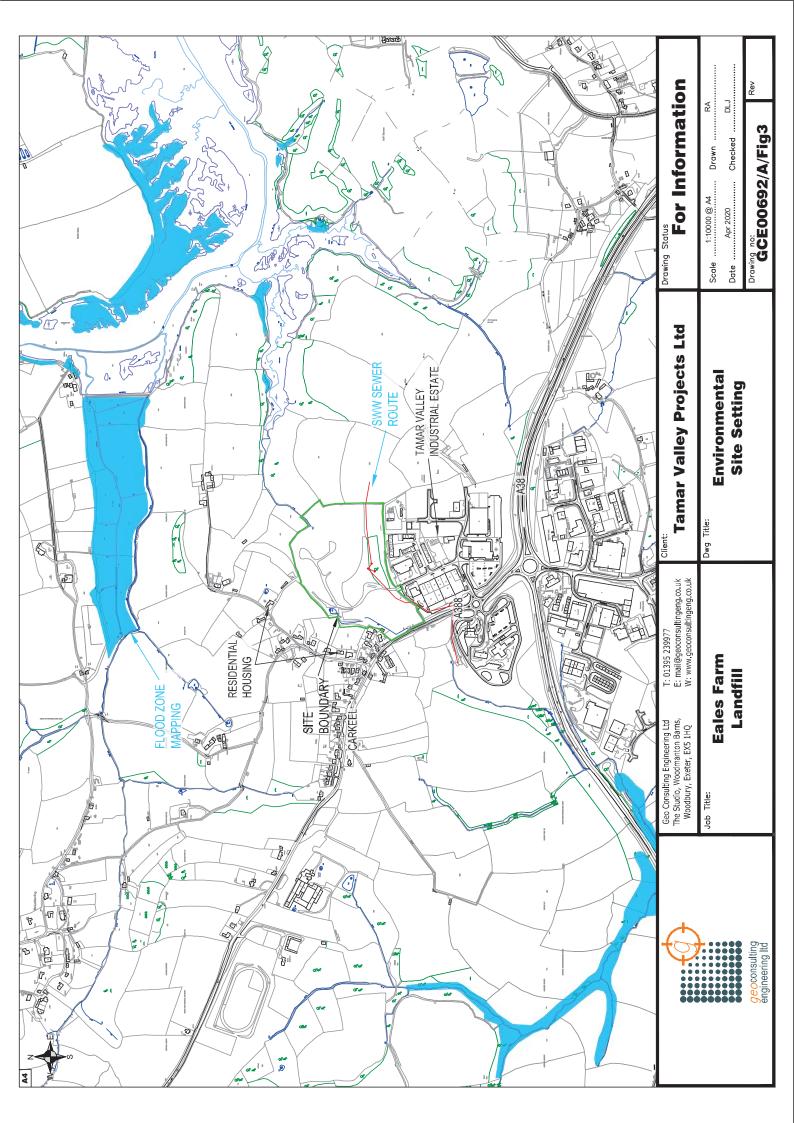
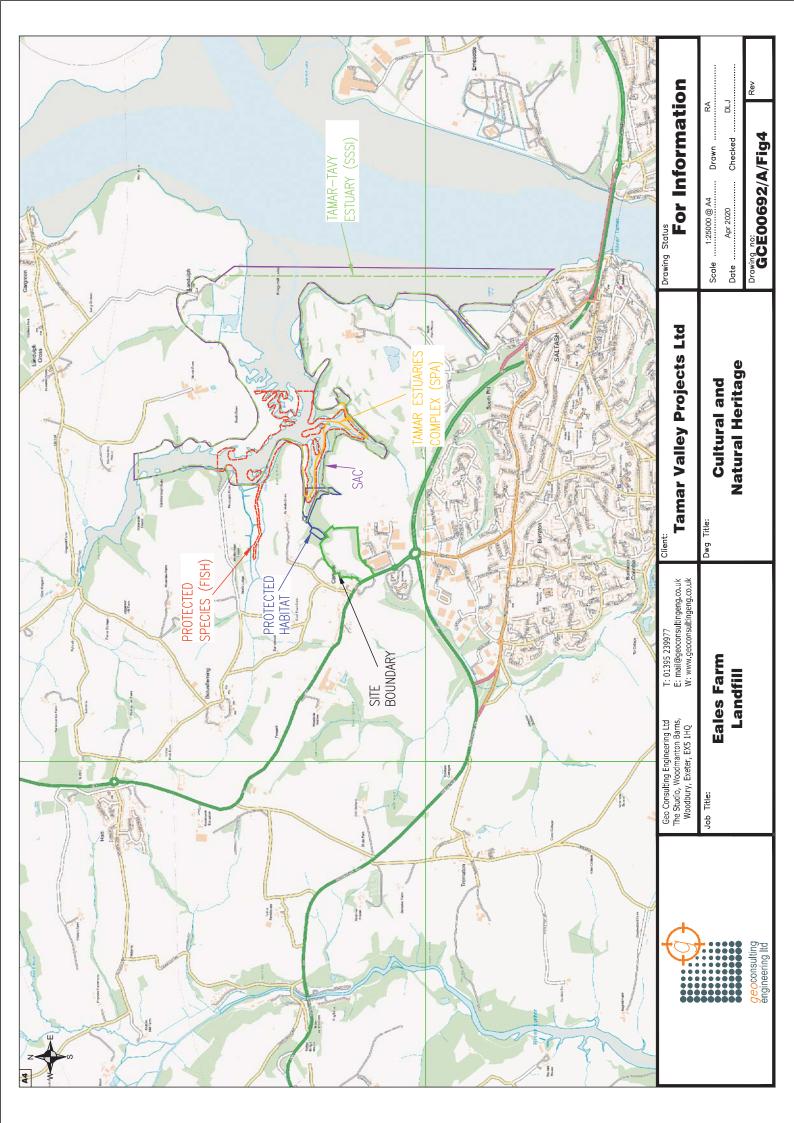
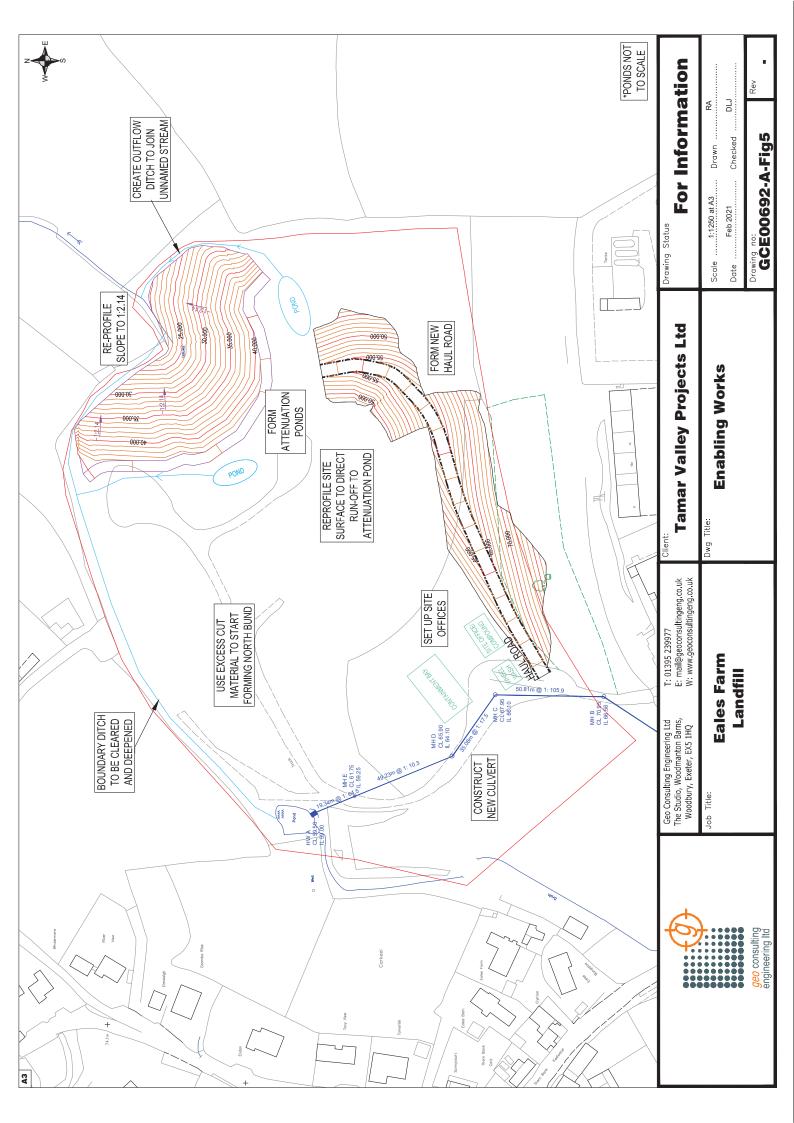
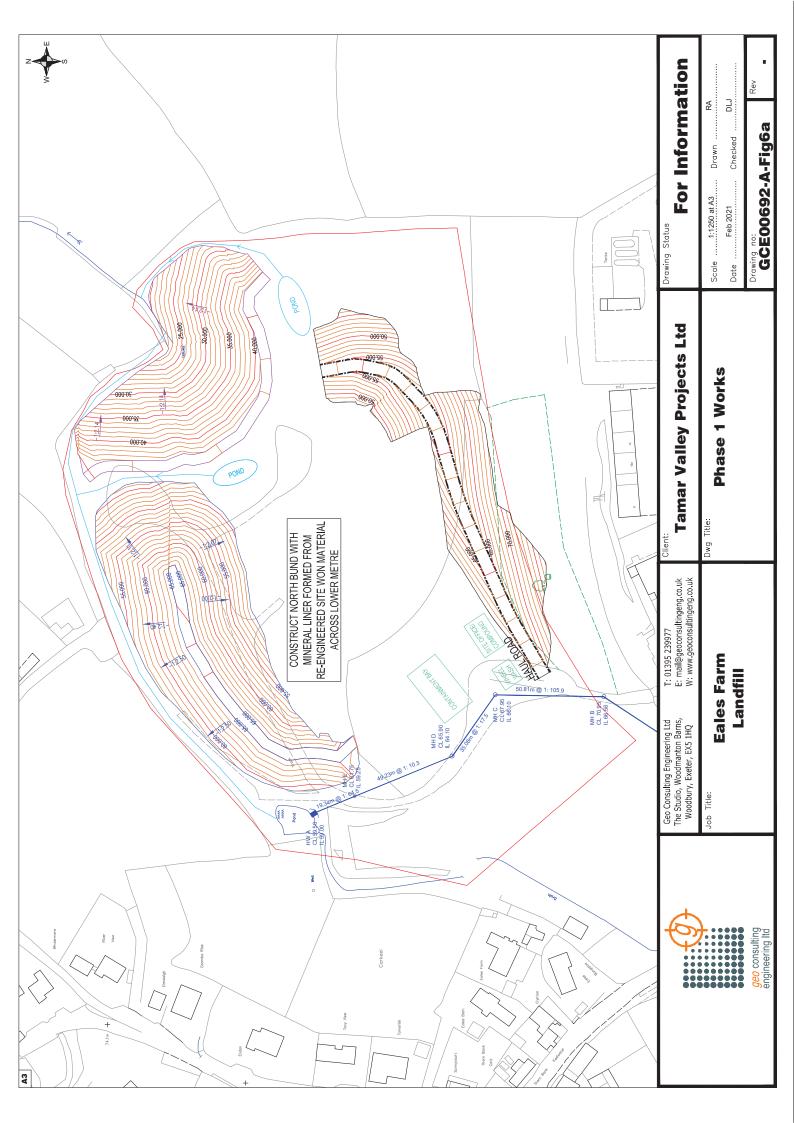
Figure 1 Site Location Figure 2 Permit Boundary and Site Layout Figure 3 **Environmental Site Setting** Figure 4 Cultural and Natural Heritage Figure 5 **Enabling Works Plan** Figure 6a Phase 1 Figure 6b Phase 2 Figure 6c Phase 3 Figure 7 Restoration Plan Figure 8 Regional Geology Figure 9 Watercourses Figure 10 Regional Hydrogeology Figure 11 **Current Monitoring Locations** Figure 12 Proposed Monitoring Locations Figure 13 Monitoring Well Designs

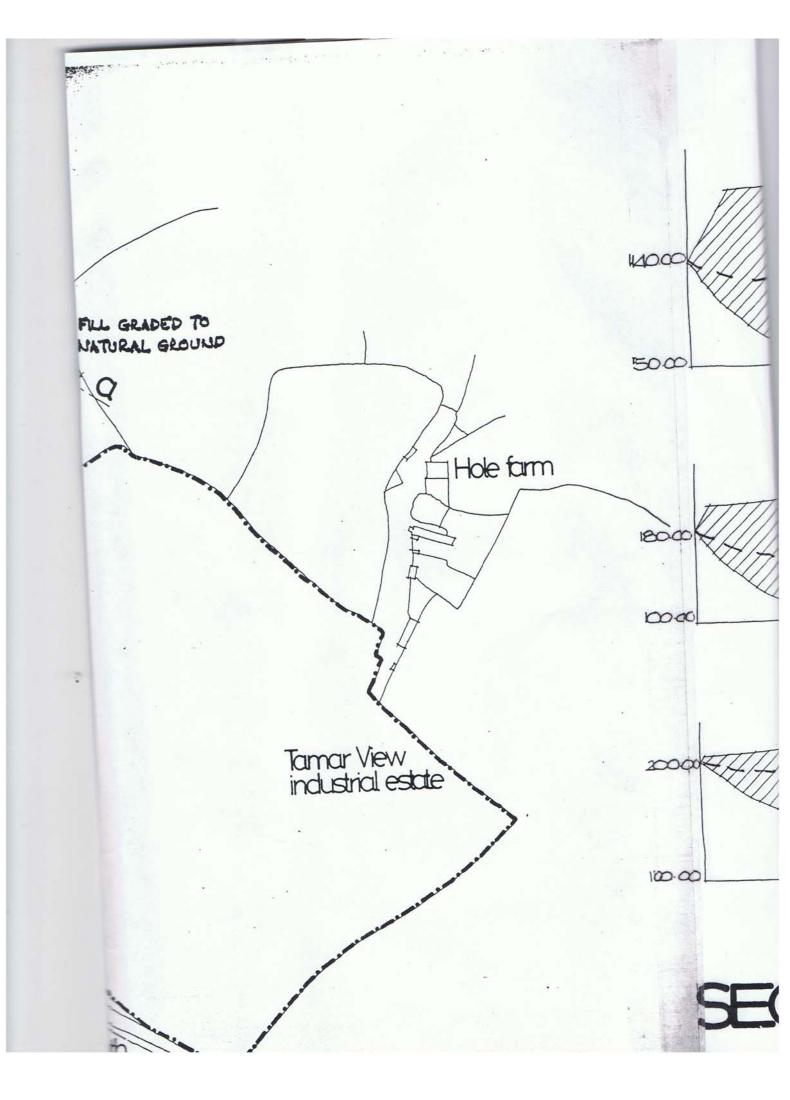
top slope lin 40 maximum 30° slope side slope 30° to boundary. stream to be culverted under fill. proposed fill shaded on plan-hatched in section
