CONTAINMENT ASSESSMENT

Environmental and sustainability solutions provided to
RESOURCE RECYCLING SOLUTIONS LTD

| Document Title | Containment Assessment |
| Client | Resource Recycling Solutions Ltd |

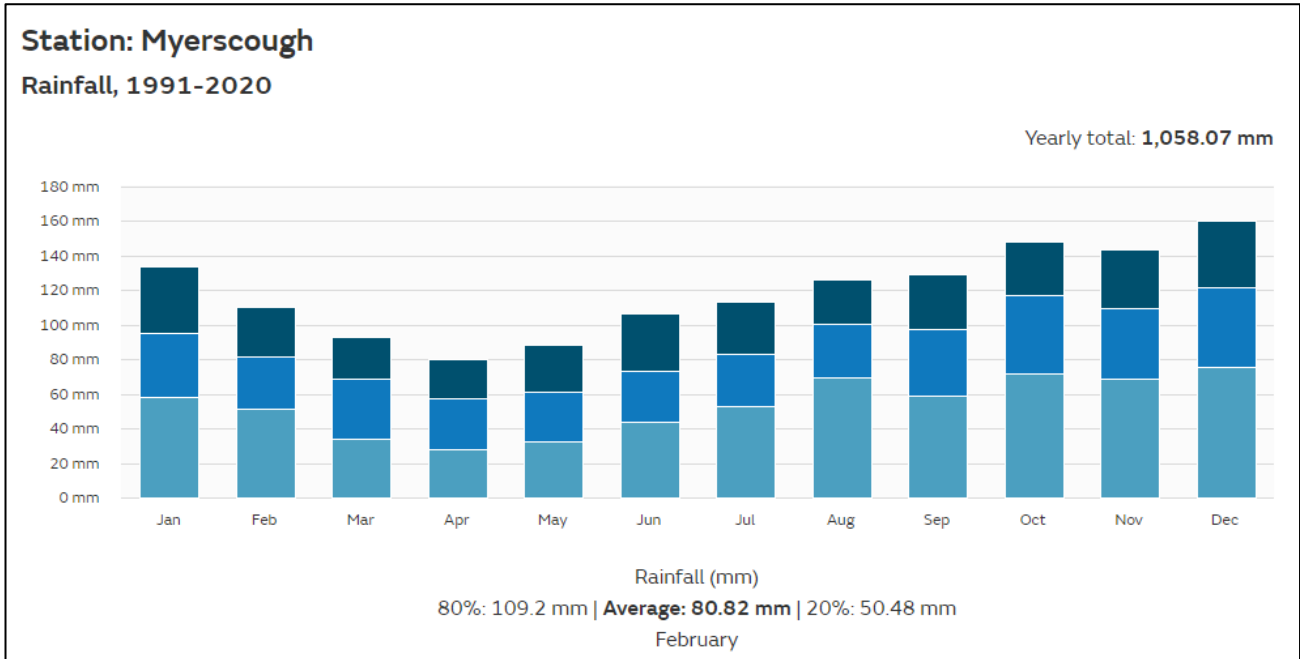
Figure 2 - Monthly Average Rainfall Data for the Site.

Monthly average rainfall for the nearest Met Office weather station (Myerscough¹, situated 4.8km from the site) is presented in Figure 2.
