Jays Close
Viables Industrial Estate
Site Baseline Report

LevertonHELM Ltd

In June 2021, Rodgers Leask Limited (RLL) was appointed by St. Modwen Developments Ltd to prepare a Development Completion Land Quality Statement (DCLQS) for the St Modwen's Park development, located at the former ITT Viables Business Park within Basingstoke (referred to hereafter as the 'Site').

This Site Baseline Report (BSR) presents factual information regarding the known development history of the Site, the results of ground investigations, details of remediation work undertaken within the Site boundary, construction drawings and information from the Contractor relating to the development. The data has been obtained from existing third-party reports, publicly available data sources and regulatory correspondence.

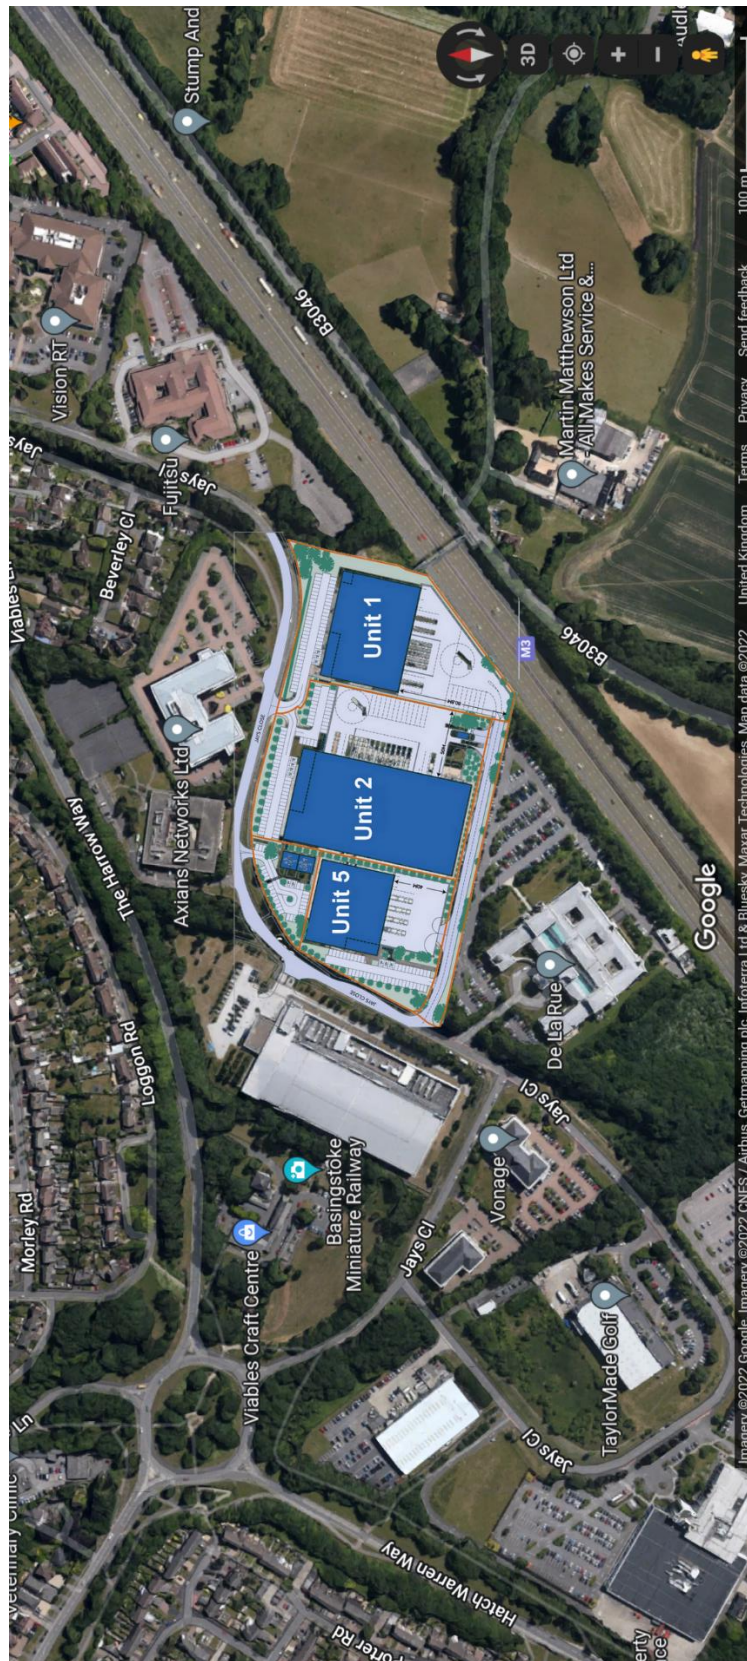
Appendix B: Site Plan

Viabes Site Plan

Operator: LevertonHelm Ltd
Site Name: St. Modwen Park
National Grid Reference:
SU 63439 50172
Scale: See image
Date 29/04/2022

Appendix B: Site Plan..... 19

- Site plan
