## Local Operating Procedure (LOP)

<b>Site</b>	Strongford STF
<b>Title</b>	Leak Detection and Repair Plan (LDAR)

<b>Purpose</b>	This Local operating procedure describes the methods applied to locating, identifying and mitigating against fugitive emissions to air as part of the Environmental Permitting Regulations requirements. As well as protecting the environment the benefits of this plan include the safety protection of site staff and increased productivity of the process.
<b>Who</b>	Site operators and managers at Strongford.

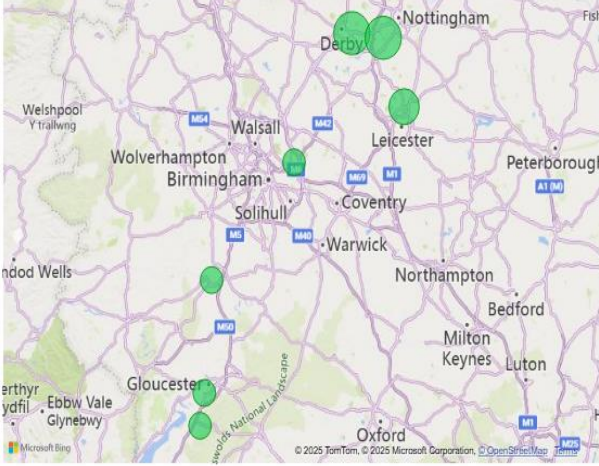
If any leaks are found, they are reported, and the severity is categorised.

**Site Name**

DERBY  
 MINWORTH  
 NETHERIDGE  
 STANLEY DOWNTON  
 STRONGFORD  
 TOTON  
 WANLIP  
 WORCESTER

**Leak Severity**

Defect  
 Emission  
 Leak  
 Venting  
 Weep

**Repaired**

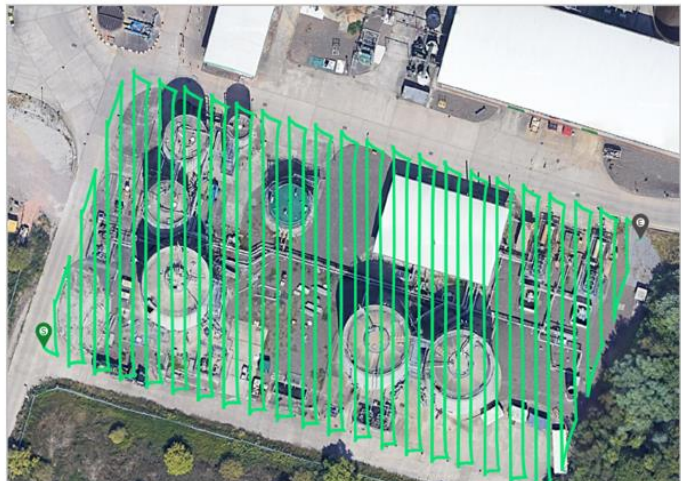
**Line1: Inspection Overview**

**Device type:**U10  
**Serial Number:**U10-215006  
**Alarms Num:**0 (0★)  
**Notes Num:**0  
**Time Length:**15min:24s  
**Distance:**2.95km  
**Start time:**  
 12 Jun 2024 at 14:44:58  
**Start location:**  
 Acquisition Location Failed  
**End Time:**  
 12 Jun 2024 at 15:00:22  
**End location:**  
 Acquisition Location Failed  
**Inspector:**derbyjune2024

A ONE Drone inspection report.  
 Waste Treatment BRef - Best Available Techniques (BAT)
