## Technical Note

### Requisite Surveillance

### Foundry Central West Teesworks

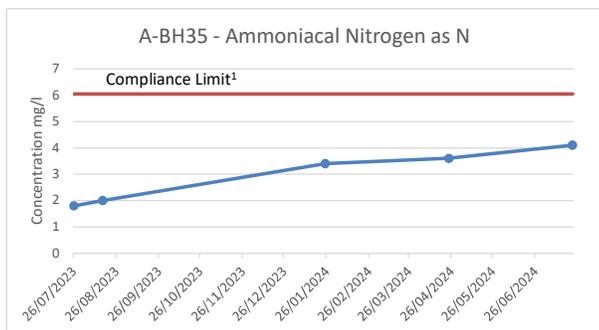
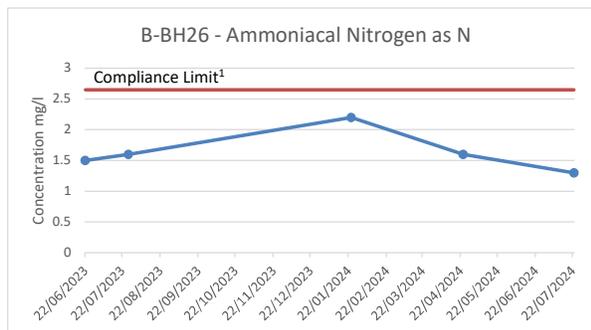
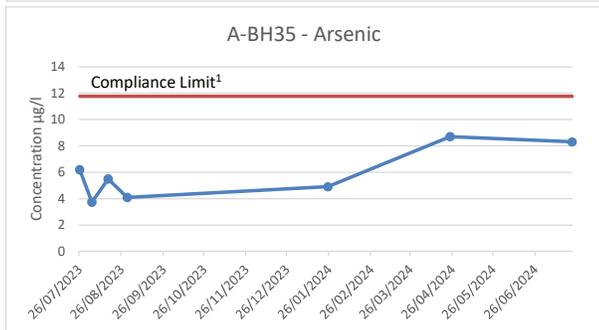
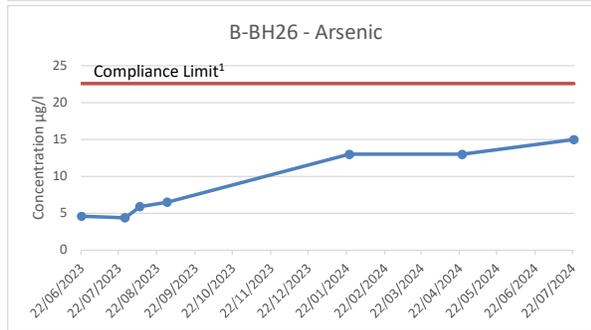
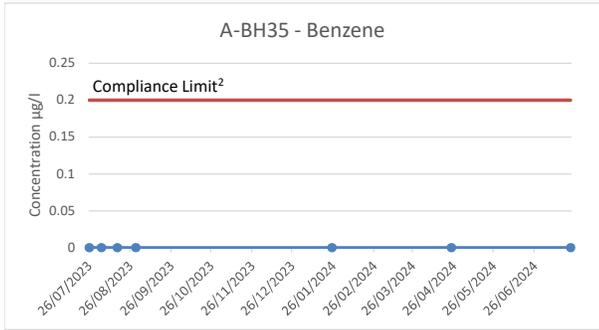
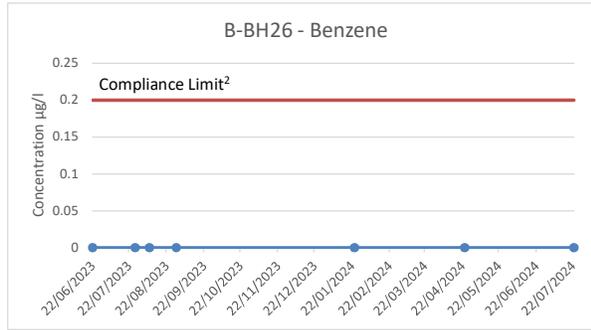
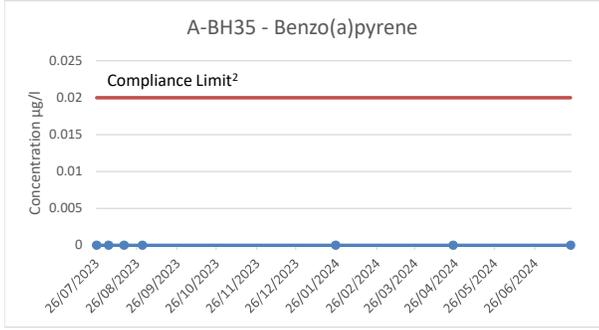
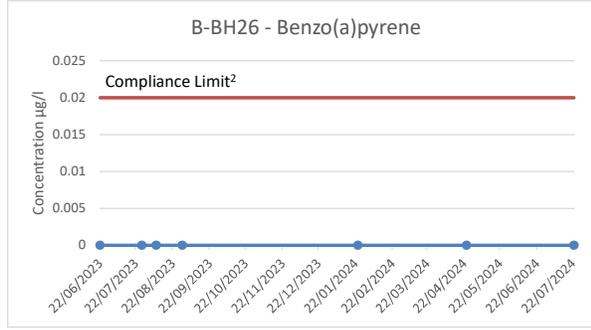
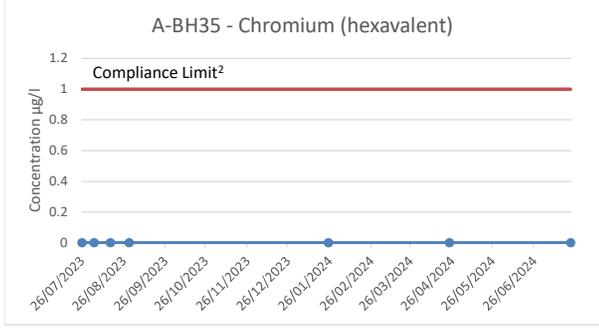
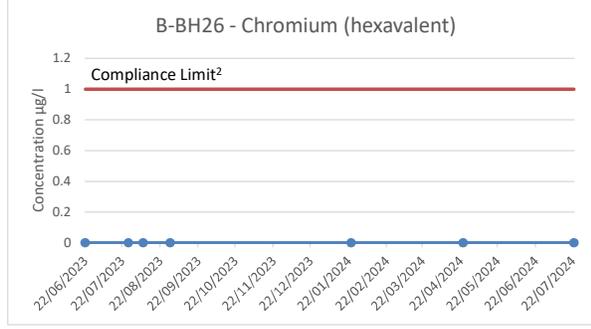
Graphs showing substance concentrations recorded in A-BH26S and A-BH35S over the period of June 2023 to July 2024

- 1 Compliance limit based on mean plus 3 x standard deviation
- 2 Compliance limit based on MRV or WQS

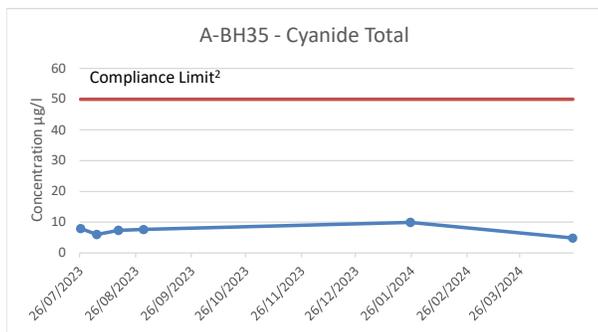
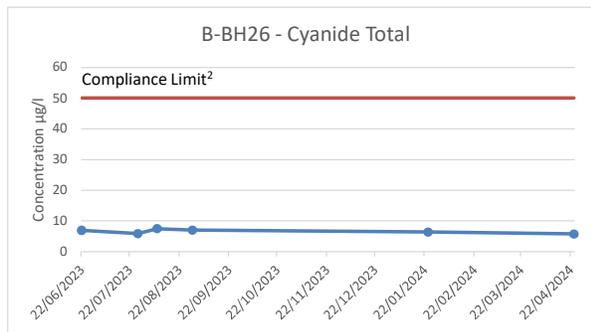
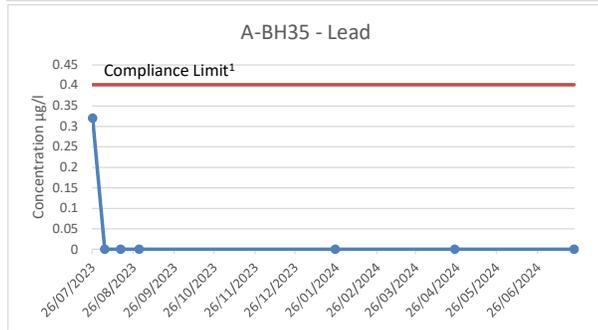
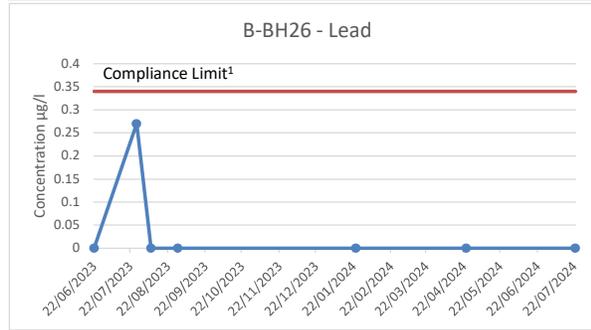
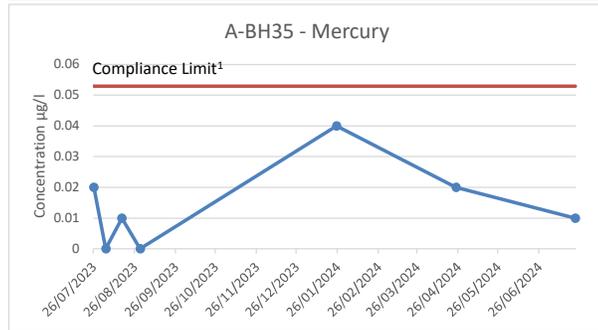
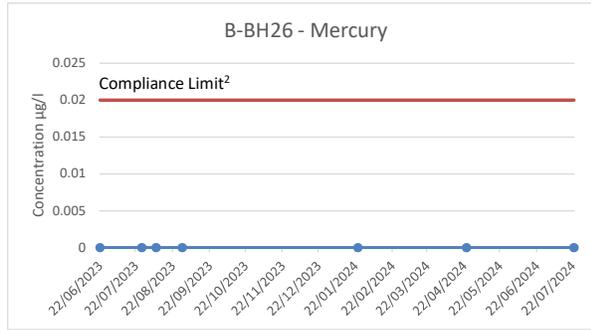
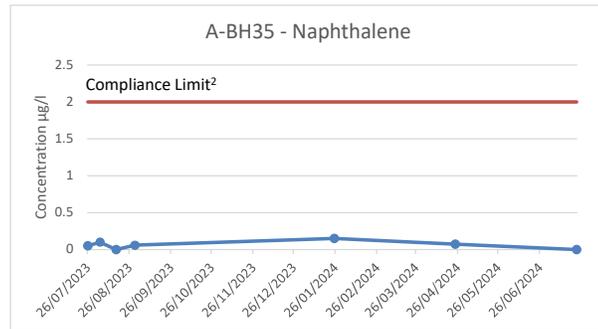
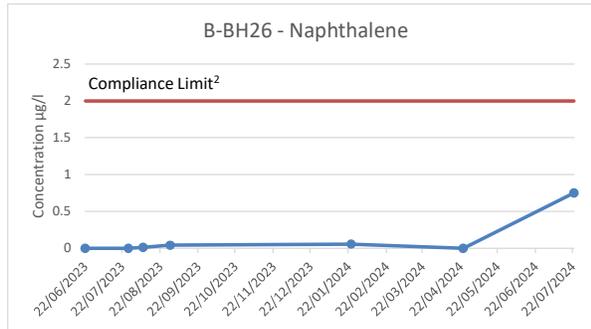
- 1 Compliance limit based on mean plus 3 x standard deviation
- 2 Compliance limit based on MRV or WQS

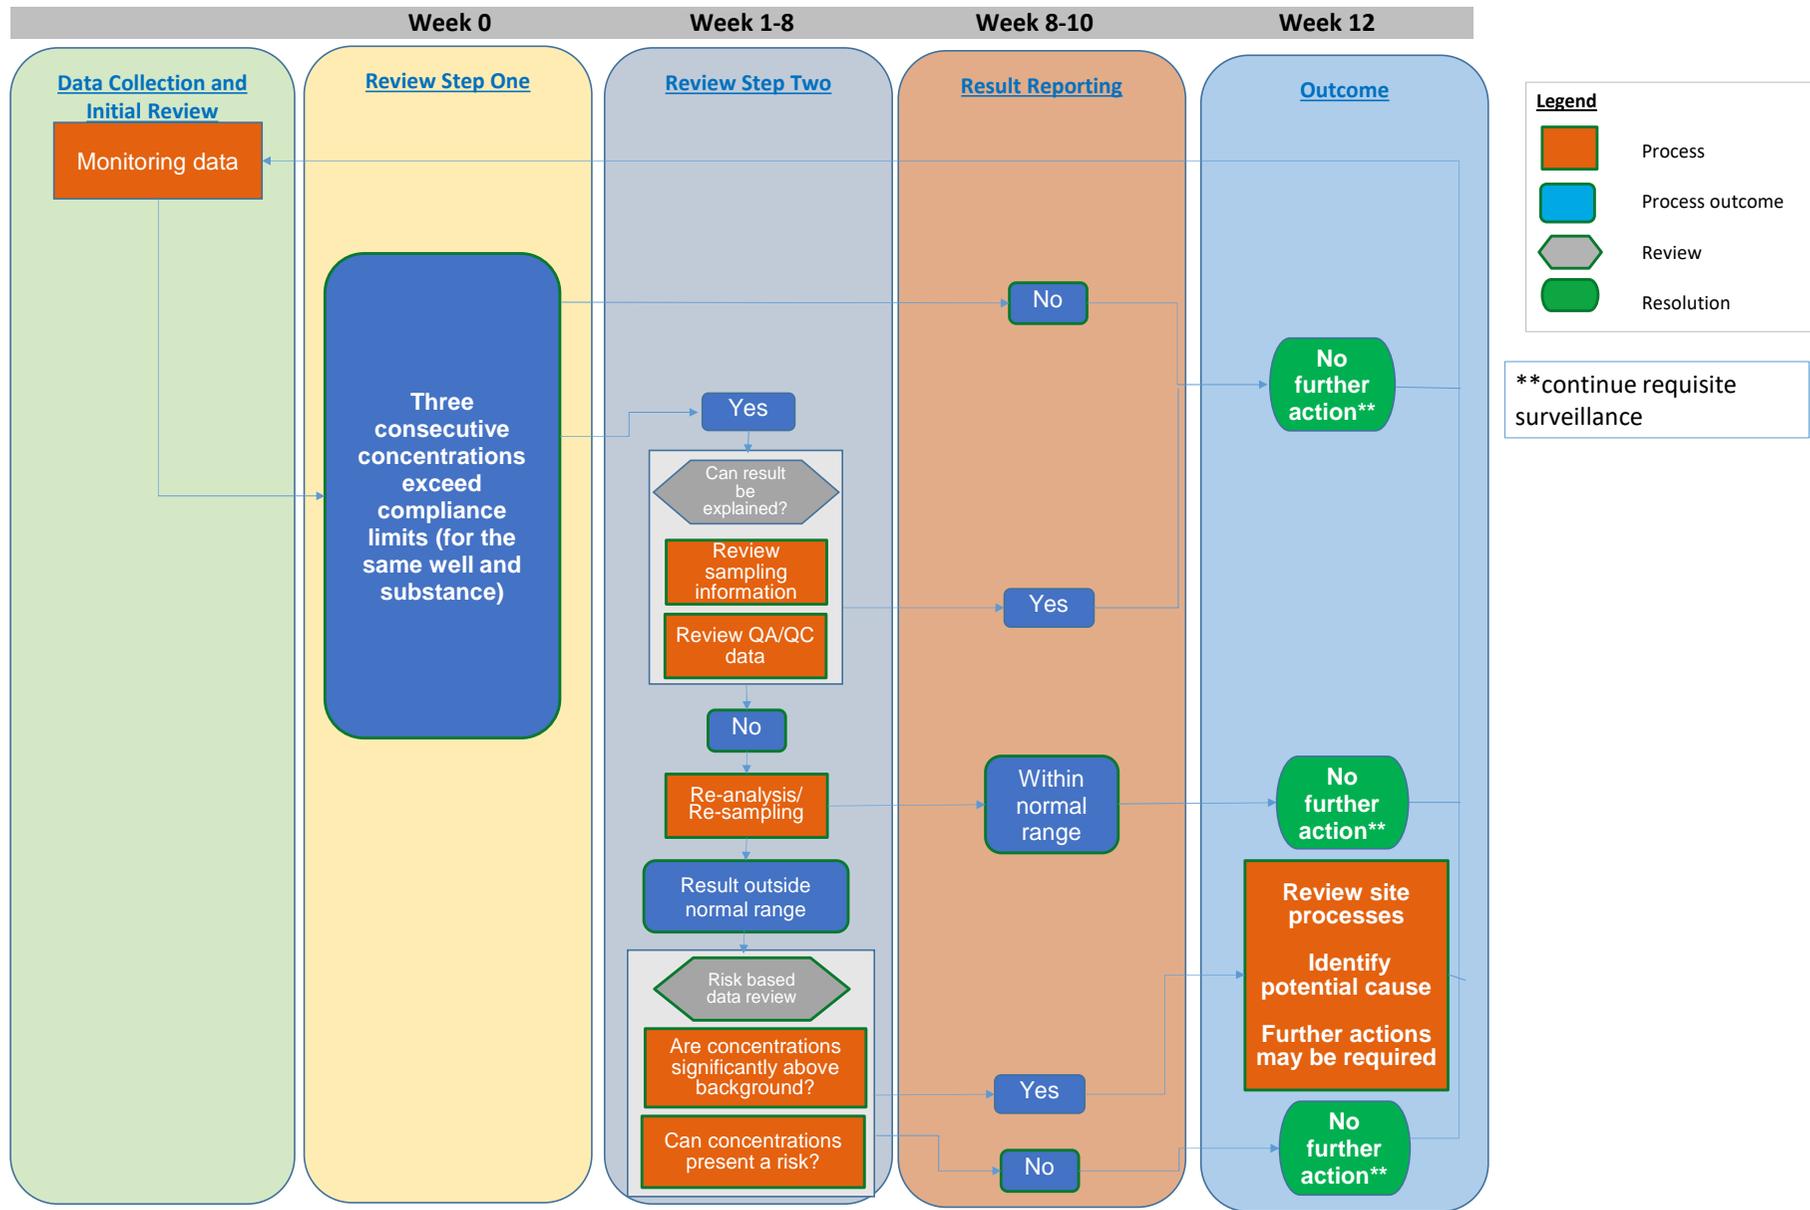
Contingency Action: Process Flow Diagram
