#### Document reference: | 790101\_MSD\_SCR\_ASH December 2024|

1.0 SITE DETAILS	
Name of the applicant	Southern Water
Activity address	Ashford Wastewater and Sludge Treatment Works Kinneys Lane, Canterbury Road, Ashford, Kent, TN24 9QB
National grid reference	TR 02107 43407
Document reference and dates for Site Condition Report at permit application	Site Condition Report: 790101_MSD_SCR_ASH
and surrender	Date of Permit Application: TBC
	Date of Surrender: TBC

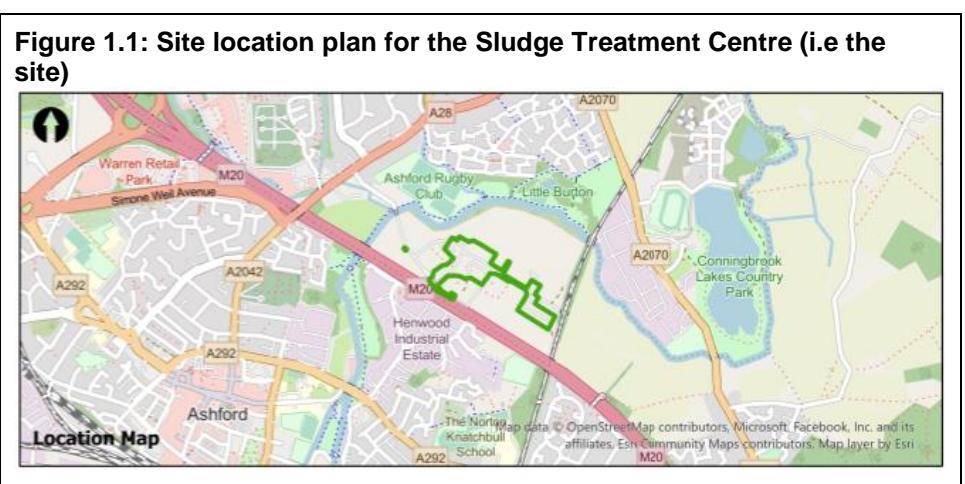
2.0 Condition of the land at permit issue		
Environmental setting	Land use	
<ul> <li>including:</li> <li>geology</li> <li>hydrogeology</li> <li>surface waters</li> </ul>	The site is located to the northeast of the town of Ashford. The areas hosts the Ashford Wastewater Treatment Works (WWTW), within which the Sludge Treatment Centre (STC) (hereby referred to as the site) is located. The first evidence of sewage treatment works on site is shown in 1898 historic mapping, with a significant expansion from 1964. The M20 is situated to the south of the site with Henwood Industrial Estate located immediately south beyond that. The River Great Stour runs approximately 250m northeast of the site along the site perimeter to the south west. To the north of the river, there are rugby playing fields and a few residential properties. The site layout is depicted in Figure 1.1
