### **RECYCLE IT GLOBAL (RIG) SCORRIER LIMITED**

PARC-AN-CHY WASTE FACILITY

SITE CONDITION REPORT

SEPTEMBER 2024

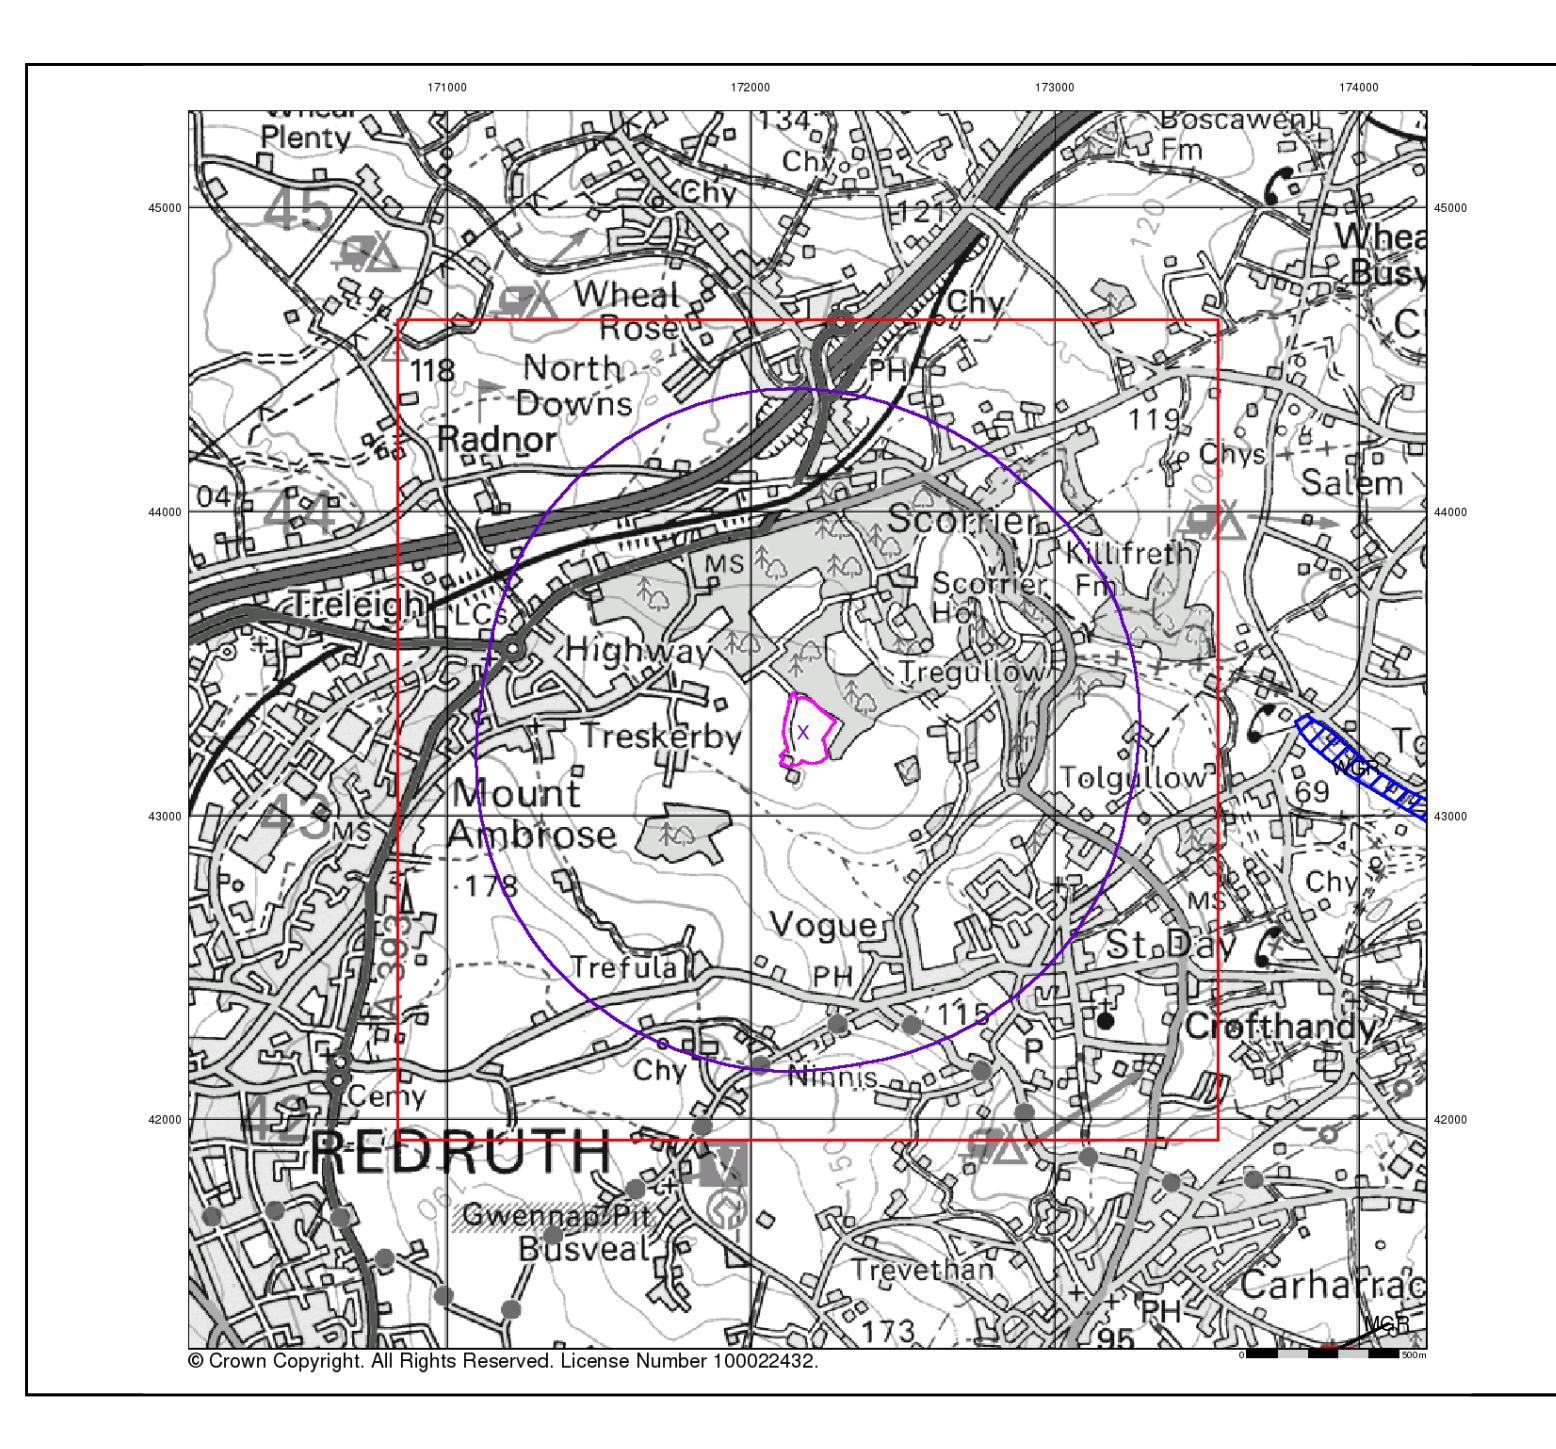
### Geology 1:50,000 Maps - Slice A

This report contains geological map extracts taken from the BGS Digital Geological map of Great Britain at 1:50,000 scale and is designed for users carrying out preliminary site assessments who require geological maps for the area around the site. This mapping may be more up to date than previously published paper maps. The various geological lavers - artificial and landslip deposits. superficial

The various geological layers - artificial and landslip deposits, superficial geology and solid (bedrock) geology are displayed in separate maps, but superimposed on the final 'Combined Surface Geology' map. All map legends feature on this page. Not all layers have complete nationwide coverage, so availability of data for relevant map sheets is indicated below.

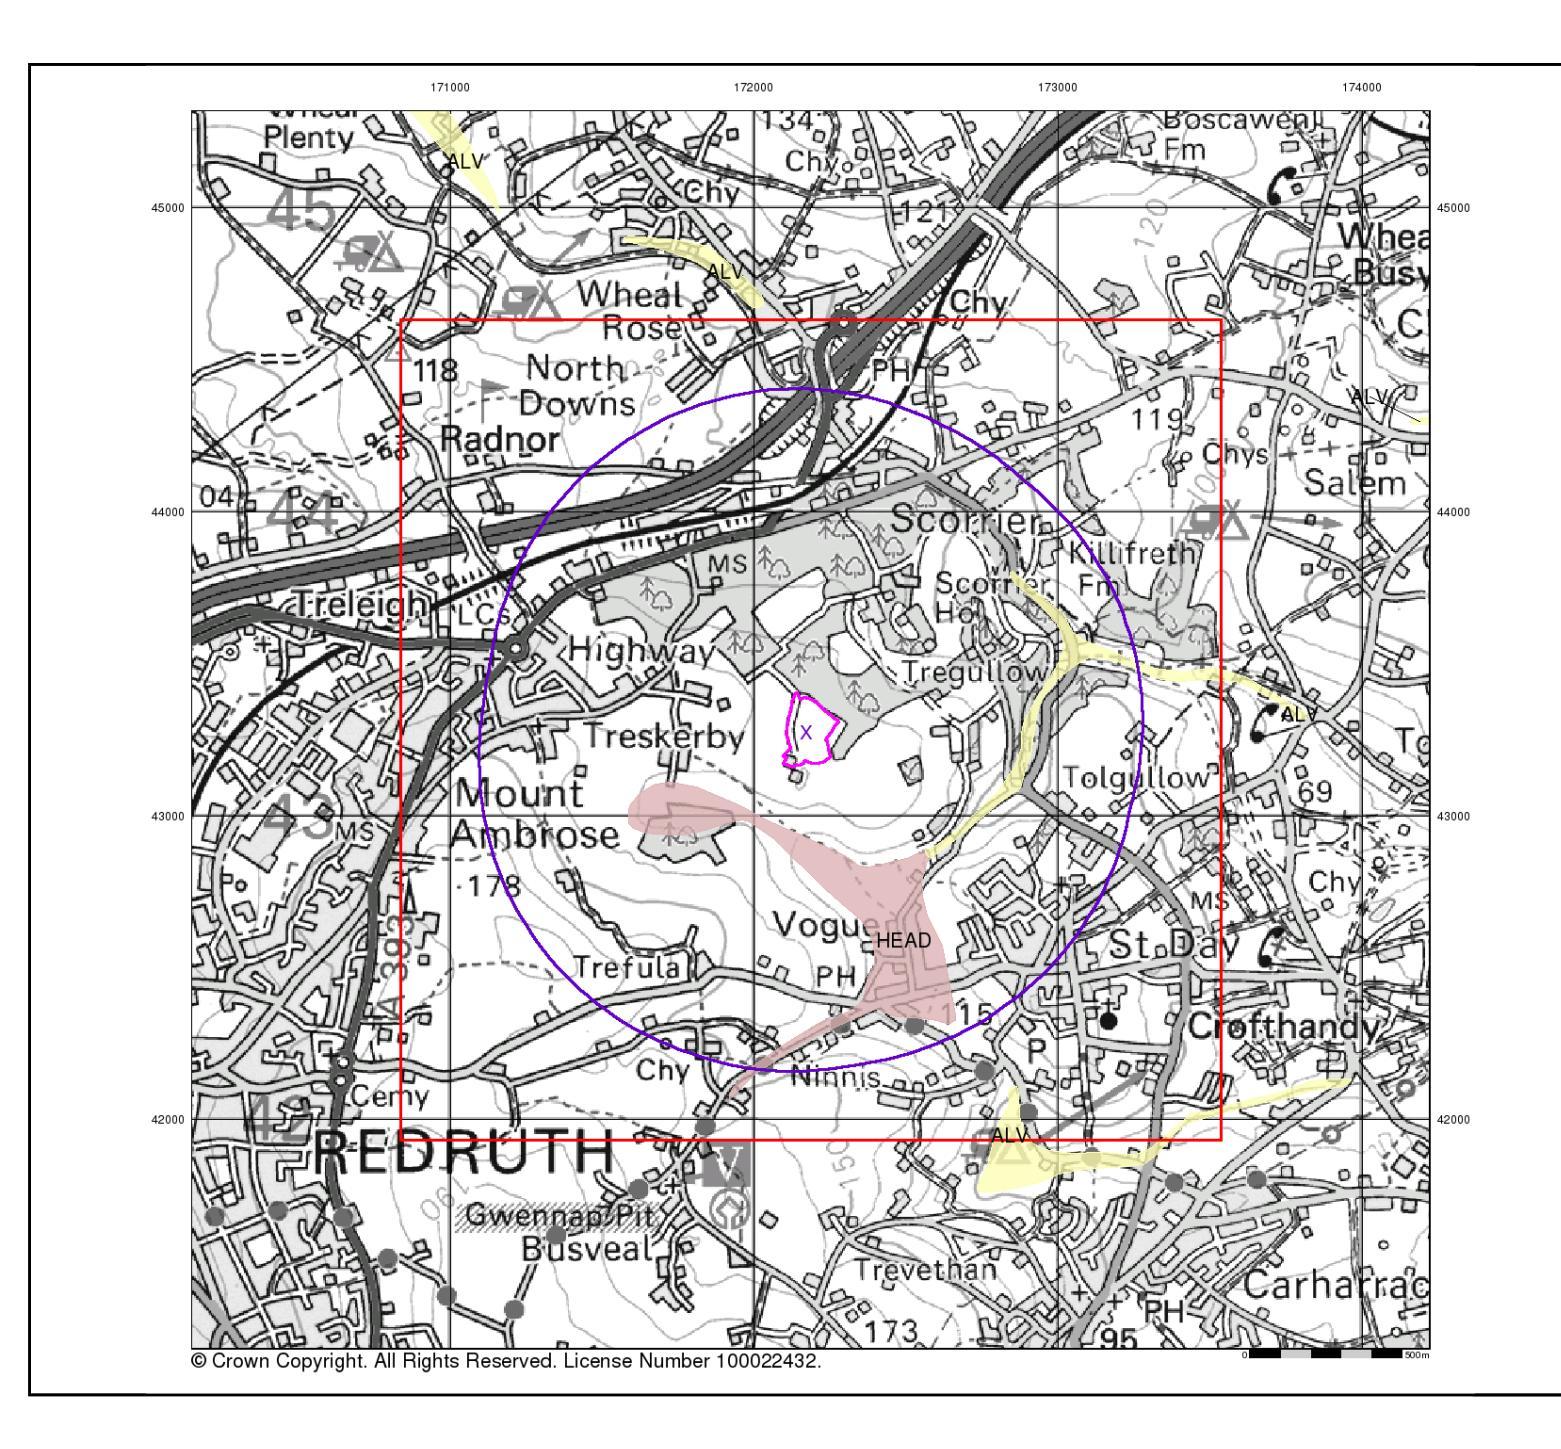
### Artificial Ground and Landslip Map - Slice A

Artificial ground is a term used by BGS for those areas where the ground surface has been significantly modified by human activity. Information about previously developed ground is especially important, as it is often engineering conditions and unstable ground.

- Made ground man-made deposits such as embankments and spoil heaps on the natural ground surface. - Worked ground - areas where the ground has been cut away such as
- quarries and road cuttings.
- Infilled ground areas where the ground has been cut away then wholly or partially backfilled.

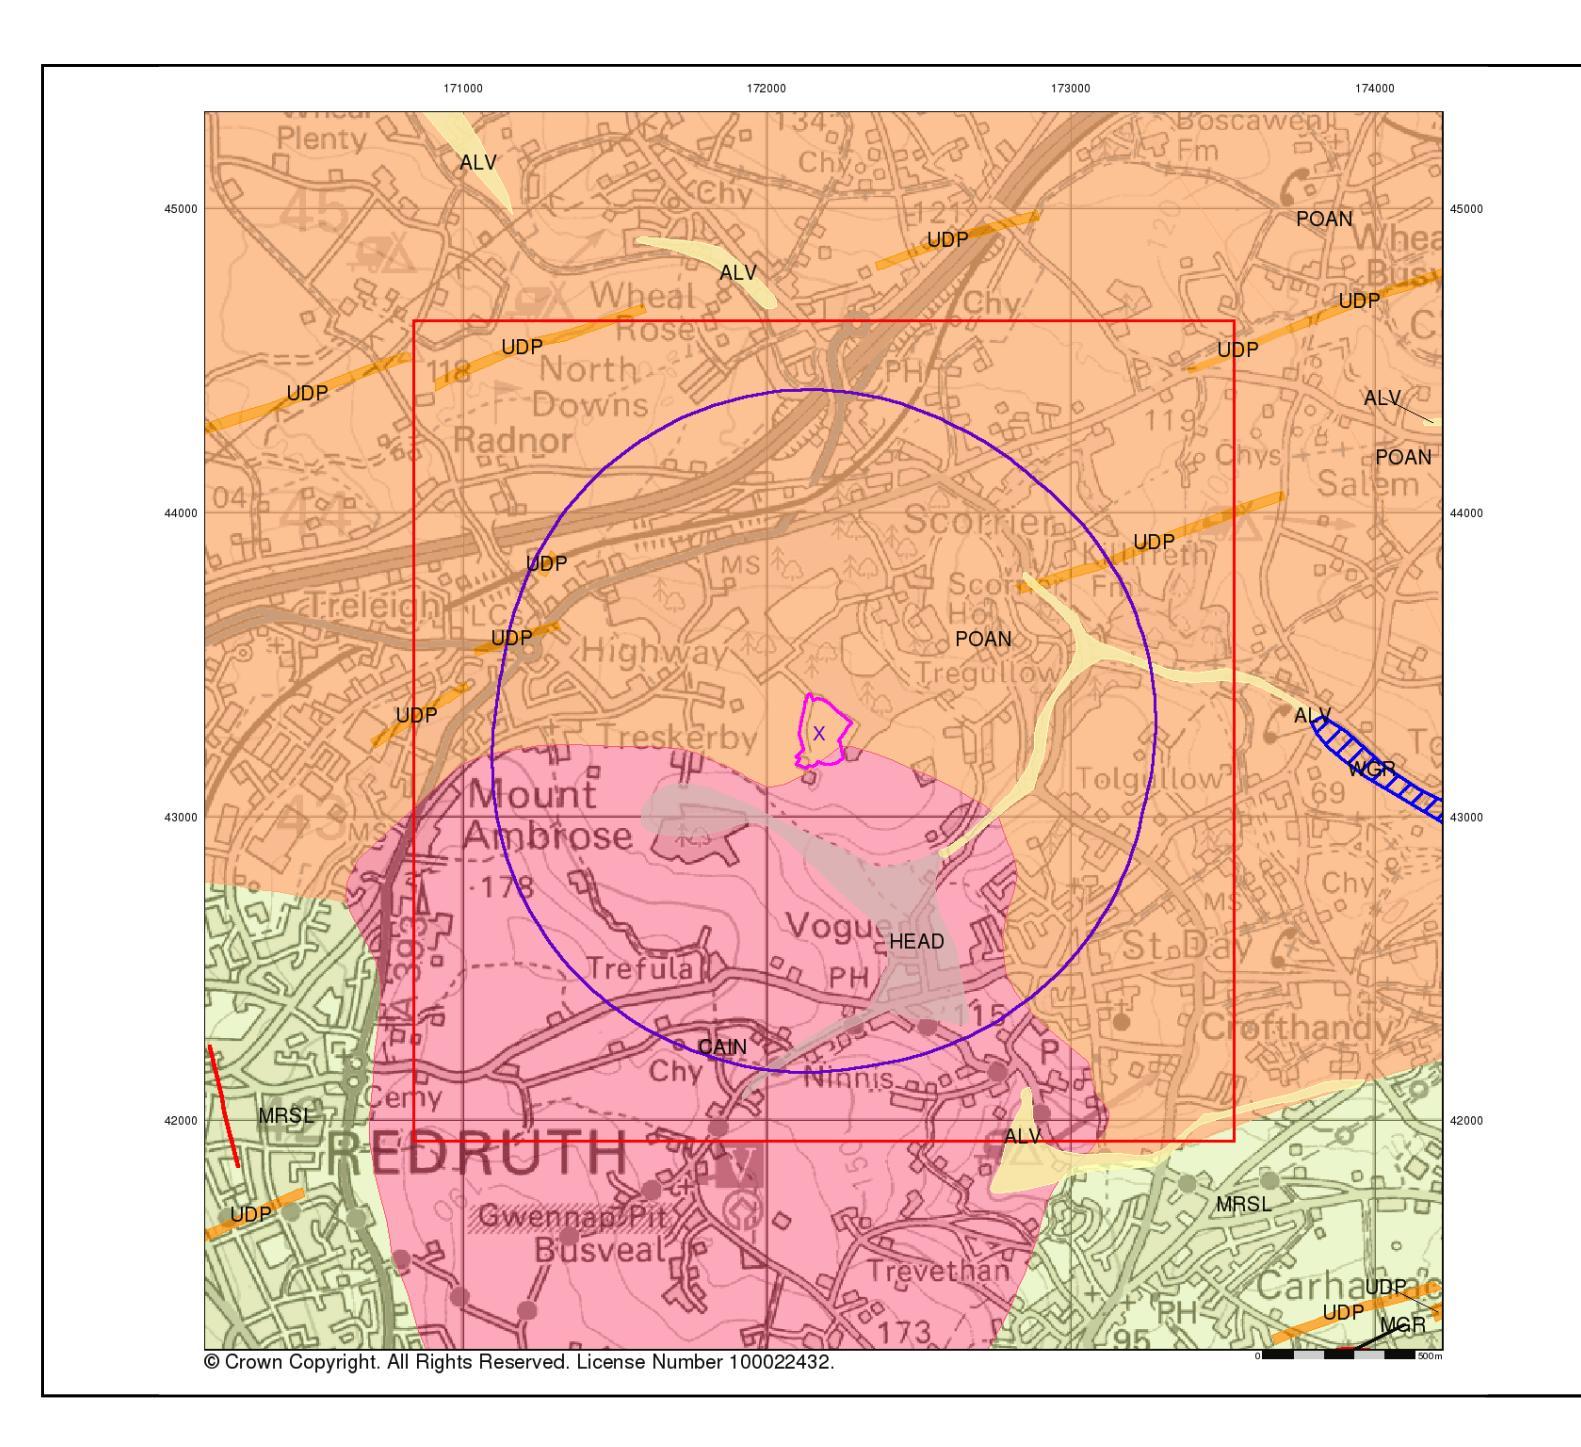
Bedrock geology is a term used for the main mass of rocks forming the Earth and are present everywhere, whether exposed at the surface in outcrops or concealed beneath superficial deposits or water.

The BGS Faults and Rock Segments dataset includes geological faults (e.g. normal, thrust), and thin beds mapped as lines (e.g. coal seam, gypsum bed). Some of these are linked to other particular 1:50,000 Geology datasets, for example, coal seams are part of the bedrock sequence, most faults and mineral veins primarily affect the bedrock but cut across the strata and post date its deposition.
