Report No. 2401-001/R/003 24 April 2025 Revision 2

Gransmoor Wet Processing Plant

Permit Application Site Condition Report

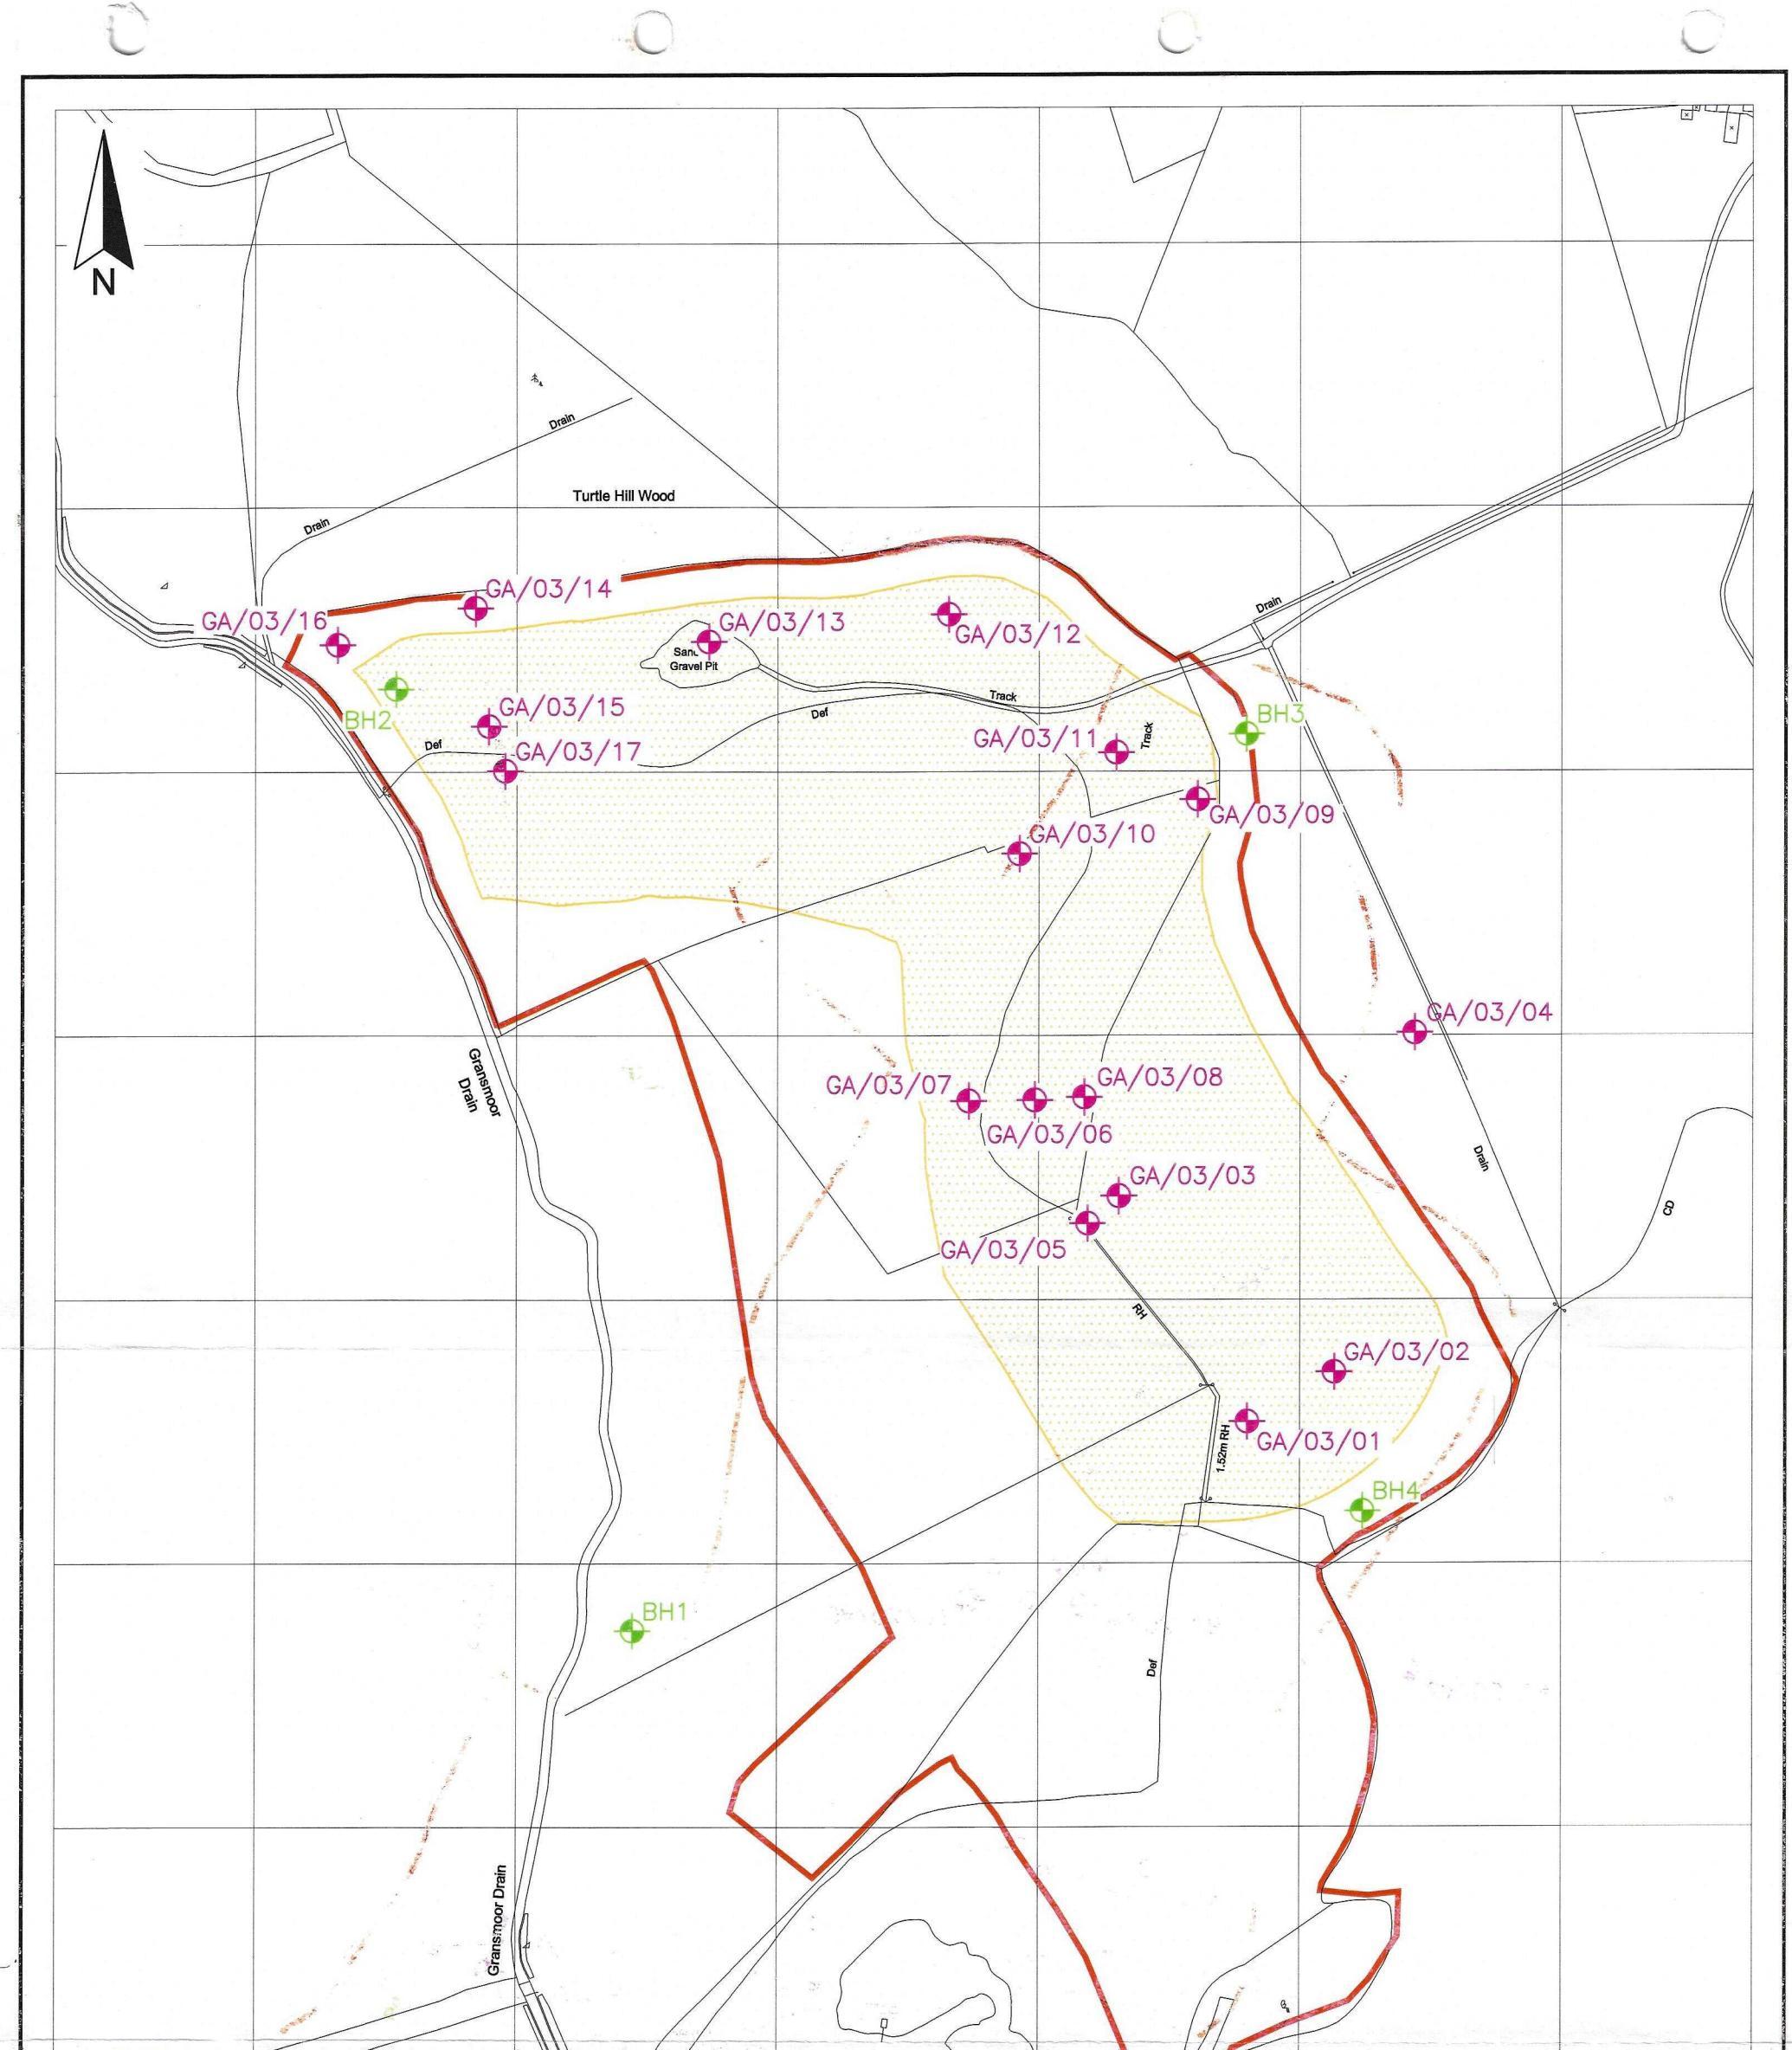
Key / Notes		Site GRANSMOOR QUARRY EXTENSION
		Client W. Clifford Watts Limited
The application boundary		Title Plan showing approximate locations of groundwater monitoring horsholes drilled in
Approximate area of the		September 2006 and mineral proving borehole drilled in September 2003
BH1 Approximate location of a		Figure 6 Scale 1:2500
groundwater monitoring borehole		Drawing Ref WCW/YO/06-07/13598
1/03/07 Approximate location of a mineral		Drawn by Approved by Checked by KR CN
proving borehole		Revisions
	•	
Baddesley Colliery Offices, Main Road, Baxteriey, Atherstone, Warwickshire, CV9 2LE. Telephone : 01827 717891		Reproduced from Land-Plan® 1:2,500 scale mapping by permission of Ordnance Survey® on behalf of The Contro of Her Majesty's Stationery Office. © Crown copyright 200

The estimated position of BH1 based on the plan provided with the MJCA report is approximately 20 m northwest of the proposed Wet Process Plant (WPP) settlement lagoons and approximately 50 m west of the closest component of the WPP itself. BH4 is estimated to be approximately 150 m east of the WPP.

The installation log for BH1 describes 0.7 m of topsoil above 3.2 m of sandy and slightly gravelly silt, under which is 1.5 m of slightly sandy, slightly gravelly clay. Below that is a 0.5 m thick band of sand and gravel and below that is 5.7 m of clay. There are then chalk gravel and silt until the chalk is encountered 16 mbgl. The installation log for BH4 describes 1.8 m of topsoil underlain by 1.2m of slightly sandy, slight gravelly clay. Beneath the clay are further alternating bands of gravel and clay before the chalk is encountered 16 mbgl.
