**TECHNICAL NOTE: Star Brands, Dunlop Road, Redditch
Inspection of Noise Control Works**

Prepared by: Graham Bowland BSc MIOA, Technical Director

Prepared for: Graham Boag – Star Brands Ltd

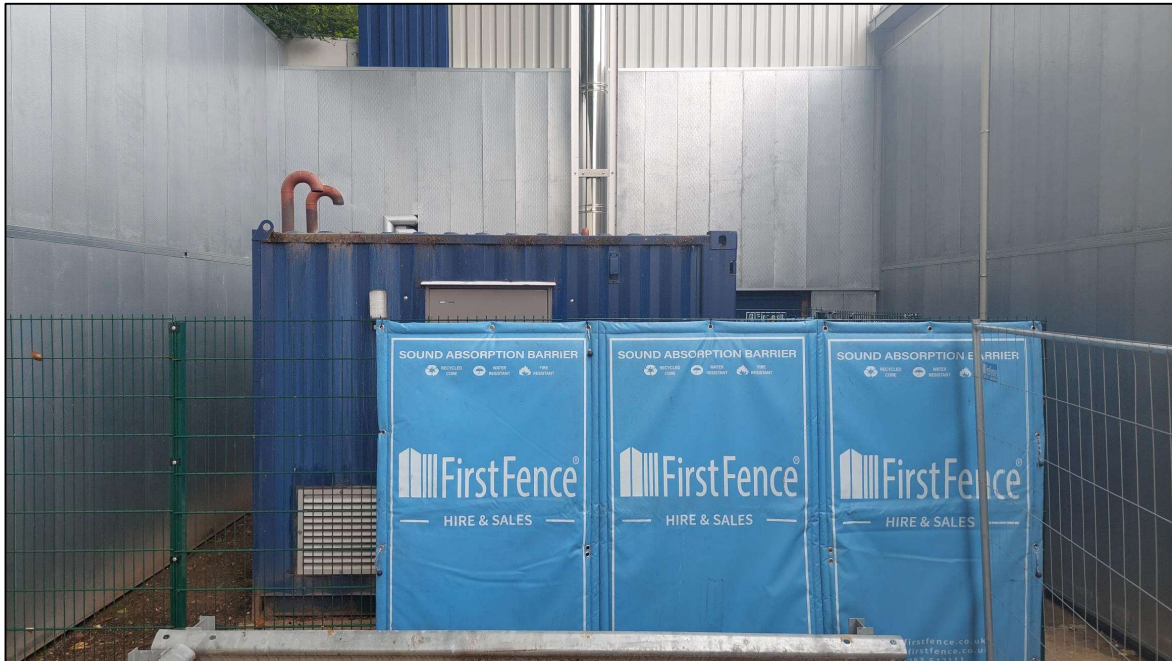
Figure 1 - Noise Mitigation Measures around Boiler Plant

4. Following, Start Brands Ltd have engaged IAC Acoustics to installed 'Varitone' panels to the surfaces surrounding the steam boiler, to control the reflections as described above. It is understood that as part of their proposals, IAC Acoustics confirmed that about a 3dB reduction in noise would be expected at the boundary. This is consistent with our own expectations and prior advice.

5. The completed installation is shown in the appending Figure 1. It is noted that this also includes a mass barrier to the northeast side, to reduce noise propagation away to the open side.

10. This indicates a reduction of 3dB due to the installed mitigation. This is consistent both with expectation based on for the measures, and also of the subjective impression that noise levels around the plant were softened by the reflection controls.

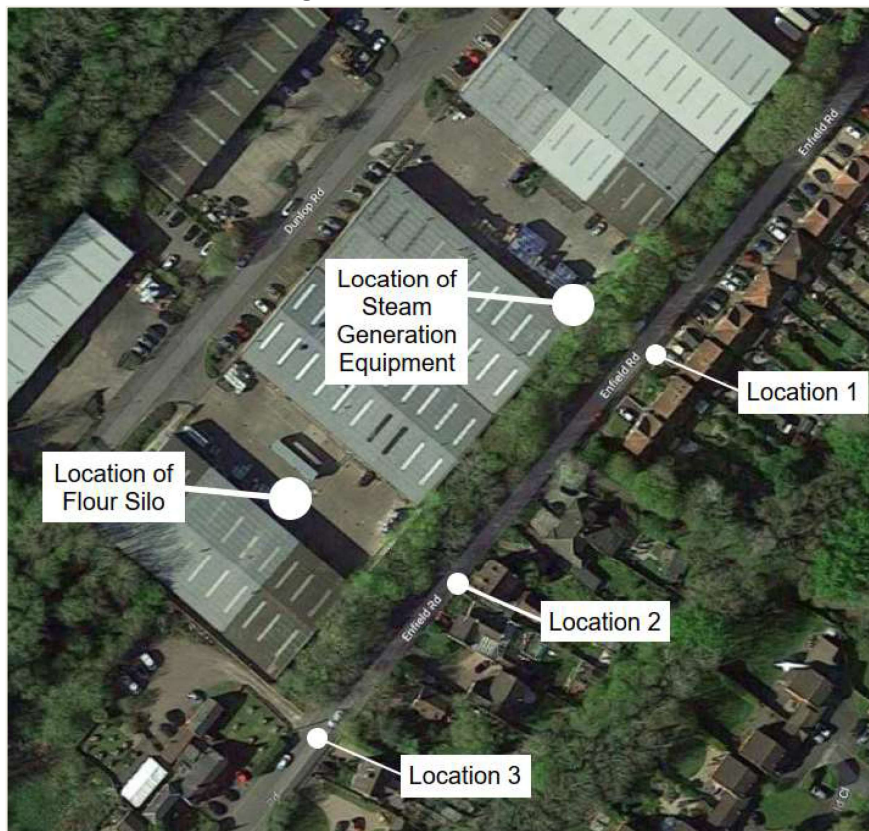
Figure 2 – Site Aerial View

7. Prior to the works, night-time noise measurements determined a noise level of 43dB L_{pA} for the steam boiler, based on a measurement of 44dB $L_{Aeq,T}$ at Location 1, and a residual noise measurement of 36dB $L_{Aeq,T}$ at Location 3, as per the site plan in Figure 2, all as per our earlier report, and at >4.0m above local ground height.

8. Subsequent noise measurements, carried out on Tuesday 18 July 2023, were undertaken using the same equipment as reported for the earlier survey.
9. During our daytime visit it was slightly less straightforward to measure boiler noise due to greater levels of residual noise, both from road traffic and from commercial type noise sources. Nonetheless, notwithstanding a small degree of uncertainty in the noise measurements due to the extraneous noise, it was possible to obtain suitably representative noise readings during lulls in extraneous noise. This included a reading of 42dB $L_{Aeq,T}$ at Location 1, with the steam boiler noise present, and a further residual noise measurement of 38dB $L_{Aeq,T}$ was recorded at Location 3. From this, an estimated steam boiler noise level of 40dB L_{pA} may be derived.

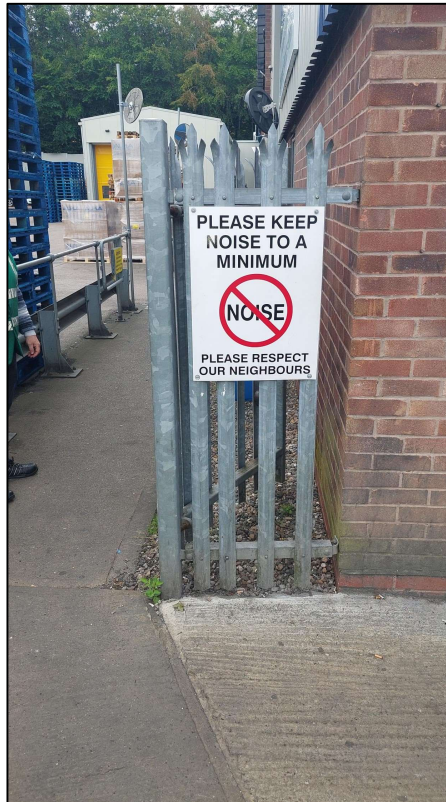
Figure 3 – Site Notice at Front of Site

15. It is noted that there are existing signs around the site reminding staff to keep noise to a minimum, and it is clear that there are management protocols in place at the site. However, in light of the comments from local residents it would be advisable to reinforce this instruction, and ensure that it is adhered to, especially during the summer months, when it is more likely staff will be outside (e.g. to smoke) during the night when on break, and that residents may have their windows open.
