## A.6 Site Photographs

## Environmental Permit Variation Application – Bishop's Stortford Sludge Treatment Centre Resubmission

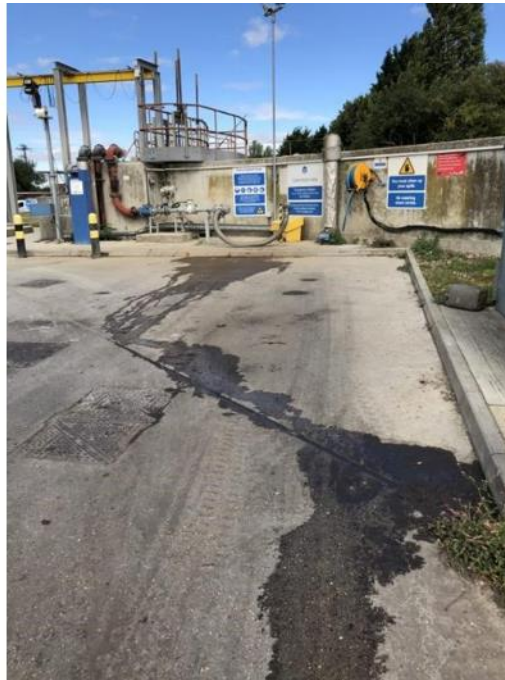
The Cess/Domestic Tanker  
Waste Imports, where waste is  
delivered to the site

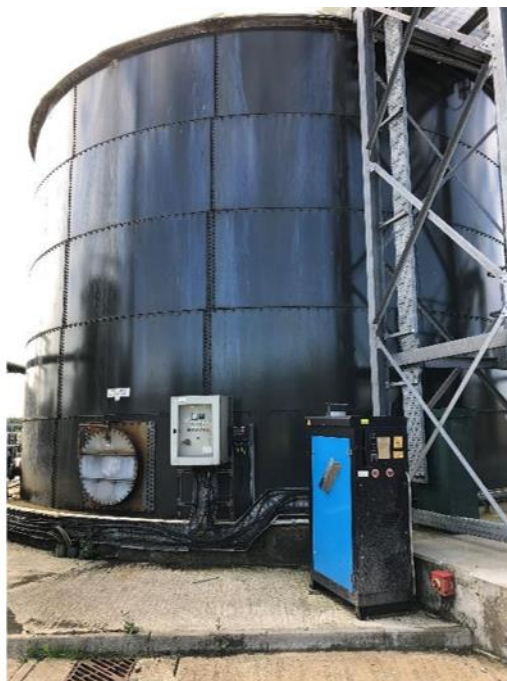
Sludge Import area and Sludge  
Buffer Tank.

From the Sludge Buffer Tank,  
sludge is thickened.

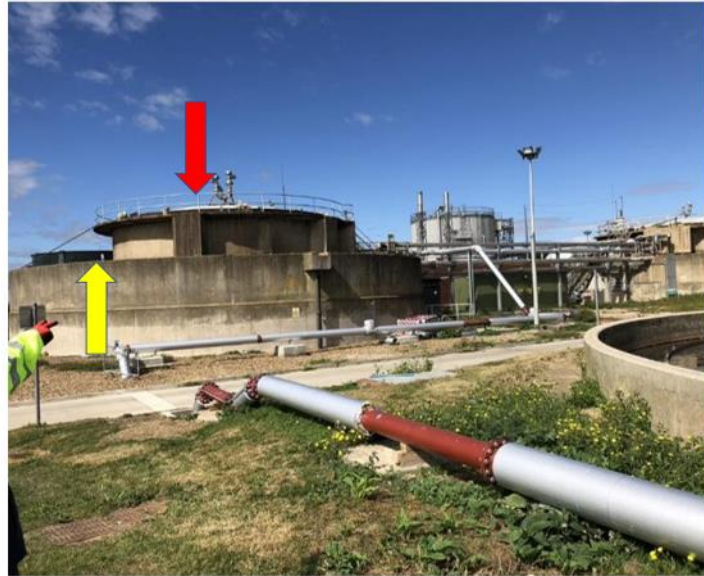
Photo of the covered Primary Digester Tank in the centre (indicated by red arrow) with surrounding uncovered Secondary Digester Tank (indicated by yellow arrow).

Indigenous and imported sludge are transferred via pipework to one of the Primary Digester Tanks at the site.

Sludge is transferred to one of the Secondary Digester Tanks. Two of the Secondary Digester Tanks take the form of concentric rings surrounding two of the Primary Digester Tanks (as illustrated in the photo).

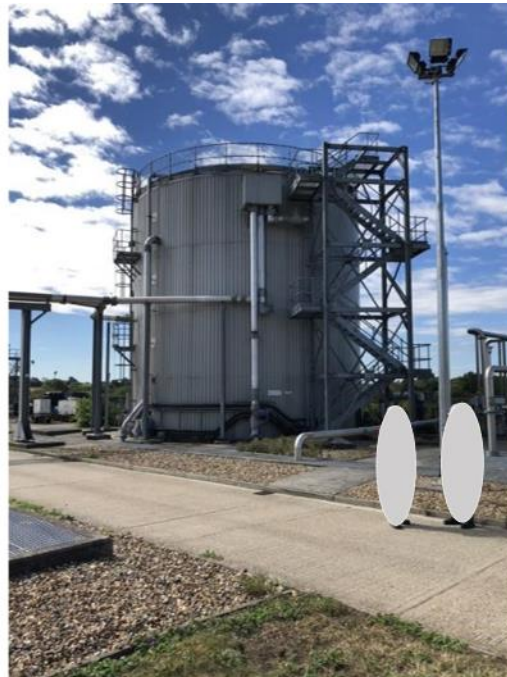
Photo showing the covered above ground Primary Digester Tank.

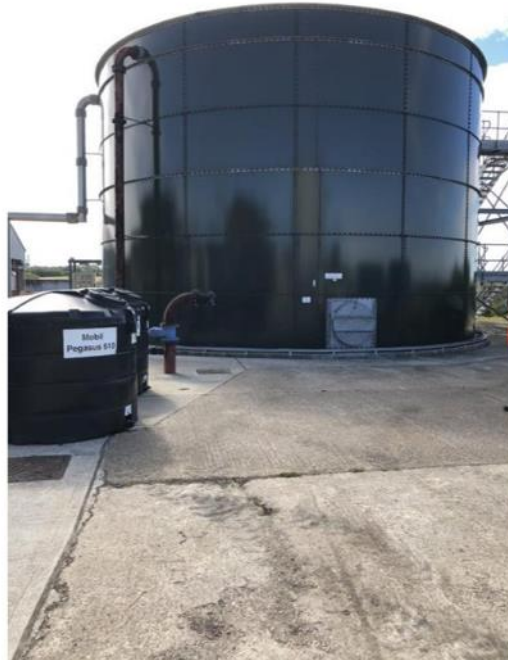
Photo showing one of the  
Secondary Digester Tanks  
at the site.

The digested sludge is  
received at the  
Secondary Digester Tank  
prior to transfer to the  
Digested Sludge Buffer  
Tank and then for  
dewatering.

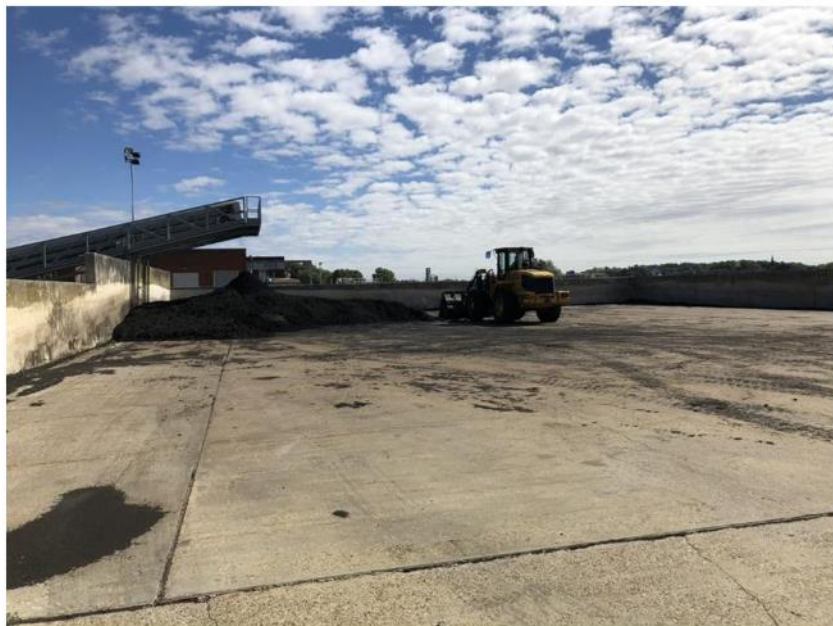
Photo showing the Cake Pad.

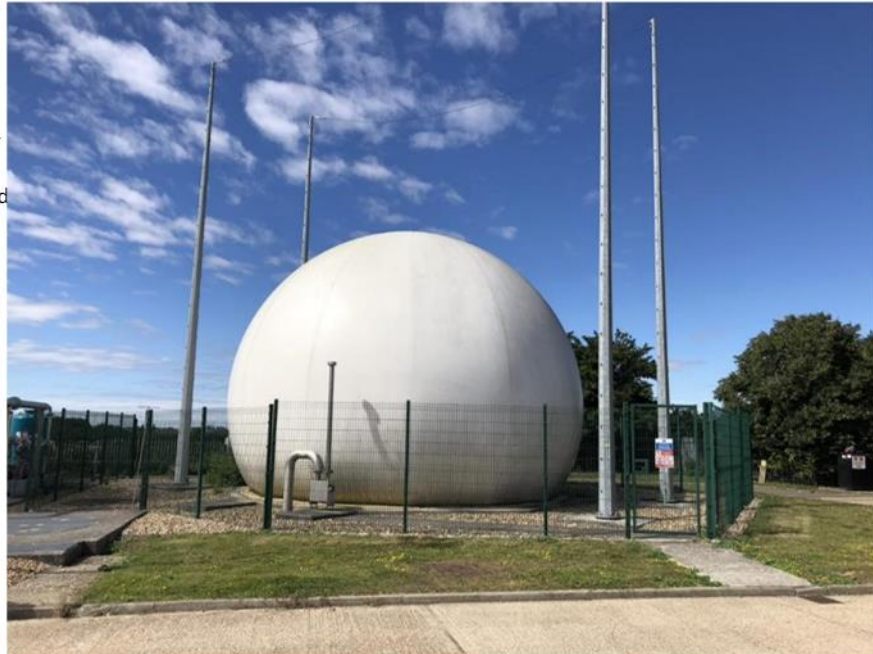
Photo showing the Biogas Storage holder at the site.

The Biogas Storage holder receives biogas from the Primary Digester Tanks and is then consumed on site.
