Document reference: | 790101_MSD_SCR_CAN September 2024|

1.0 SITE DETAILS	
Name of the applicant	Southern Water
Activity address	Canterbury Wastewater Treatment Works Sturry Road, Canterbury CT1 1DT
National grid reference	616815, 159737
Document reference and dates for Site Condition Report at permit application and surrender	Site Condition Report: 790101_MSD_SCR_CAN September 2024 Date of Permit Application: TBC Date of Surrender: TBC
Document references for site plans (including location and boundaries)	Document reference 790101_MSD_SiteLayoutPlan_CAN September 2024

A. Site Walkover Record

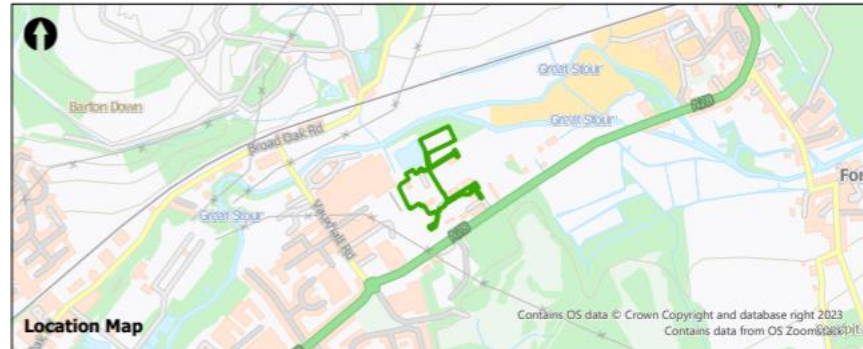
Figure 1.1: Canterbury Sludge Treatment Centre (STC) Site Plan

2.0 Condition of the land at permit issue	
Environmental setting including: <ul style="list-style-type: none"> geology hydrogeology surface waters 	<p>Land use</p> <p>The Canterbury Sludge Treatment Centre (STC) (hereby referred to as ‘the Site’) is located within the Canterbury Wastewater Treatment Works (WTW), which is 2.75km to the northeast of the centre of the town of Canterbury, Kent.</p> <p>The site has an irregular shape, with the majority of the process works in the southwestern areas of the site. The northern areas of the site area are used as drying beds. Figure 1.1 displays a high-level green line boundary for the site.</p> <p>The Great Stour river is located approximately 15m north of the Site area, and beyond this, the South Eastern railway is located 150m north of the Site, with grazing fields between. Immediately adjacent to the west of the site area, the Vauxhall Industrial Estate is present, including a steel stockpiling centre located immediately adjacent to the site. To the south of the site, a park and ride area is located 70m away with a park adjacent. To the east of the Site is a car dealership, with agricultural fields beyond, including an agricultural development comprising greenhouses 180m east of the Site area.</p> <p>A more detailed plan of the site layout with the STC permit boundary, as of September 2024, can be found in 790101_MSD_SiteLayoutPlan_CAN September 2024.</p>
