Project
213189
 Lower Hare Farm

Title
Phase 2 Overview
 Landfill North Construction

Scale 1:2,000@A3	Date Apr'22	Drawn KW	Chkd. ML	Drg. No. 213189/D/PH2/001A	Rev.
---------------------	----------------	-------------	-------------	-------------------------------	------

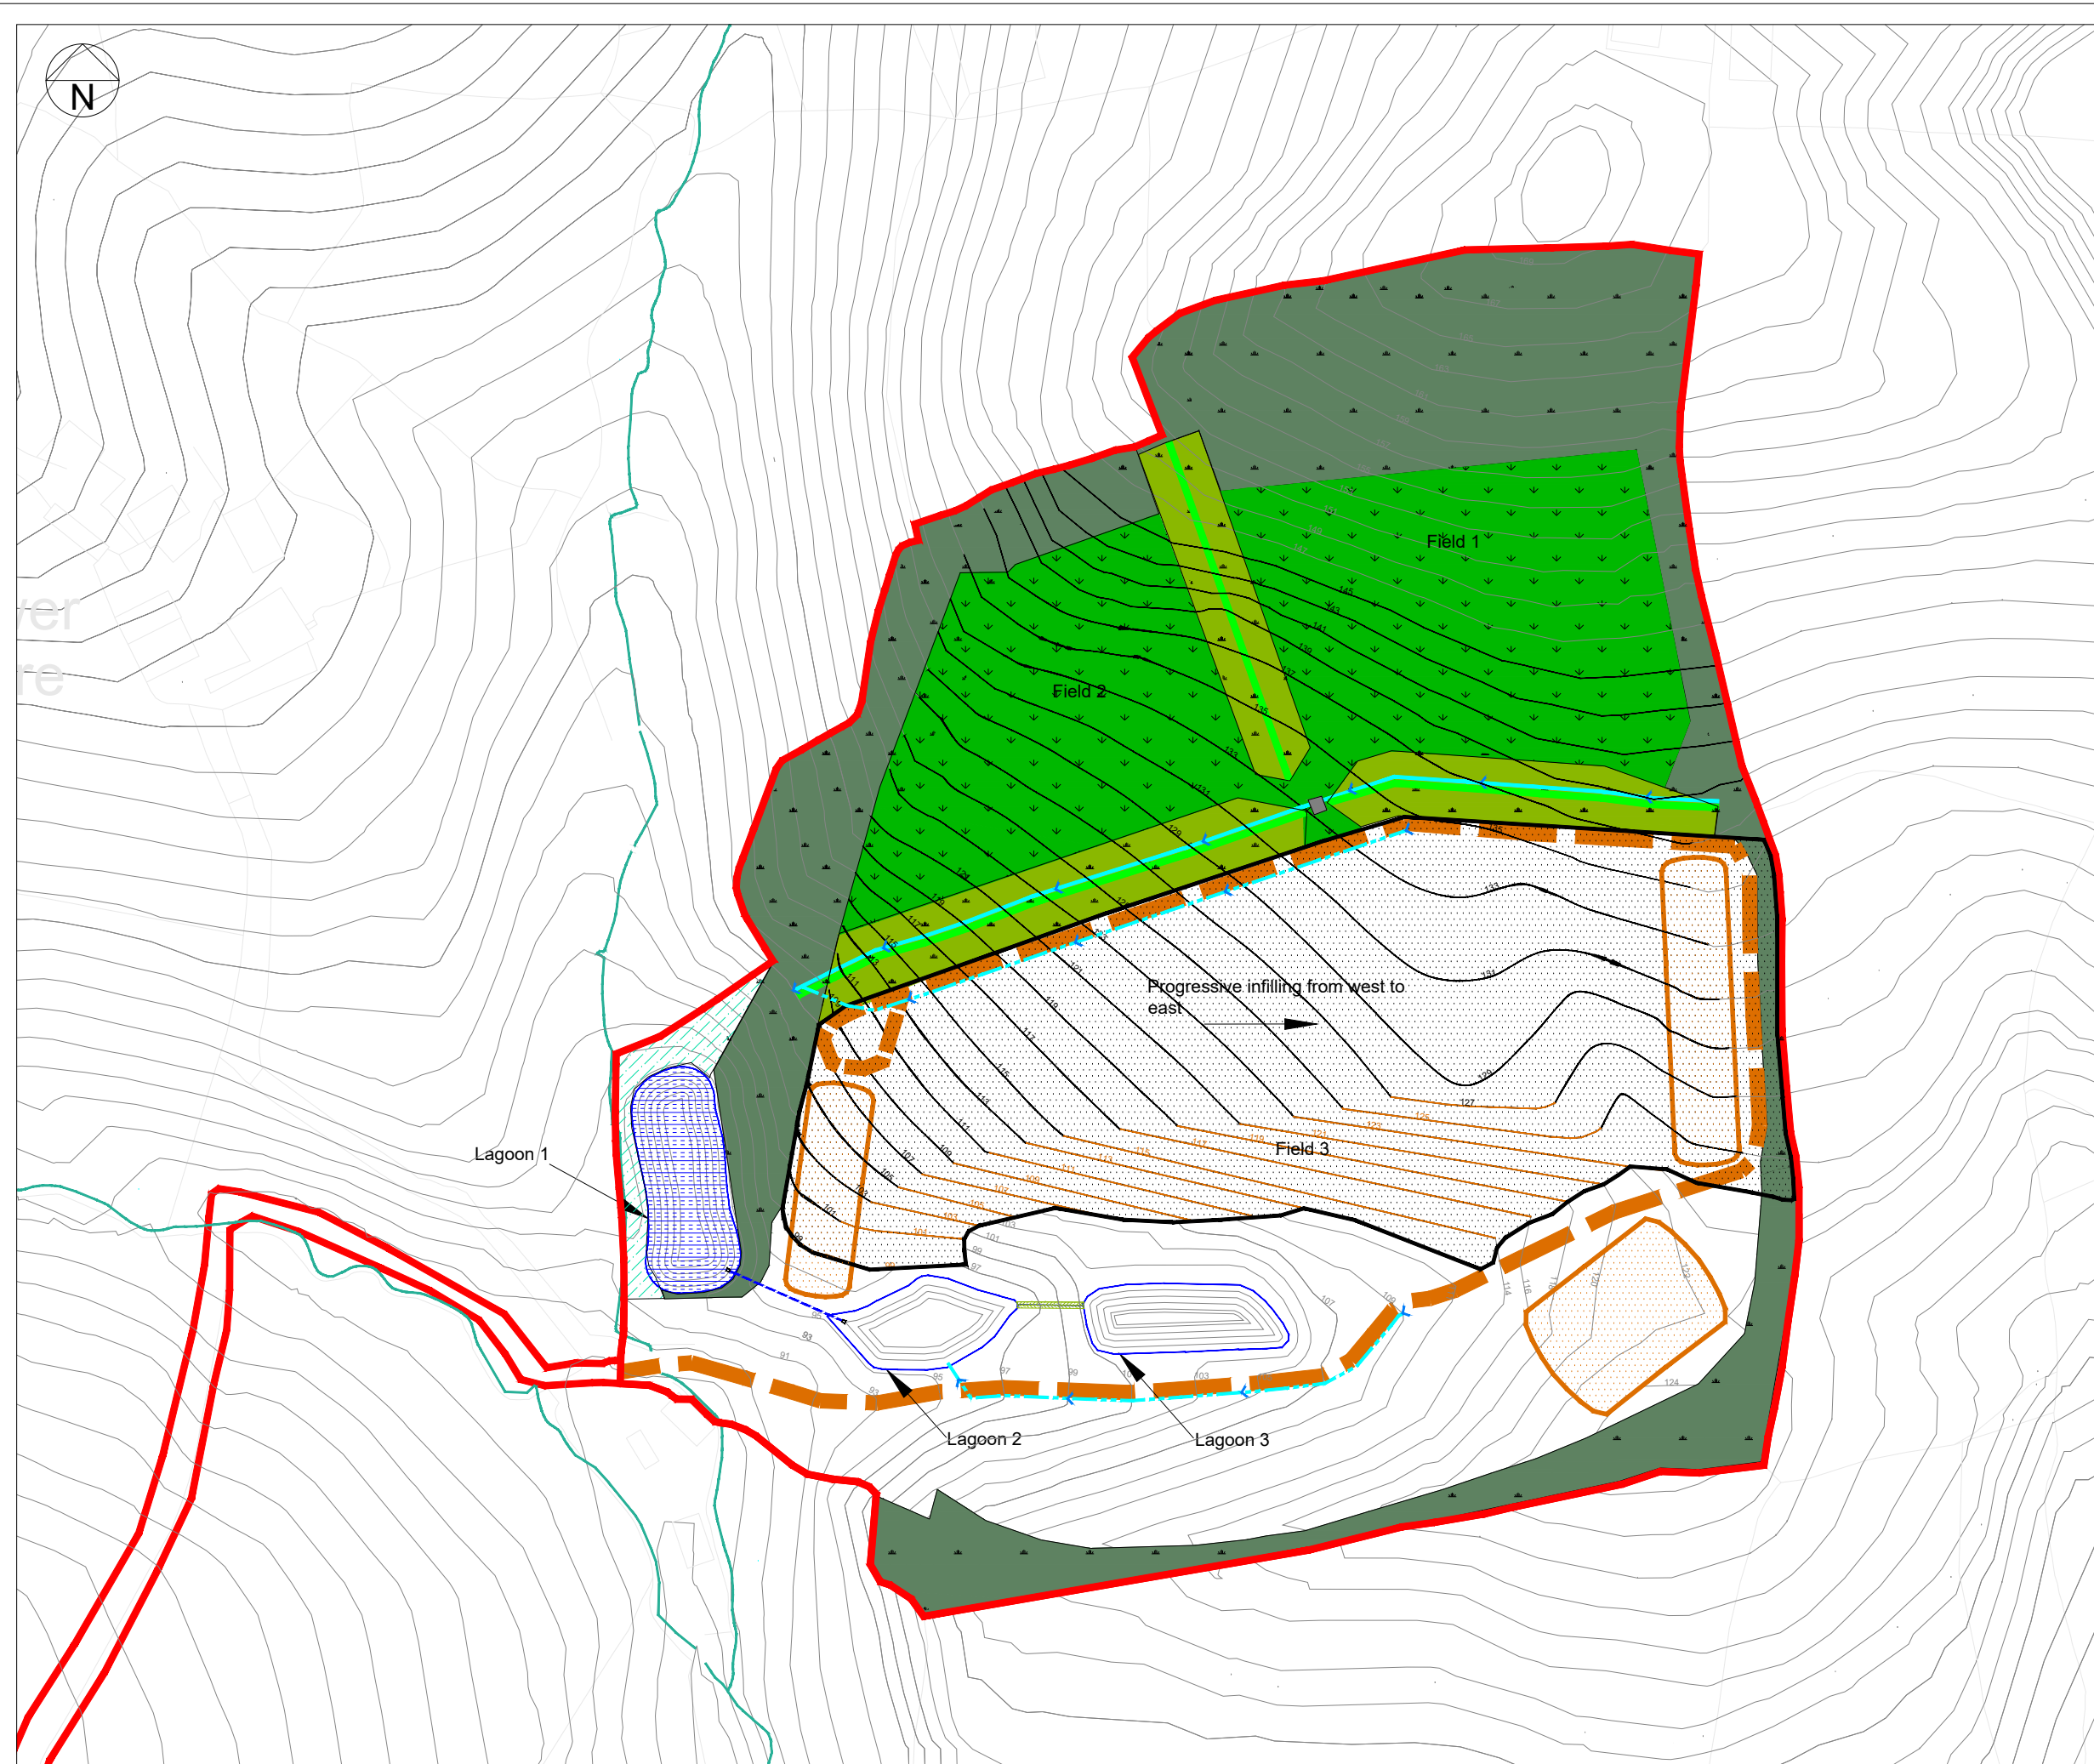
- Notes:**
1. Total site area: 115,385 m²
Site area fully restored in Phase 2: 78,091 m²
Percentage of site fully restored in Phase 2: 67%
 2. Phase 2 volume of engineering fill / geological barrier: 23,260 cu m.
 3. Eastern and Western topsoil stockpiles will be progressively used during the restoration of Phase 2.
 4. Phase 2 volume of restoration soils: 13,180 cu m.
 5. Phase 2 volume of inert waste: 55,820 cu m.
