Rev.	Details	Drawn Chkd.	Date
Project 213189 Lower Hare Farm			
Title Phase 2 Overview Landfill North Restoration

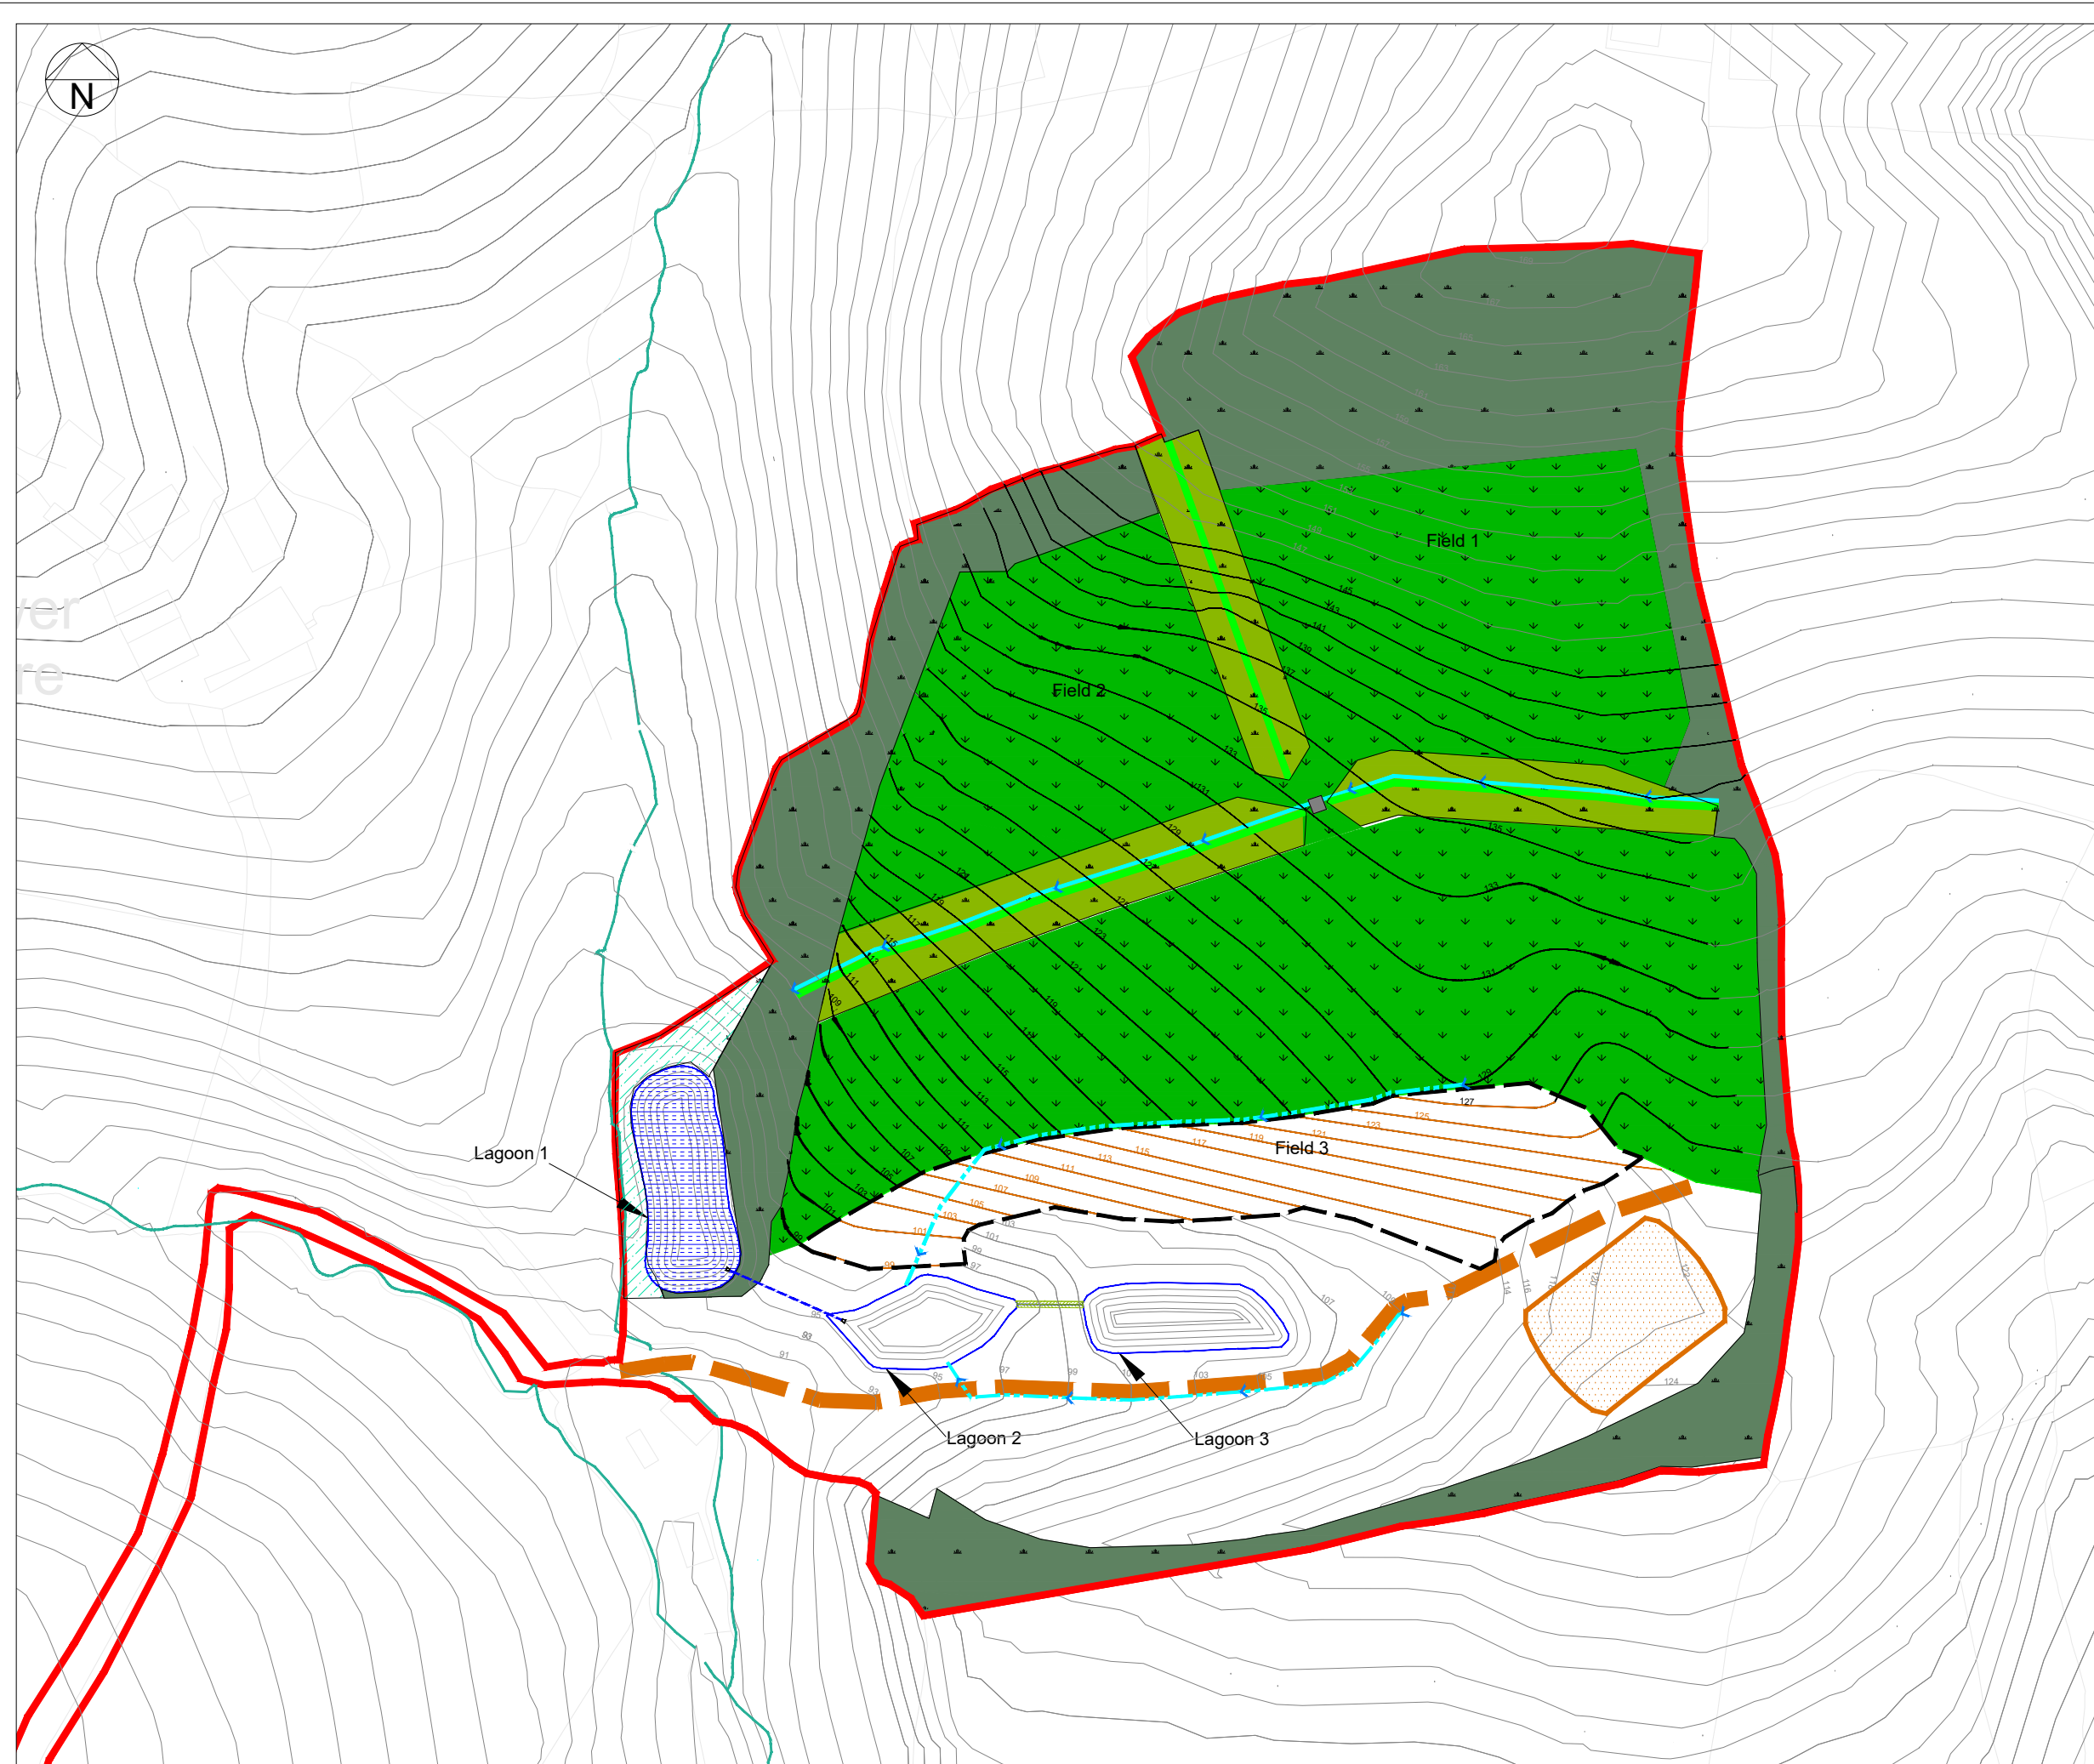
- Notes:**
1. Total site area: 115,385 m<sup>2</sup>  
 Site area fully restored in Phase 2: 78,091 m<sup>2</sup>  
 Percentage of site fully restored in Phase 2: 67%
  2. Phase 2 volume of engineering fill / geological barrier: 23,260 cu m.
  3. Phase 2 volume of restoration soils: 13,180 cu m.
  4. Phase 2 volume of inert waste: 55,820 cu m.
