<p>Bourne Works Collingbourne Ducis Marlborough Wilts, SN8 3EQ Tel 01264 850446 - Email info@atssltd.com</p>	Title Slurry Lagoon Construction	Drn by RB	Date 14.2.17	Chk by LM	Scale 1:100
								Number - Rev - Client - Project 01180-03 - A - Much Fawley Farm - Slurry Lagoon			Sheet 01

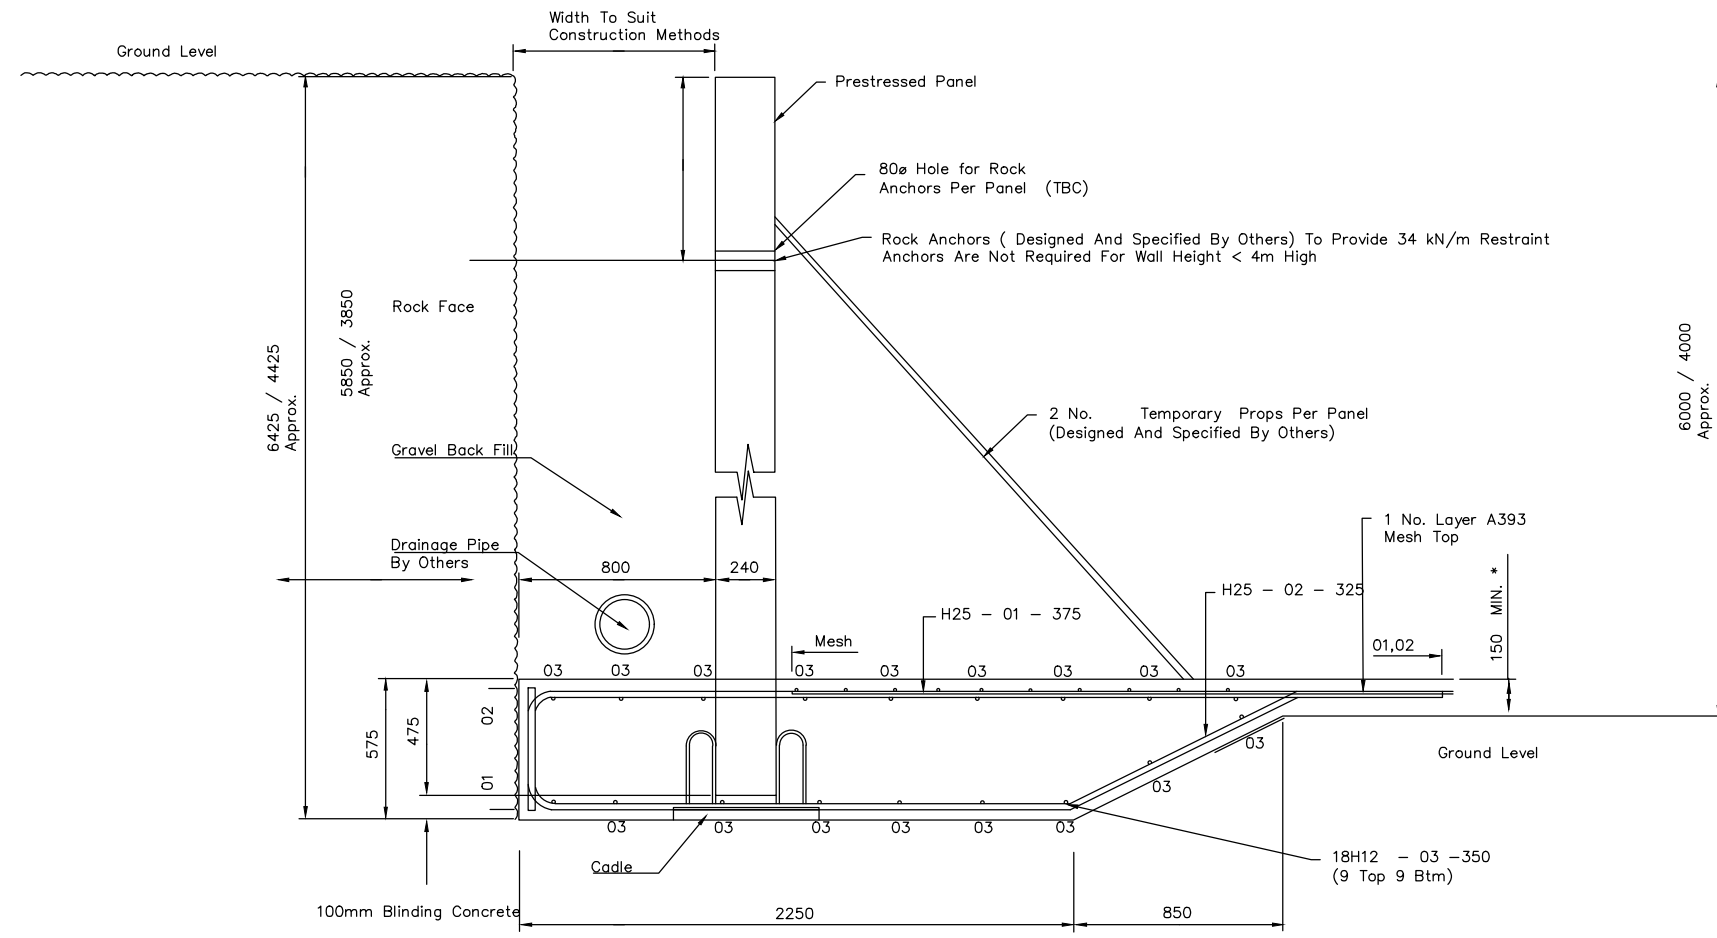
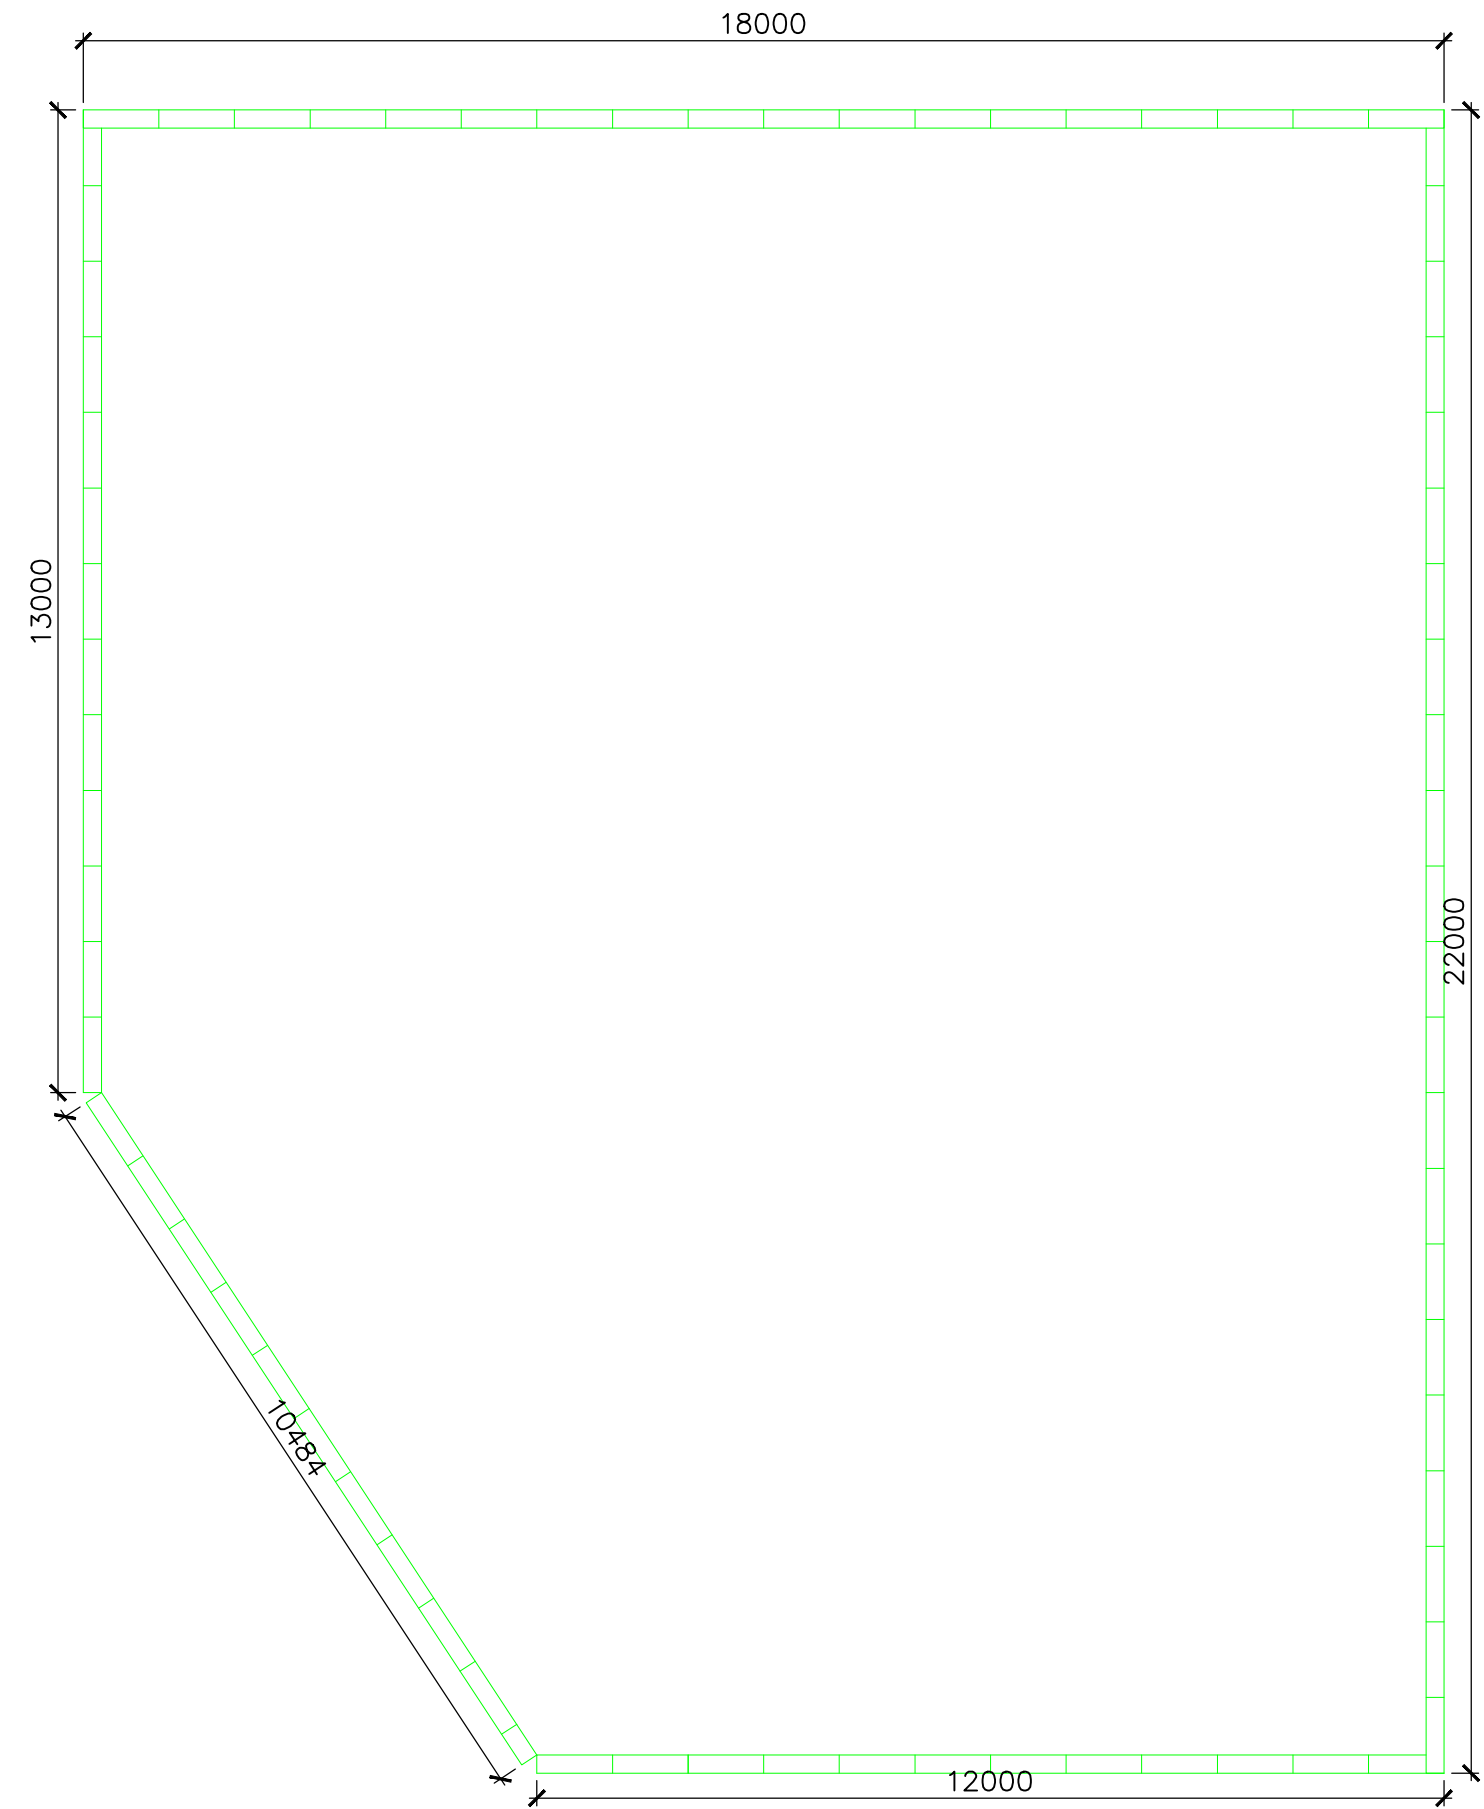
Slurry lagoon constructed using pre-stressed vertical panels. Perforated pipe is installed at the base of the construction to allow for regular inspection of leaks from the lagoon.

Lagoon has been designed and constructed to meet all requirements of BS 5502
