TITLE	DRN BY	DATE	CHK BY	SCALE
Digestate Lagoon	LM	7.2.18	JD	1:100
NUMBER - REV - CLIENT - PROJECT	SHEET			
01180-01 - A - Construction Details	01

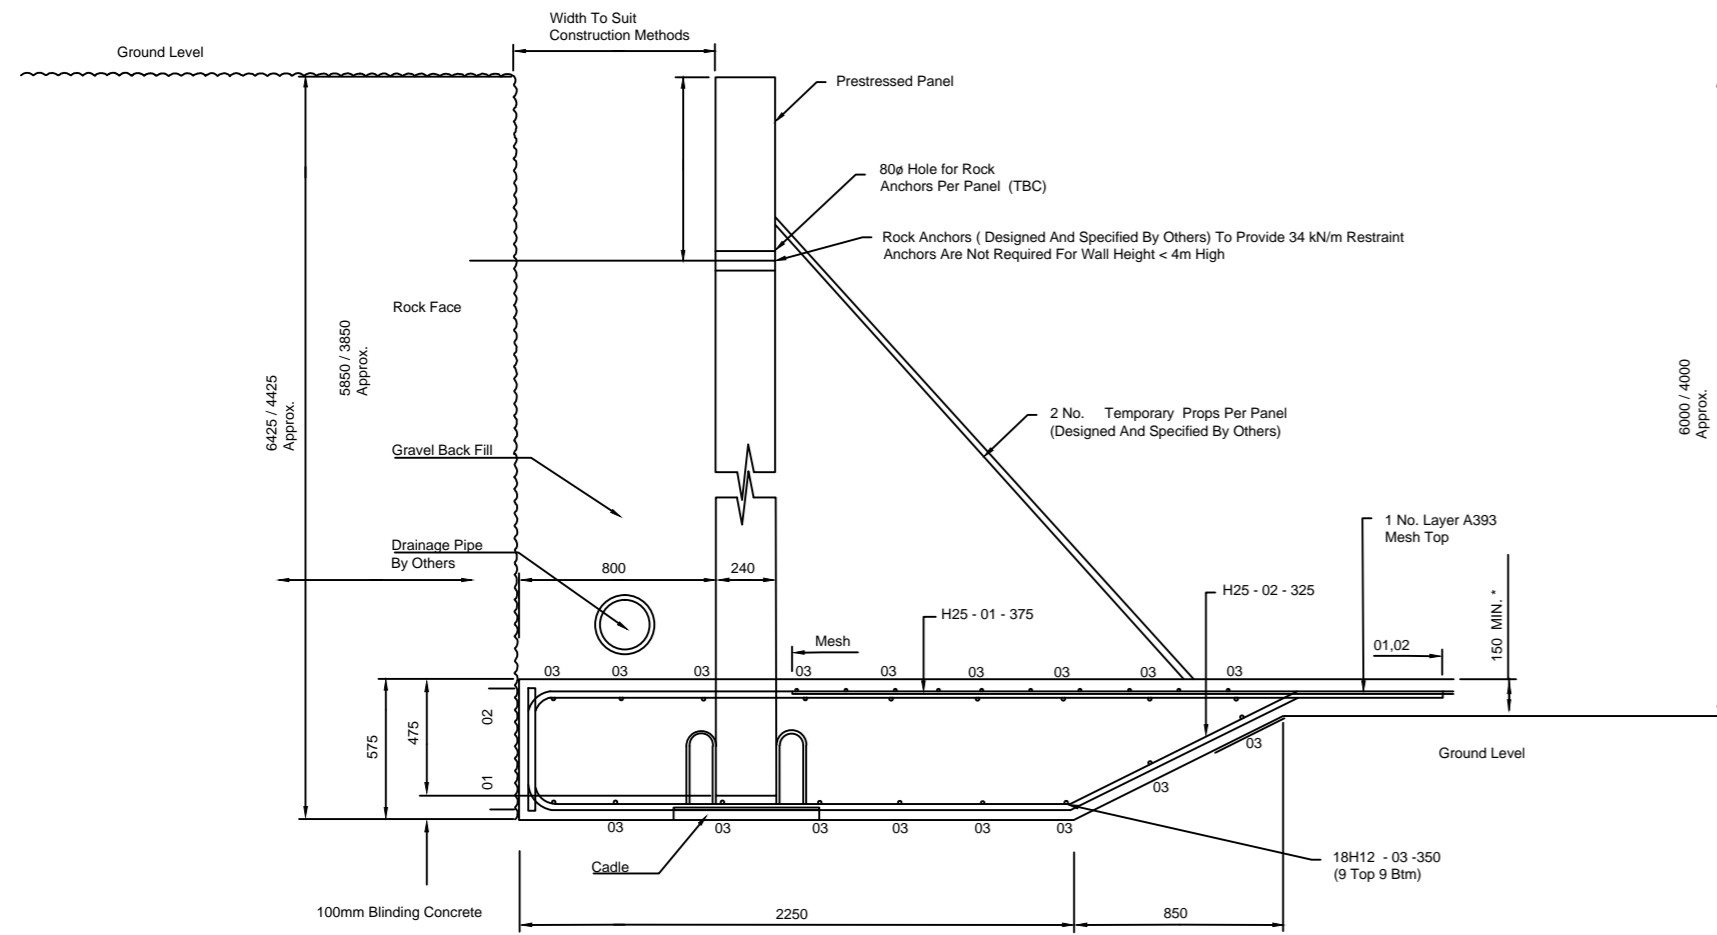
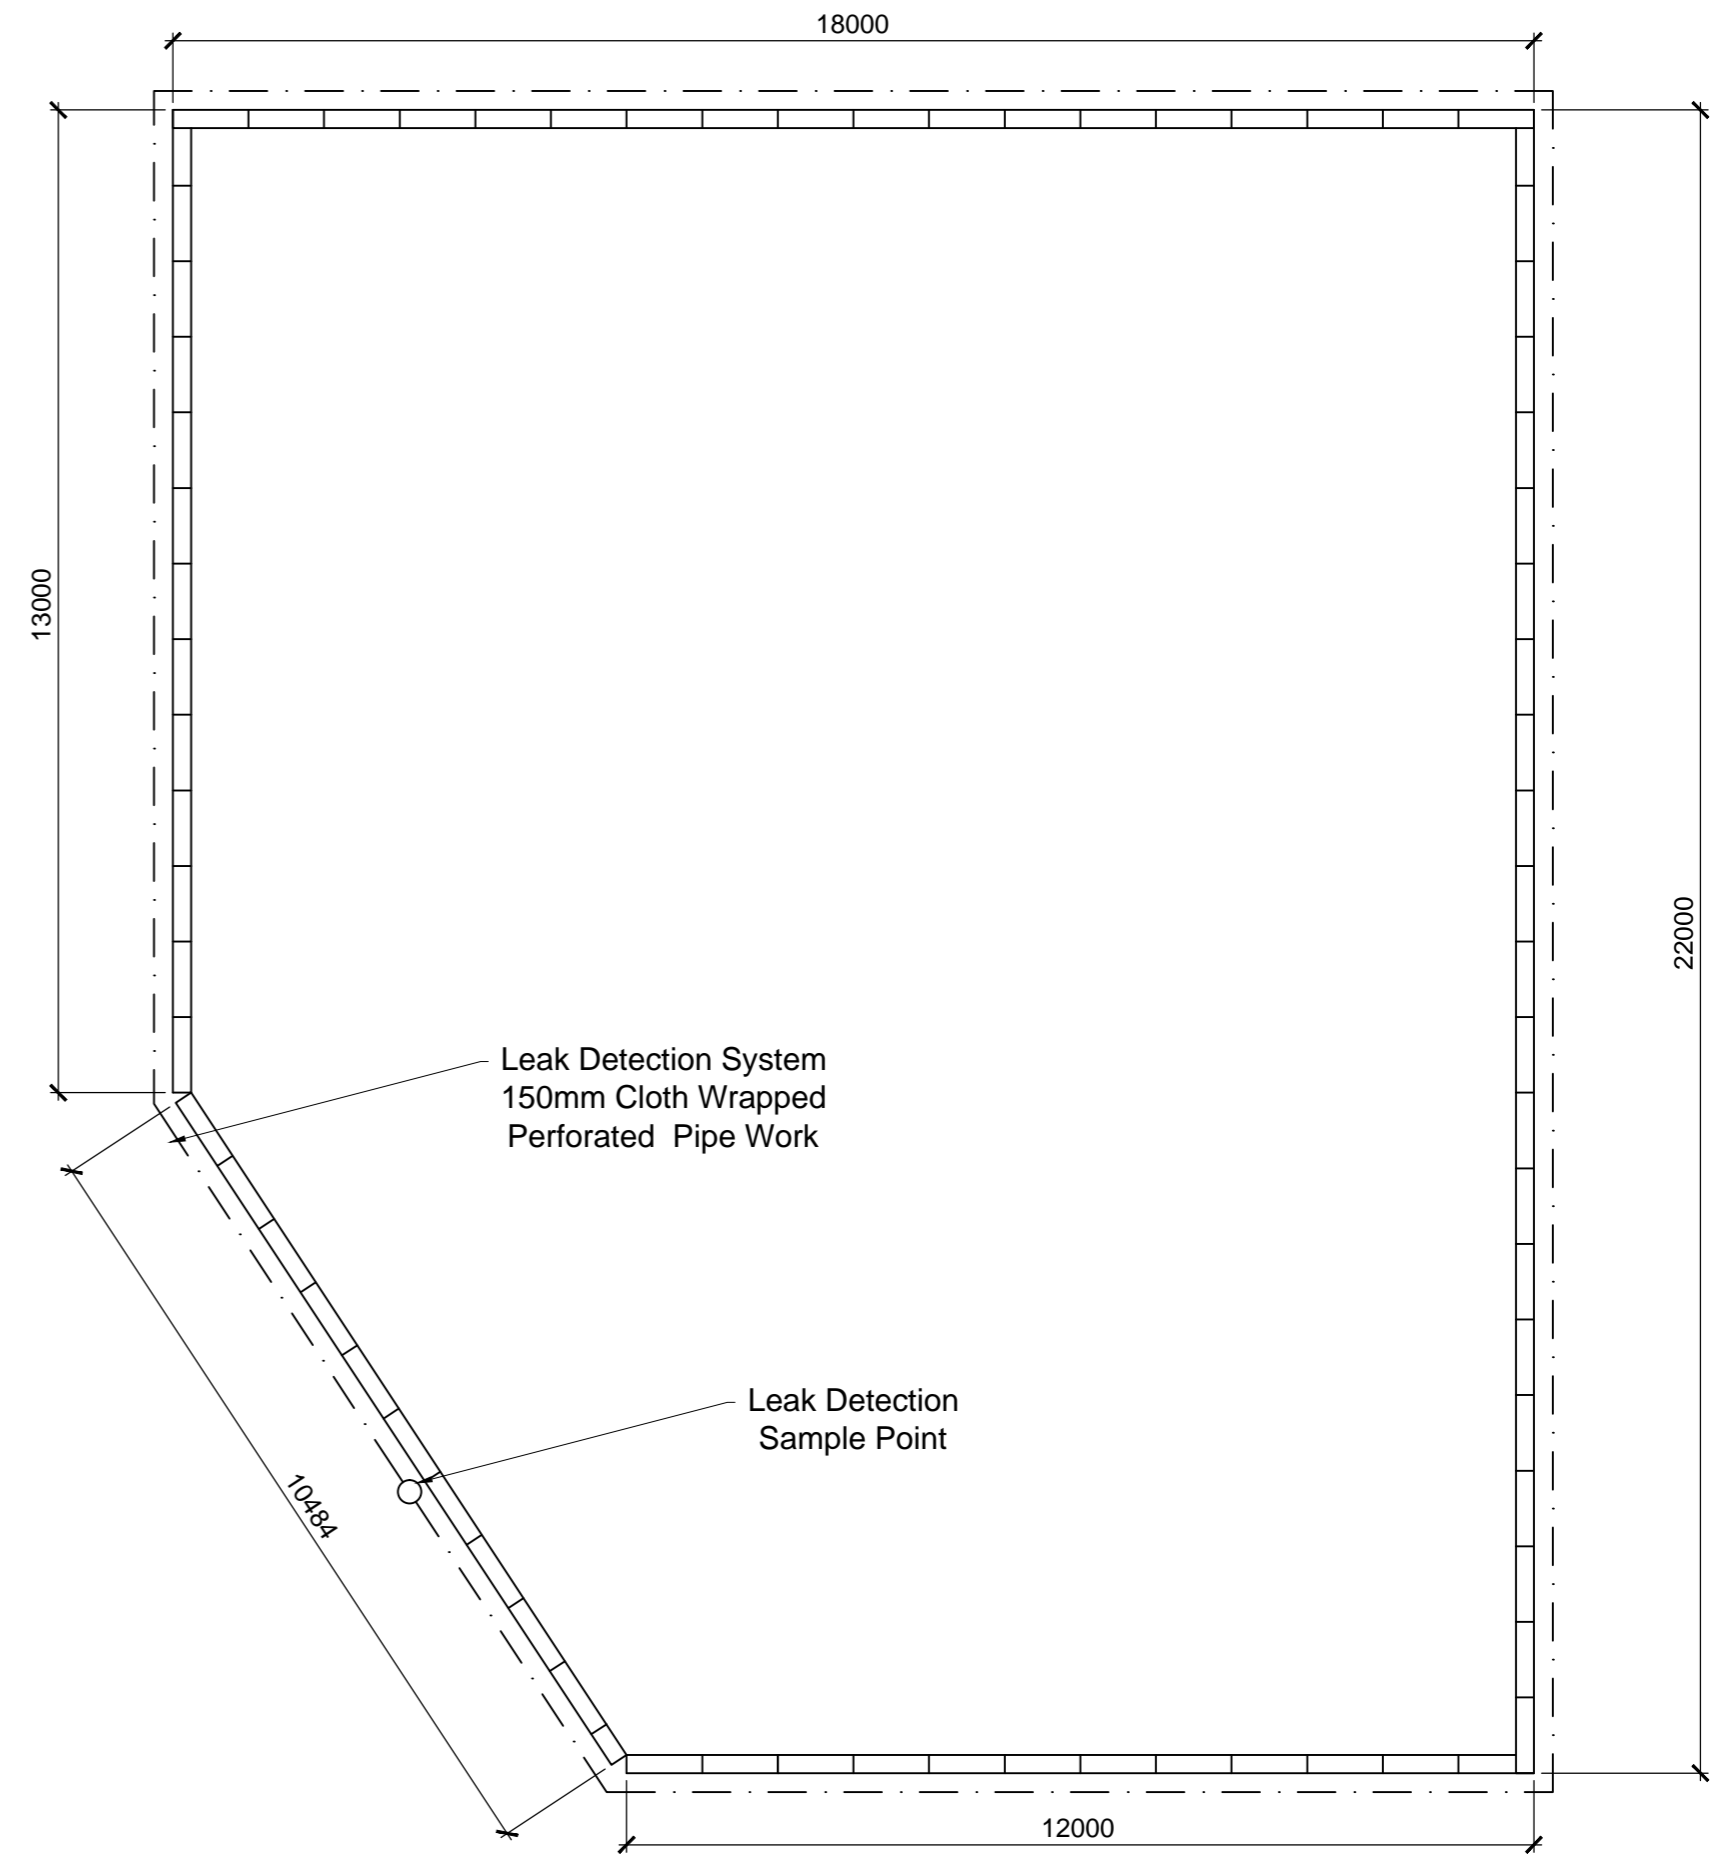
Slurry lagoon constructed using pre-stressed vertical panels. Perforated pipe is installed at the base of the construction to allow for regular inspection of leaks from the lagoon.

Lagoon has been designed and constructed to meet all requirements of BS 5502
