Construction Quality Assurance Report (CQA) – Digestate Storage Tank

The following is the CQA report for the digestate store at Much Fawley Farm.

The report refers to the Digestate Storage lagoon at Much Fawley which is used to store digestate from the anaerobic digester and is the subject of a permit variation request.

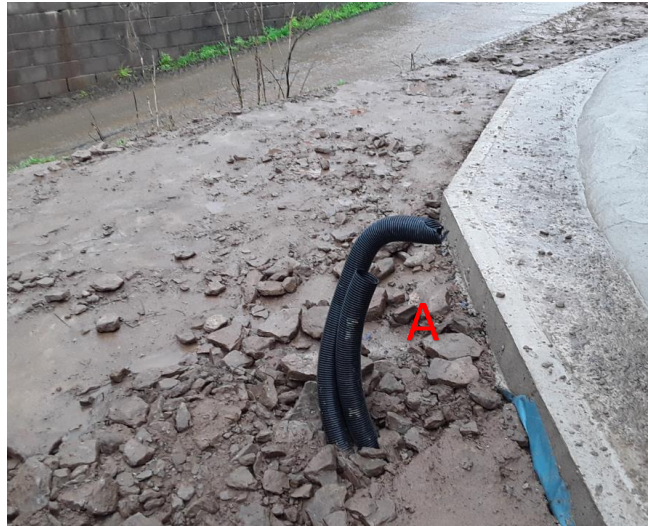
Leak detection has been installed as mitigation for the structure holding waste as per the attached plan. Installation as per Bradshaws design as stipulated. Leak detection is employed by groundwater testing from hydrostatic pressure outlet. Sample point located on southwest side of tank as indicated on EMS Section 22 drawing and will be capped to prevent contamination of the containment system, current picture shows in construction. Planning permission is awaited before completing this structure further. Design as per CIRIA 736. Location of leak detection sampling as in picture below – Marked as A. Tank currently in construction awaiting planning consent.

Sampling as per maintenance section of Management System and as monitoring section above.
