DIRTY/STORM WATER ISOLATION VALVE ARRANGEMENT

CLIENT: CROWN CHICKEN LTD			
DATE: JANUARY 2023			
SUBJECT: BRECKLAND FARM, BRANDON ROAD, METHWOLD, IP26 4RJ - POULTRY FARM REDEVELOPMENT			
DRAWING NO: BRECK-DRAIN-N			
SCALE: 1:500, 1:25 AT A1			
APPROVED BY:		PGD	DRAWN BY: CPD
REV	DATE	DESCRIPTION	
1	31-08-2023	NORTH SITE DRAINAGE LAYOUT	
2	07-11-2023	NORTH SITE DRAINAGE LAYOUT

CLIENT: CROWN CHICKEN LTD
 DATE: JANUARY 2023
 SUBJECT: BRECKLAND FARM, BRANDON ROAD, METHWOLD, IP26 4RJ - POULTRY FARM REDEVELOPMENT
 DRAWING NO: BRECK-DRAIN-S
 SCALE: 1:500, 1:25 AT A1

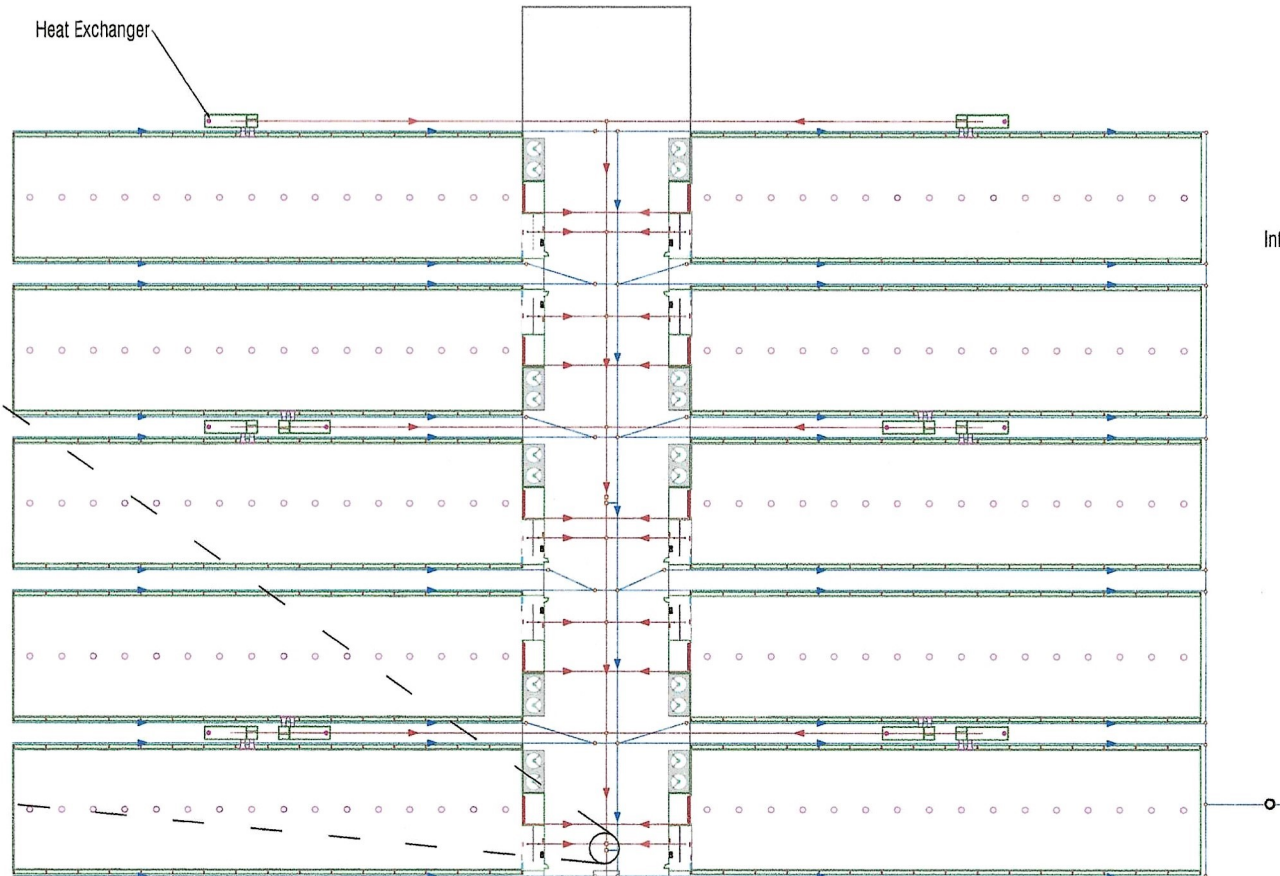
Infiltration Basin W3

60,000 litre underground, concrete encased, dirty water tank

Filter Trench W1

Water Infiltration Basin W2

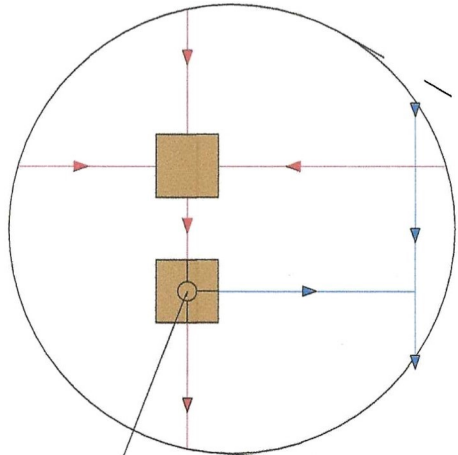
DIRTY/STORM WATER ISOLATION VALVE ARRANGEMENT

Isolation Valve

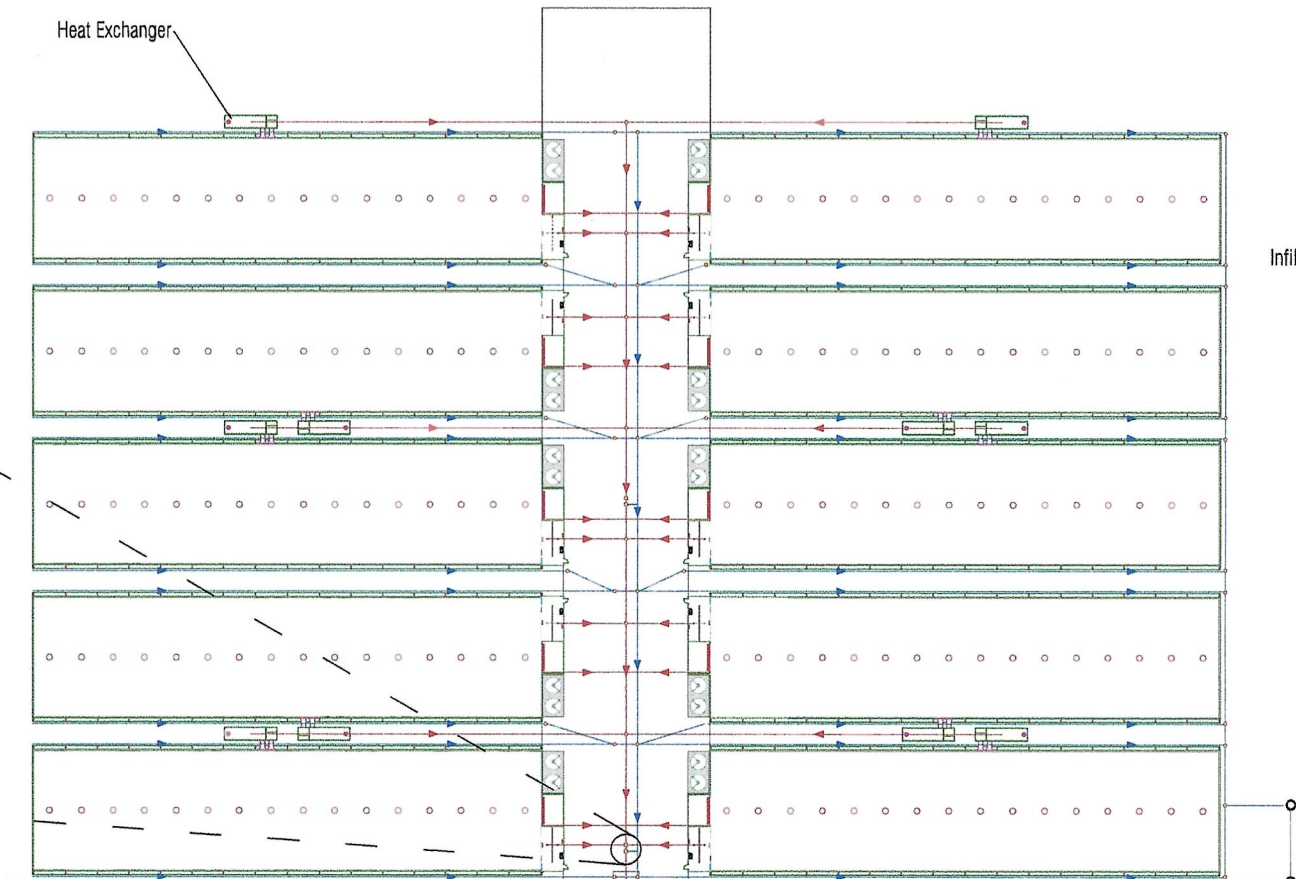
Infiltration Basin W6

Infiltration basin W7

60,000 litre underground, concrete encased, dirty water tank

Water Infiltration Basin W5
