## **Appendix G – Site Condition Report Update**

## BARROW SITE CONDITION REPORT - UPDATE SUMMARY EXTRACT

**RE: KIMBERLY-CLARK, BARROW: SITE VISITS DURING DUNELM GROUND INVESTIGATION**

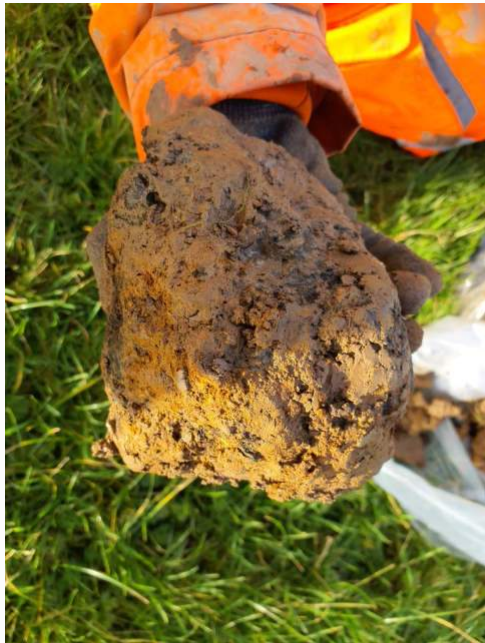
3

| Top depth (m) | Base depth (m) | Descriptions | Stratum thickness |
|---|---|---|---|
| 0.40 | 0.80 | Soft brown slightly gravelly slightly sandy clay with low cobble content. Hydrocarbon odour noted from 0.6m. | 0.40 |

| Top depth (m) | Base depth (m) | Description |
|---|---|---|
| 0.60 | | Cobble encountered with Hydrocarbon odour with dark staining. |

Cobble at 0.6m bgl.

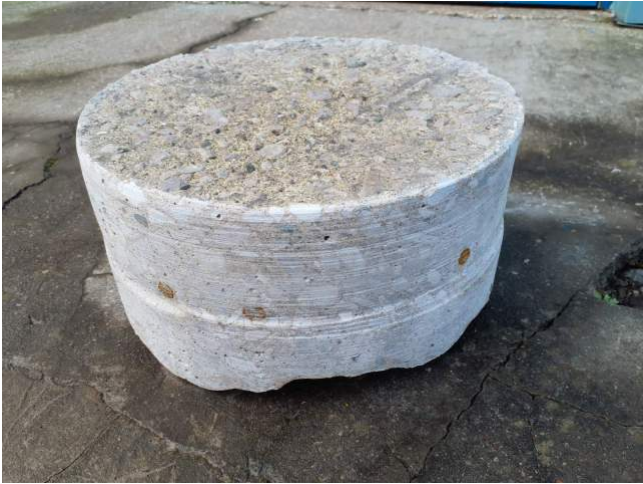
| Photo number | Photo | Description of photo | Time taken |
|---|---|---|---|
| 2 | | Concrete core with 20mm rebar | 14 Jan<br>2026 11:<br>07:40 |

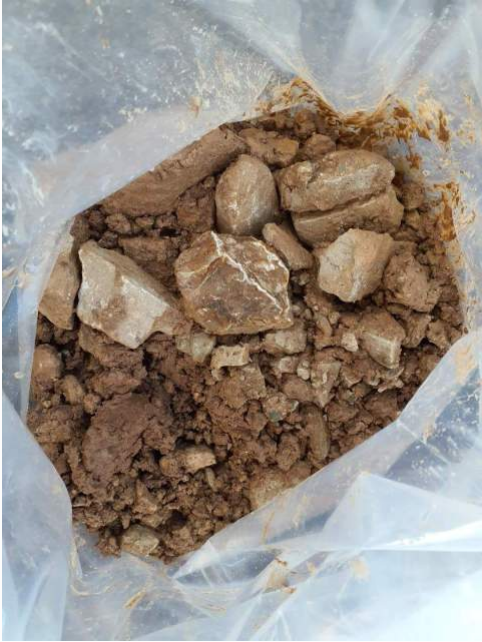
| Photo number | Photo | Description of photo | Time taken |
|---|---|---|---|
| 3 | | Made ground with limestone gravel and cobbles | 14 Jan<br>2026 11:<br>08:48 |

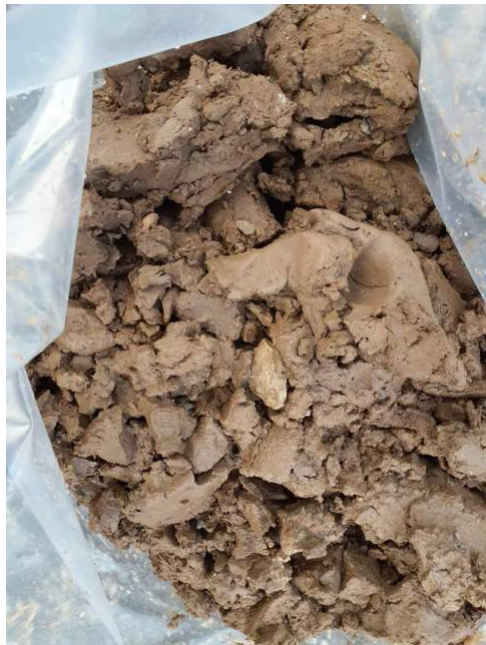
4

Shallow natural soils from 1m bgl.
