Issue and Revision Record

Document reference: | 790101_MSD_SCR_SAN July 2024|

1.0 SITE DETAILS	
Name of the applicant	Southern Water
Activity address	Sandown Water Treatment Works/Sludge Treatment Centre, East Yar Road, Sandown, Isle of Wight PO36 9AS/9AX
National grid reference	SZ 60221 85285

A. Site Walkover Record

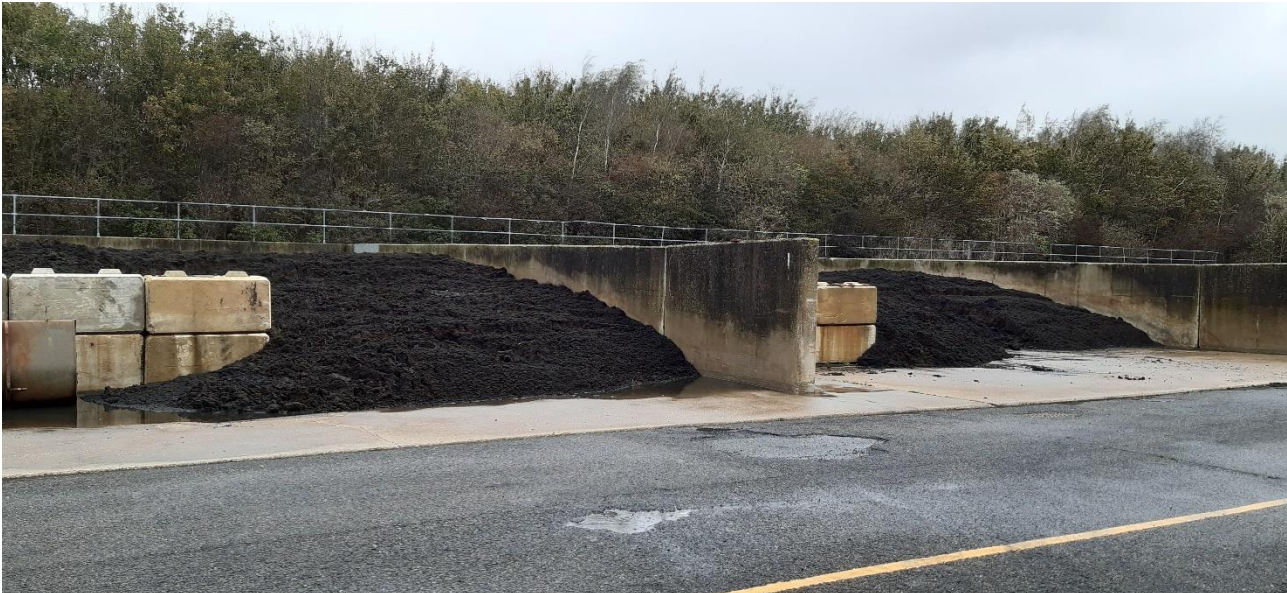
Cake storage

Where is cake stored?	Cake bays for maturation then collected for sale
How many cake bays are there on site?	6 x cake bays (3 in the north of the site and 3 in the south). Bays in the sought side appear larger Approx 1-1.5m high wall (sides concrete ½ side legioblocks approx. 80l x40h x40d (2 high)) surrounds the area which are just enough for the amount of cake stored. Hardstanding looks in good condition as does the walls.
Water usage	
What sources of water does the site use? What proportion? E.g. 2% potable water for polymer make-up and drinking, 98% primary or secondary wash water for other i.e. cleaning etc?	Site uses approx. 2% potable water for office and polymer make up. Rest of water used on site comes from either primary or secondary washwater.
Does the site get water from other sources? Abstraction from river etc?	No although water is removed from the river during flooding periods as the site is surrounded by a flood plain. This eases the pressure off the flood plain. This is at the request of the EA and this water is stored in storm tanks and released back out slowly.

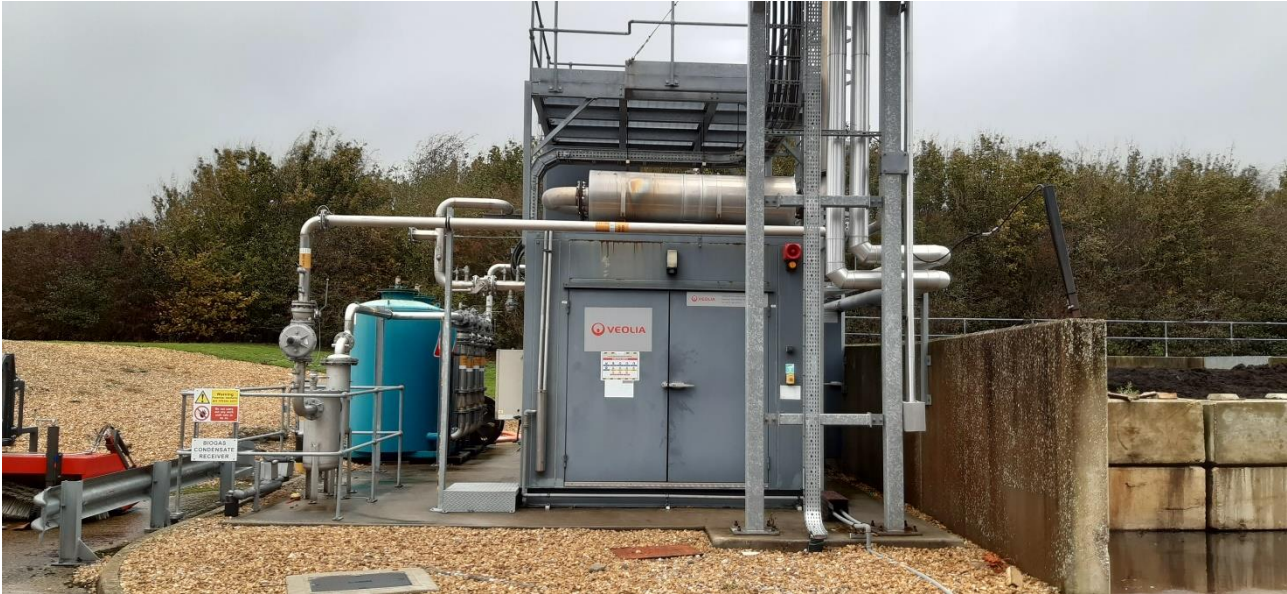
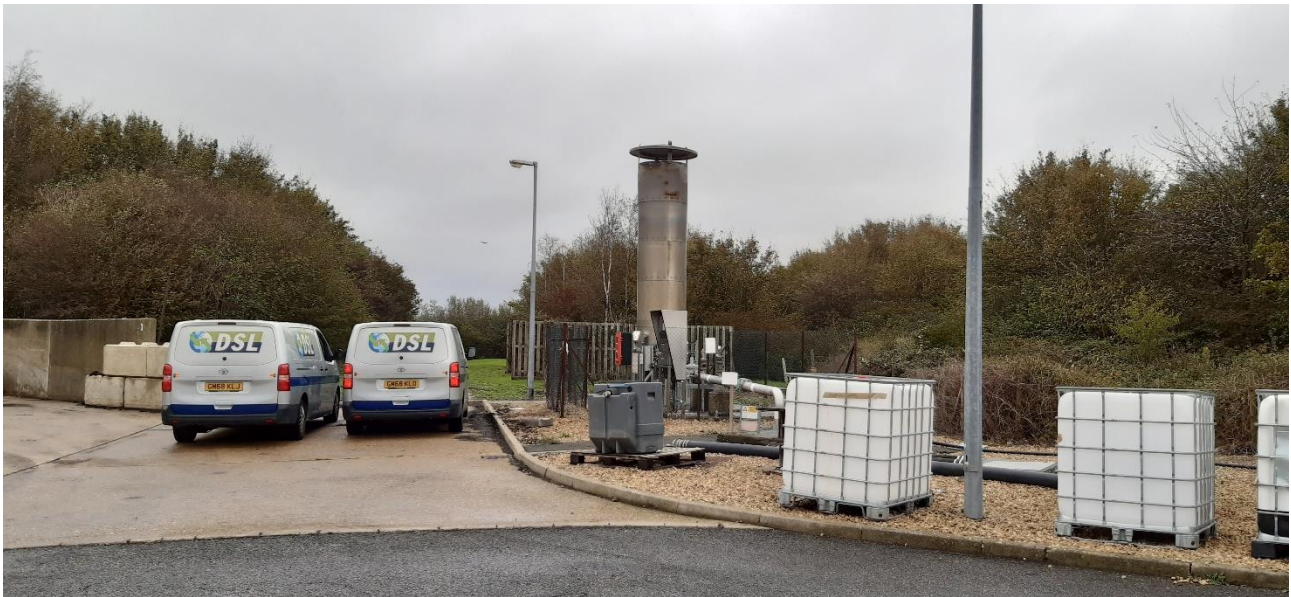
<p>How many CHPs on site?</p>	<p>1 CHP – although this was switched off as it was having maintenance undertaken by Veolia.</p>
<p>Are the CHP's adequate for the amount of gas produced by the site?</p>	<p>No – Andy Webb said that the site generates too much gas for 1 CHP but not enough for 2</p>
<p>Are there any flares? If so how often is the flare used? E.g. during emergency or maintenance of the engines or all the time?</p>	<p>1 flare – currently being used on a daily basis as the CHP is working at full capacity but the site does not generate enough to run 2 so flare off excess</p>

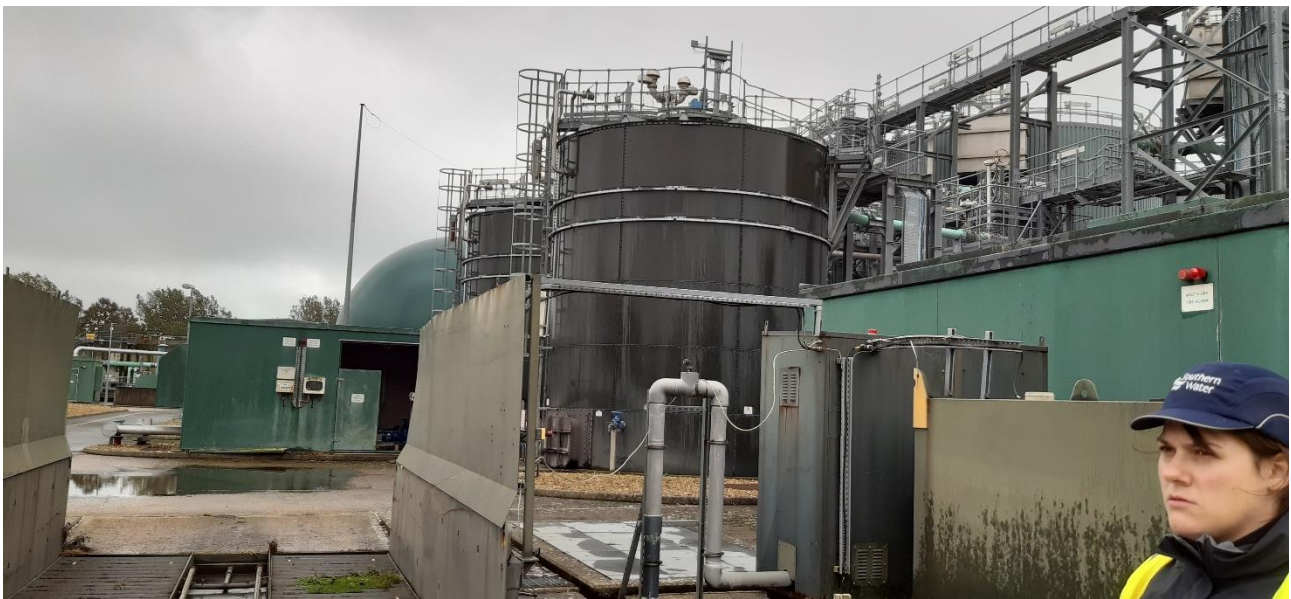
Gas holder

What storage volume of gas can be held at one time	780m ³
Noise	
Please describe any noise mitigation measures on site.	No noise abatement needed majority of operations are fully enclosed.
Other abatement?	No
Have any noise assessments been undertaken on the site?	No
Have there been any noise complaints?	Some historic complaint, but this was thought to be from when one of the centrifuges was being run. This has since been rectified with better maintenance and servicing
Any monitoring undertaken?	No
Odour

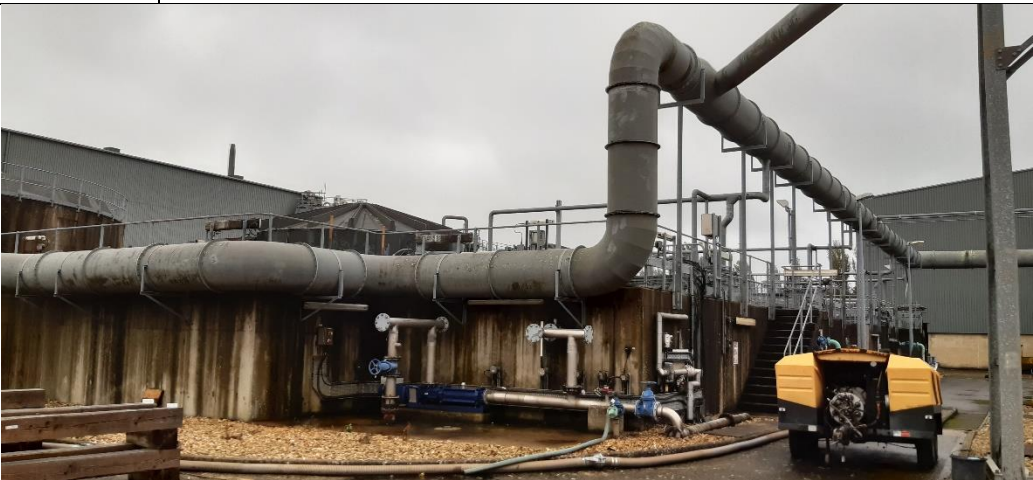
Please describe any odour mitigation measures on site.	Specialist unit treating air. Large grey pipes around the site is the odour control system which goes to a scrubber/filter system
What is there odour control system?	Carbon filters
Is odour monitored?	Yes, monitored for H2S 24/7 and chemicals added to system to combat odours. No other details given. No AQ assessments have been undertaken Odour loggers for cess and sludge import area No thresholds given

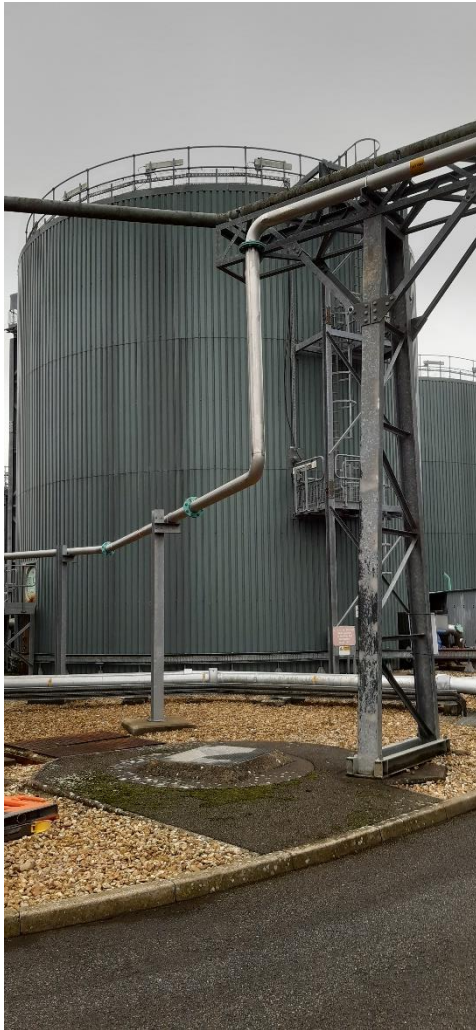
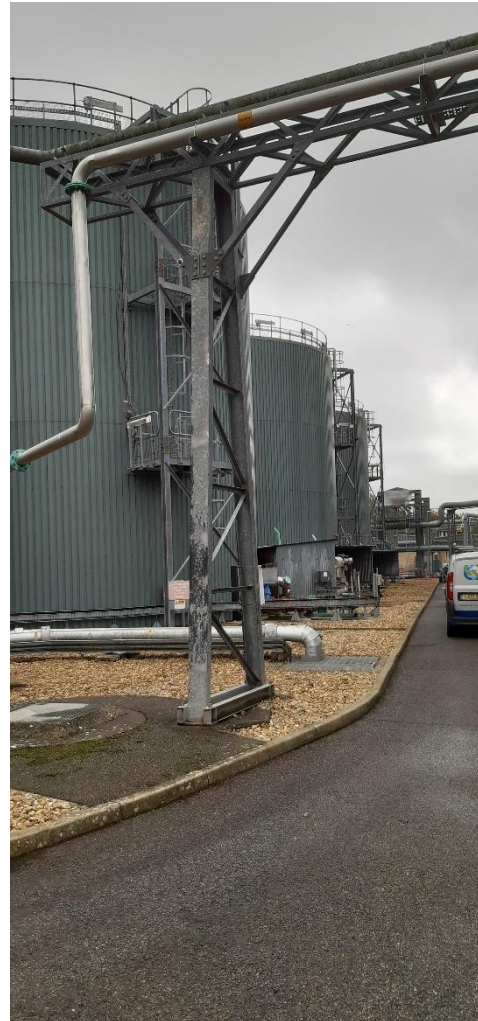
Digesters

How many digesters on the site?	3
Digester capacity	1,285m ³ each
Any Whessoe valves? How many	2 per digester
Any monitoring of tanks/gas?	SCADA monitoring of flows around site, and contents of gas holder. Pressure is monitored to some level, but the Whessoe's apparently make an audible high pitched noise, if there is a problem which alerts the operatives. Andy said that they are allowed to release a certain amount from the AD, after which it has to be reported as a pollution incident to the SW team. No further details were given.
What is the ground like surrounding the tanks? E.g. permeable gravel, concrete etc	Permeable gravel surrounding digesters with concrete pathways
Drainage	
Where do the drains go? E.g. Head of the works	Drainage from site roads and reception areas lead to return liquor pumping station which then returns to inlet works.

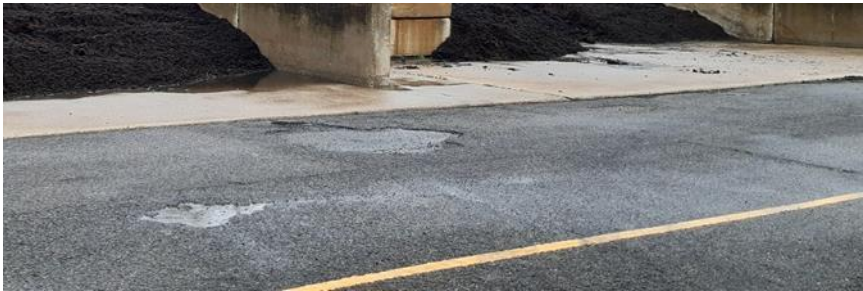
Is site adjacent to a river or stream?	Yes and the surrounding area (agriculture) is prone to flooding as is a flood plain.
Is the whole site bunded	Reportedly so. Site appears to be in good condition. Although so areas of wear were noted around the site
Are there any cracks in the pavement	Yes – see photos
