BOREHOLE LOG				BOREHOLE No BH01	
Client: R. Collard Ltd					
Project No: 422.064757.00001	Date: 31/10/2023	Ground Level: 94.00m	Co-ordinates: E478531 N159781		
Project: Busta Triangle Site Investigation				Sheet 1 of 2

Client: Collard Group Ltd	Created: GA
	Checked: AB
Project: Busta Triangle, Eversley Deposit for Recovery	Date: 24/09/2024
Title: Borehole Monitoring Plan	Version: 1
Drawing No: COL/B068370/MON/01	Scale: 1:6,500

project
Busta Triangle Restoration, Hampshire

drawing title
 CROSS SECTION - EXISTING SITUATION & RESTORATION PLAN

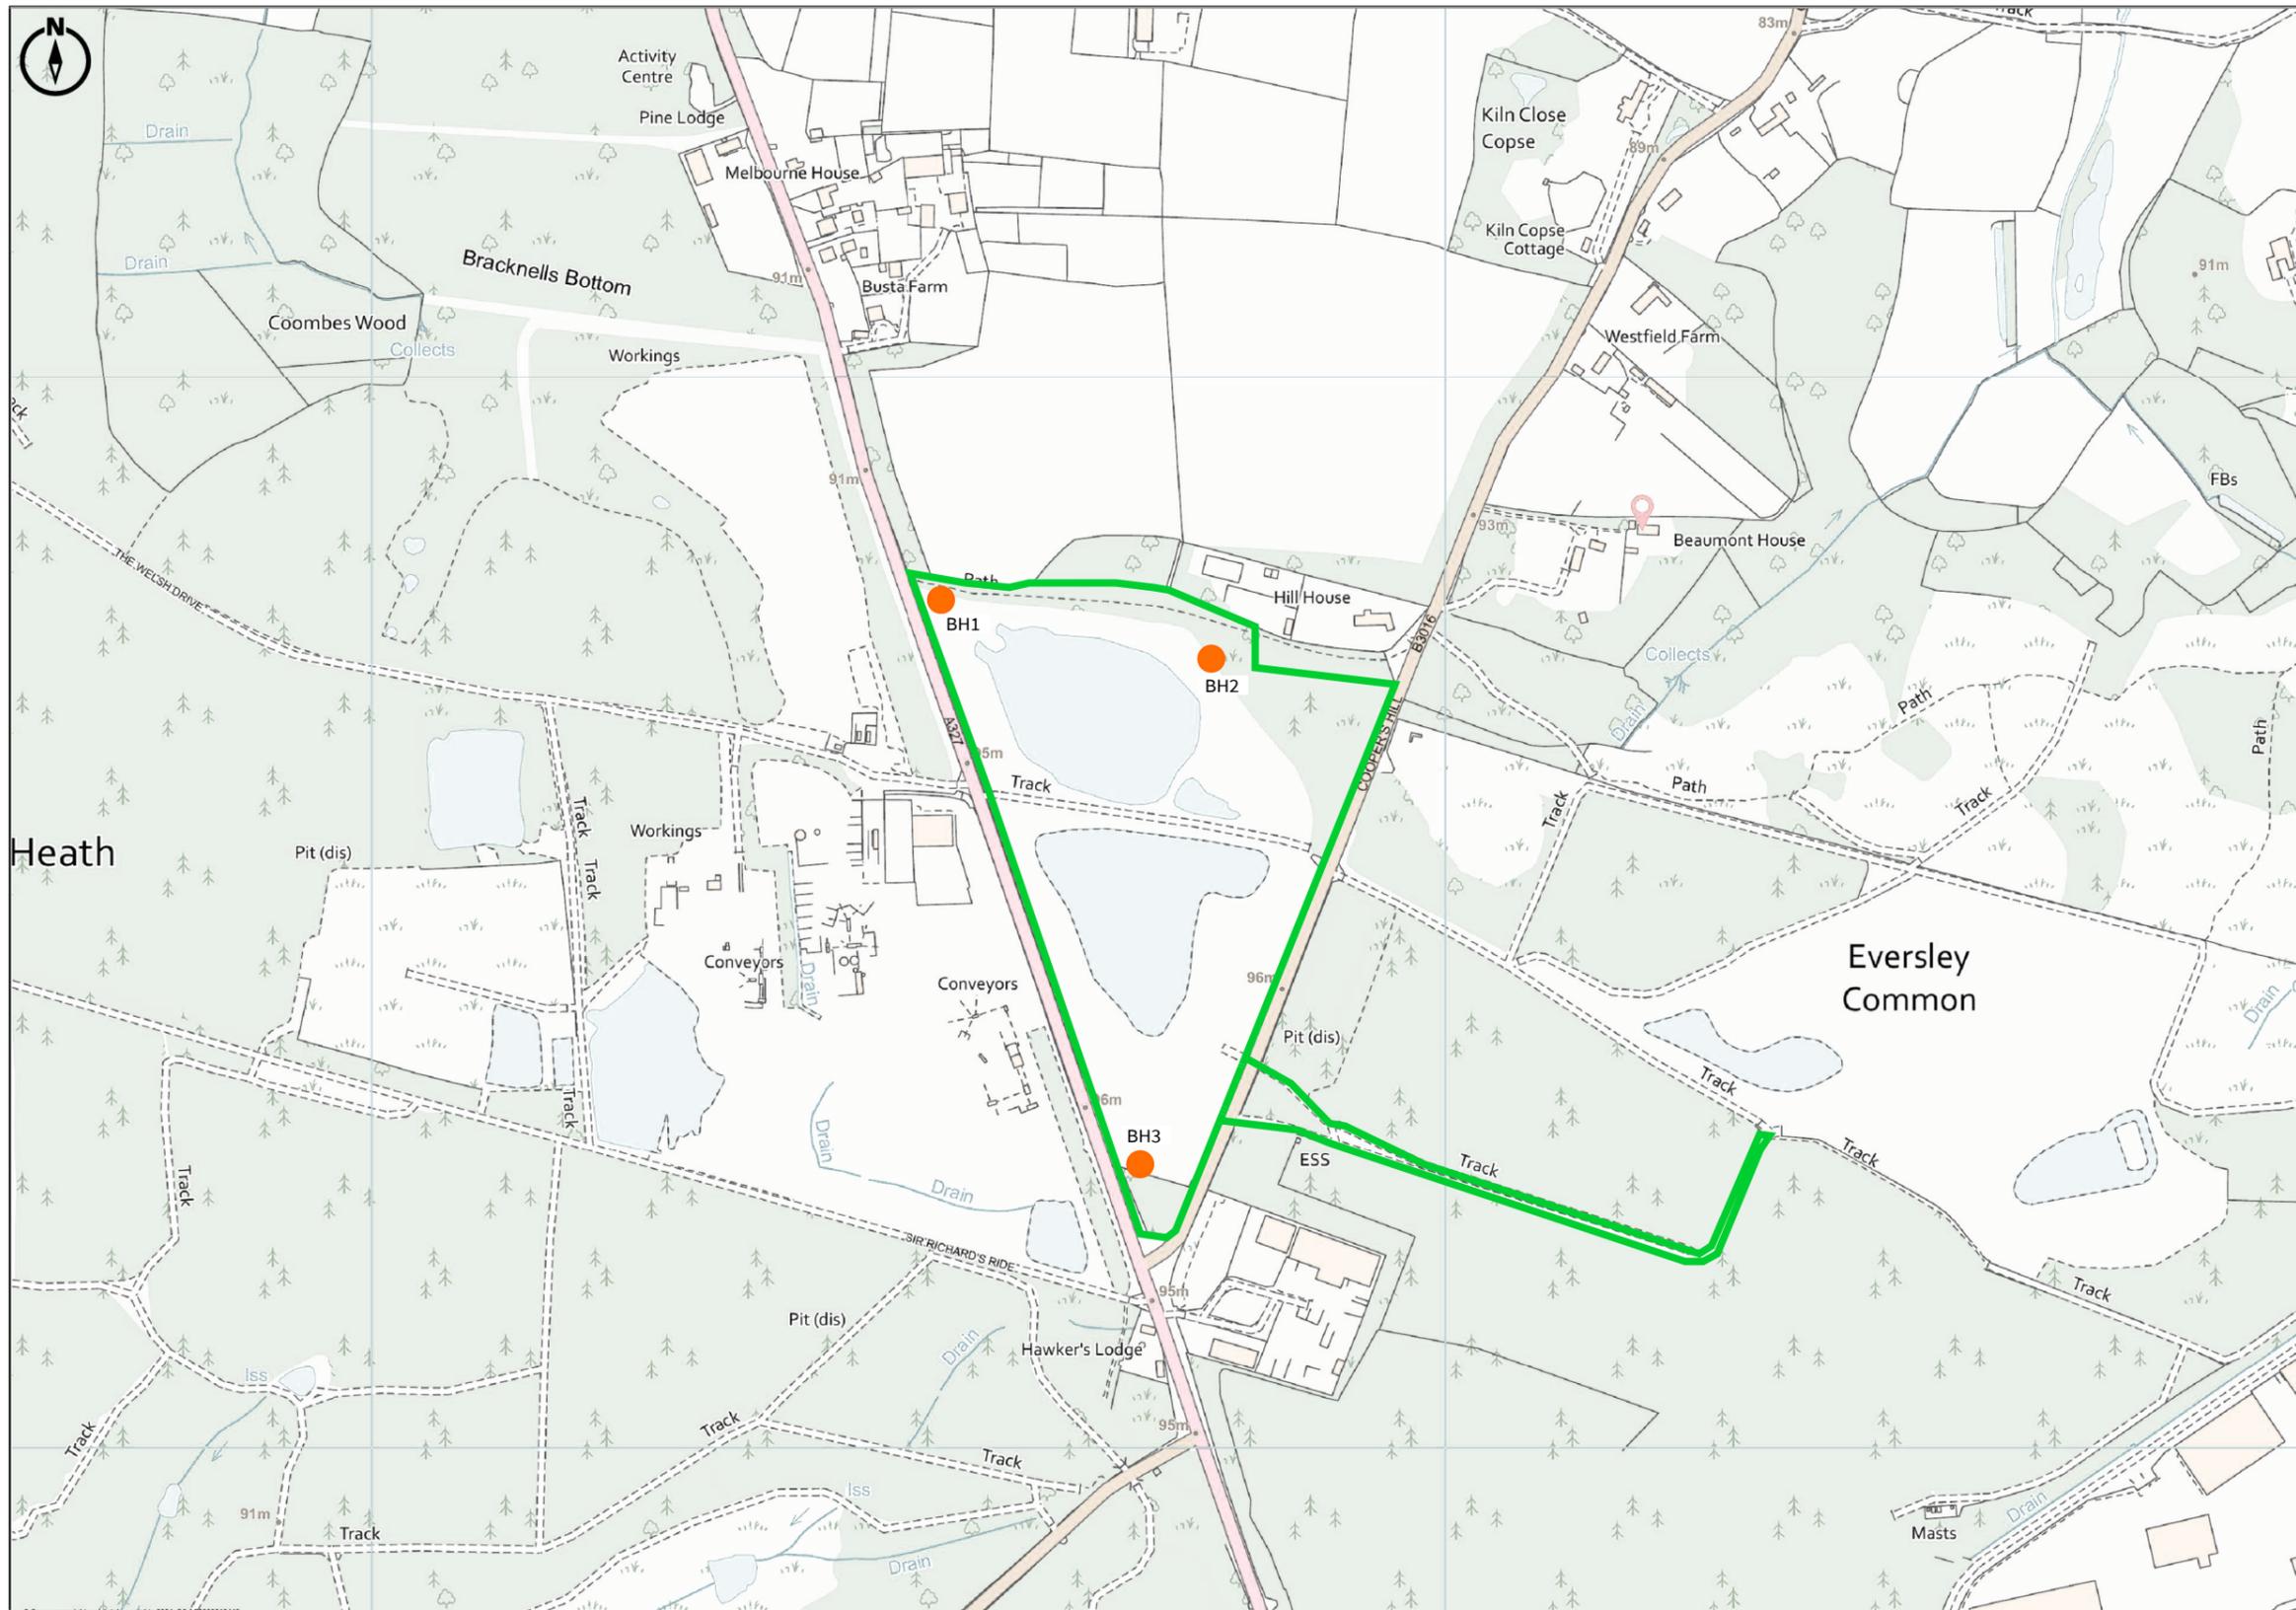
Borehole

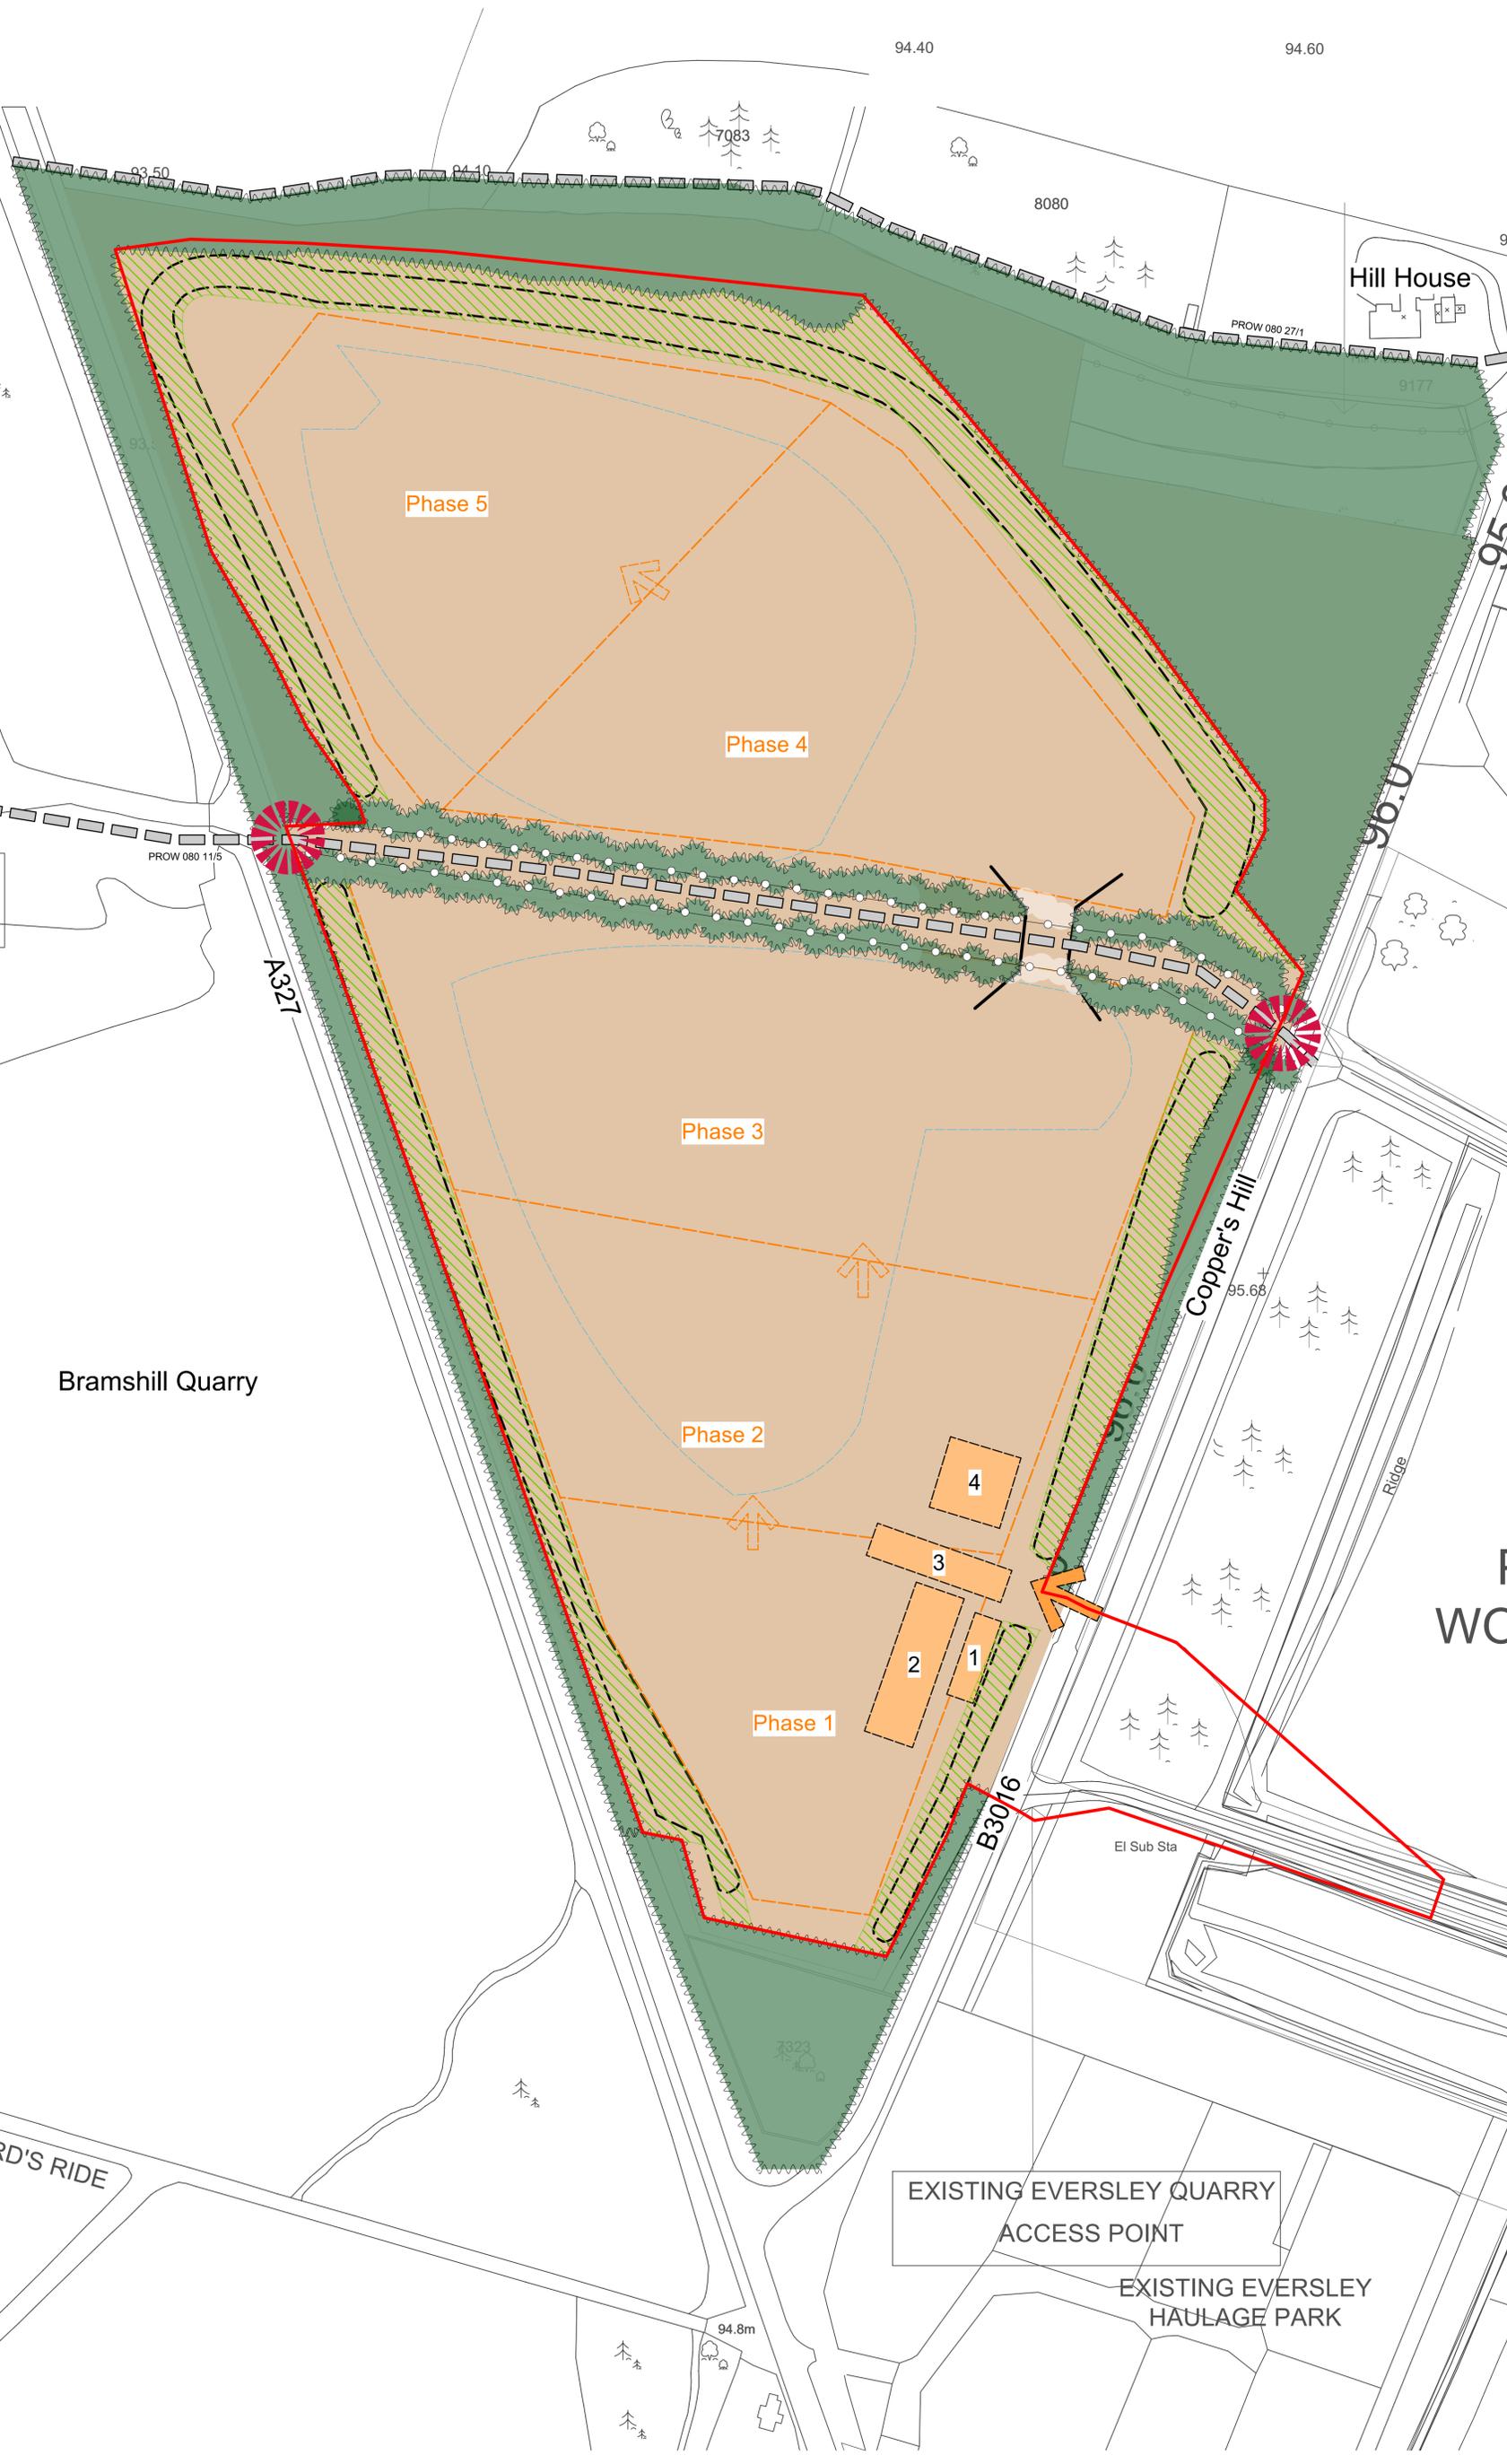
drawing title
OPERATIONAL PLAN

- KEY**
- Site Boundary 12.04h
 - Public Right of Way
 - Retained Woodland & Vegetation
 - Existing Lagoons
 - Existing Swale
 - Restoration Area (Phases 1 to 5)
 - ↑ Directions of Works (Phases 1 to 5)
 - Heras Fencing
 - Proposed Bunding
Proposed 2m high temporary bunding with wild flower meadow mix on top, bunding to hug redline boundary
 - Proposed Wild Flower Meadow Mixture
 - ↑ Site Access - Vehicles
 - ⊙ Site Access - Pedestrian
 - Temporary Crossing
 - Proposed Site Buildings (Indicative Locations)
 - 1 Site Office (two storey stacked cabin)
 - 2 Vehicle Car Parking Area
 - 3 Weigh Bridge + Wheel Wash
 - 4 Quarantine Area

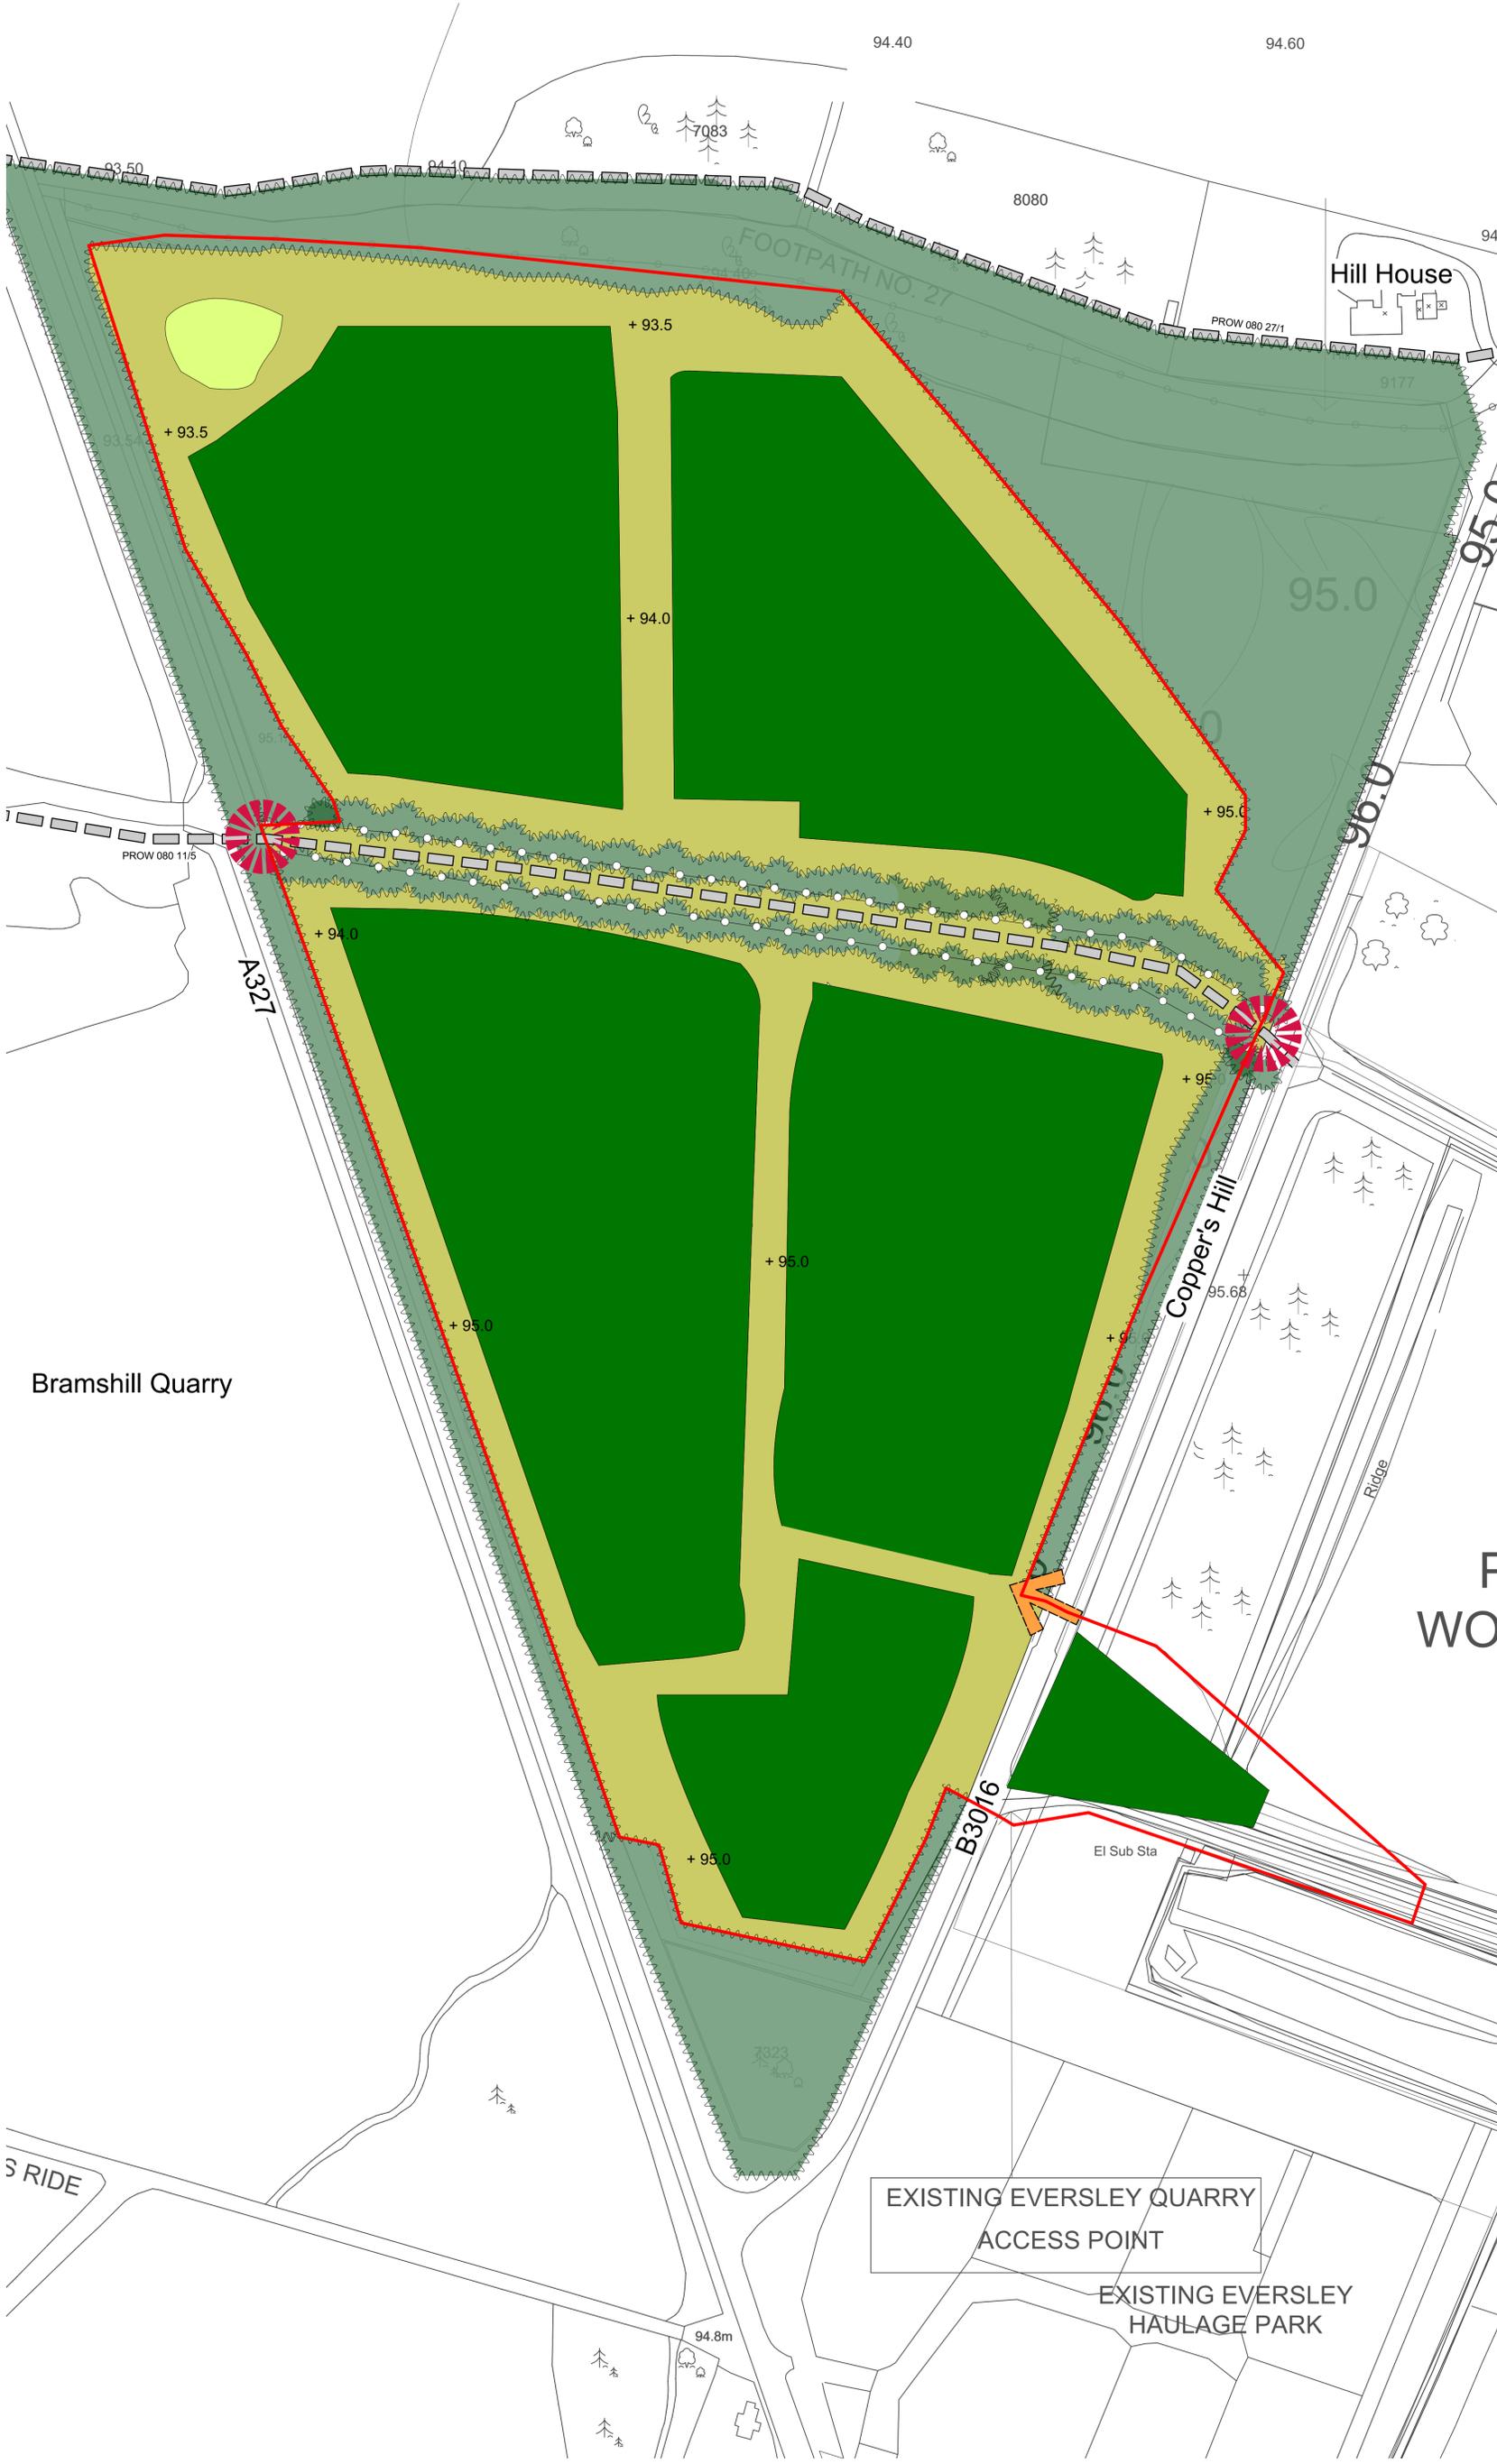
drawing title
 RESTORATION PLAN

- KEY**
- Site Boundary 12.04ha
 - Public Right of Way
 - Retained Woodland
 - Proposed Coniferous Forestry Plantation 62% of site
 - Proposed Lowland Heathland 18% of site
 - Proposed Wet Heathland
 - Site Access - Maintenance
 - Site Access - Pedestrian PROW
- Other land use including wetland and walk through path 20% of site
