NEPTUNE CONTRACT SERVICES LTD.
THUNDER ROAD, CHEQUERS LANE, DAGENHAM RM9 6PU

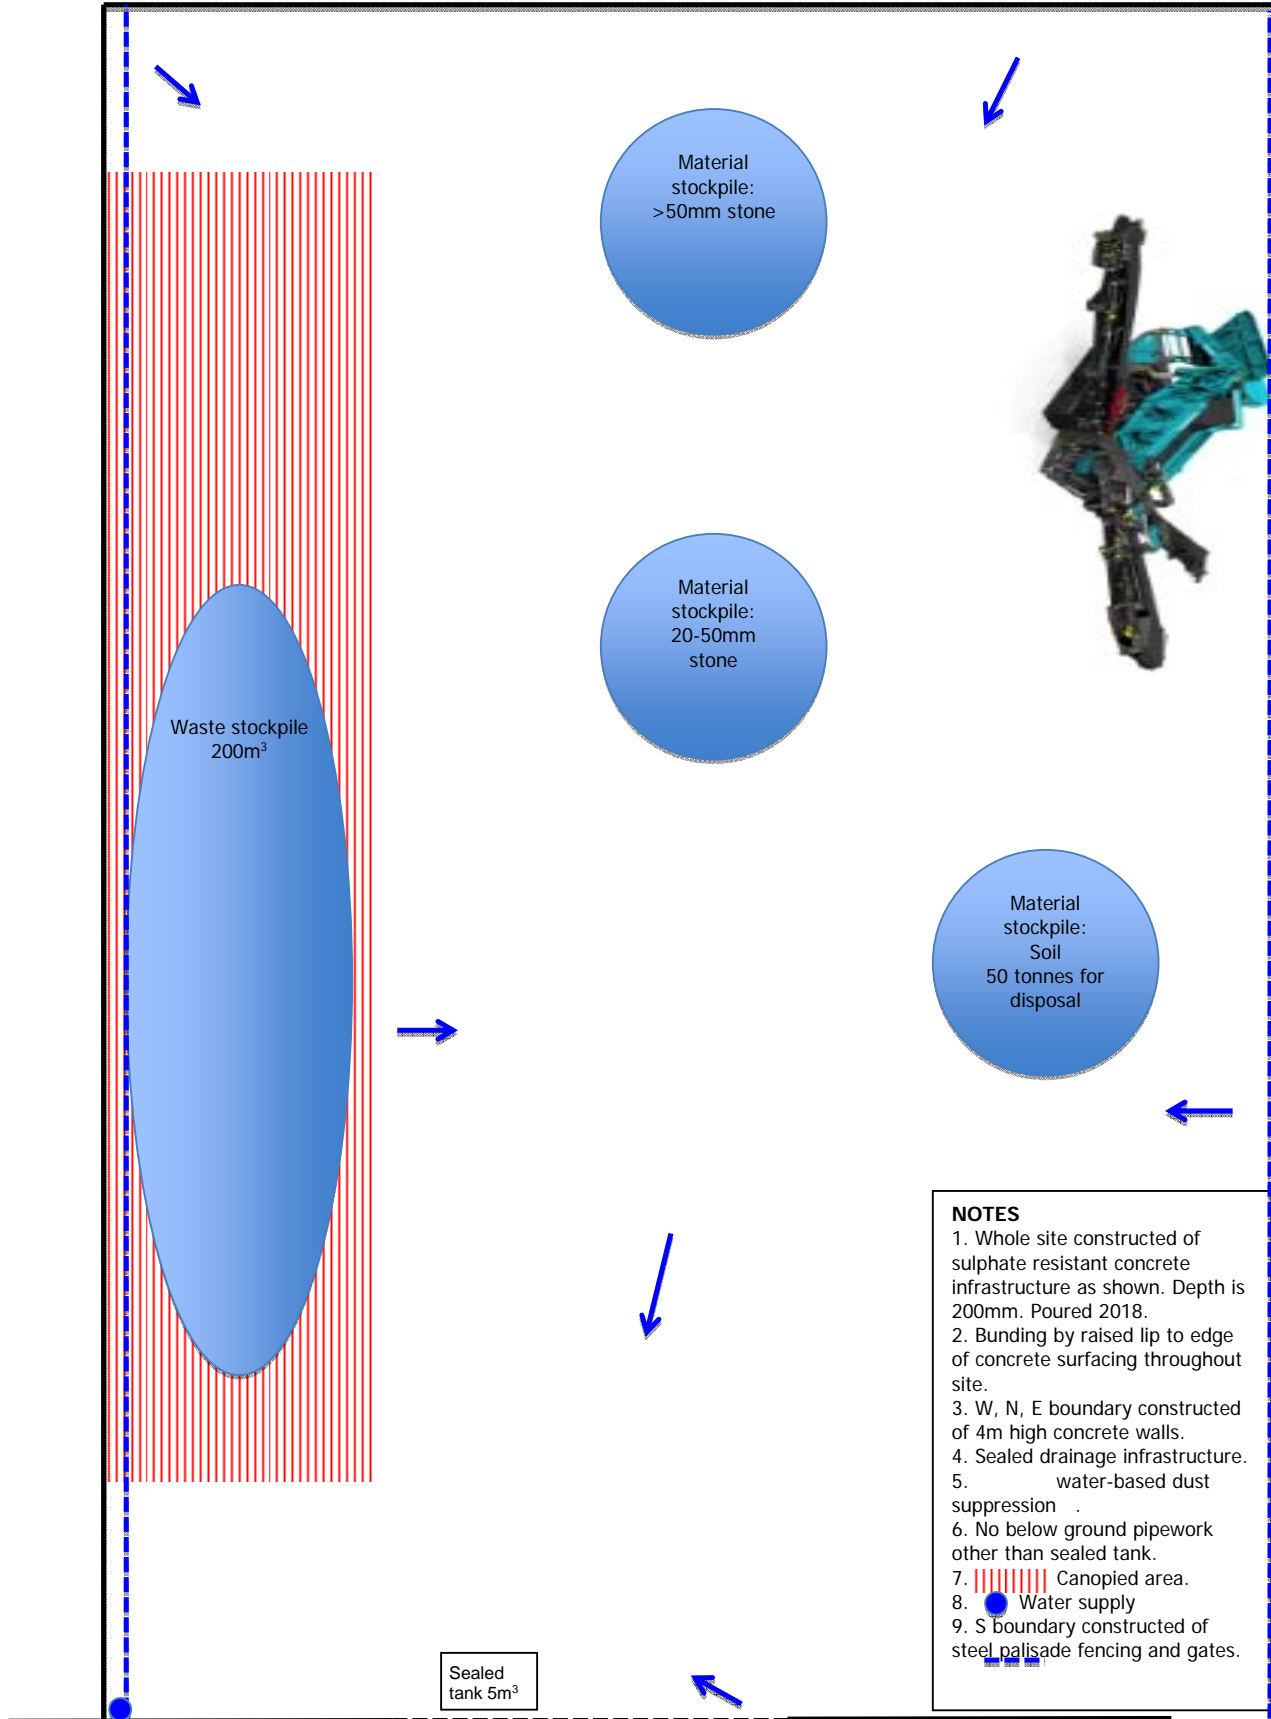
1. Whole site constructed of sulphate resistant concrete infrastructure as shown. Depth is 200mm. Poured 2018.
2. Bunding by raised lip to edge of concrete surfacing throughout site.
3. W, N, E boundary constructed of 4m high concrete walls.
4. Sealed drainage infrastructure.
5. water-based dust suppression
6. No below ground pipework other than sealed tank.
7. ||||| Canopied area.
8. ● Water supply
9. S boundary constructed of steel palisade fencing and gates.

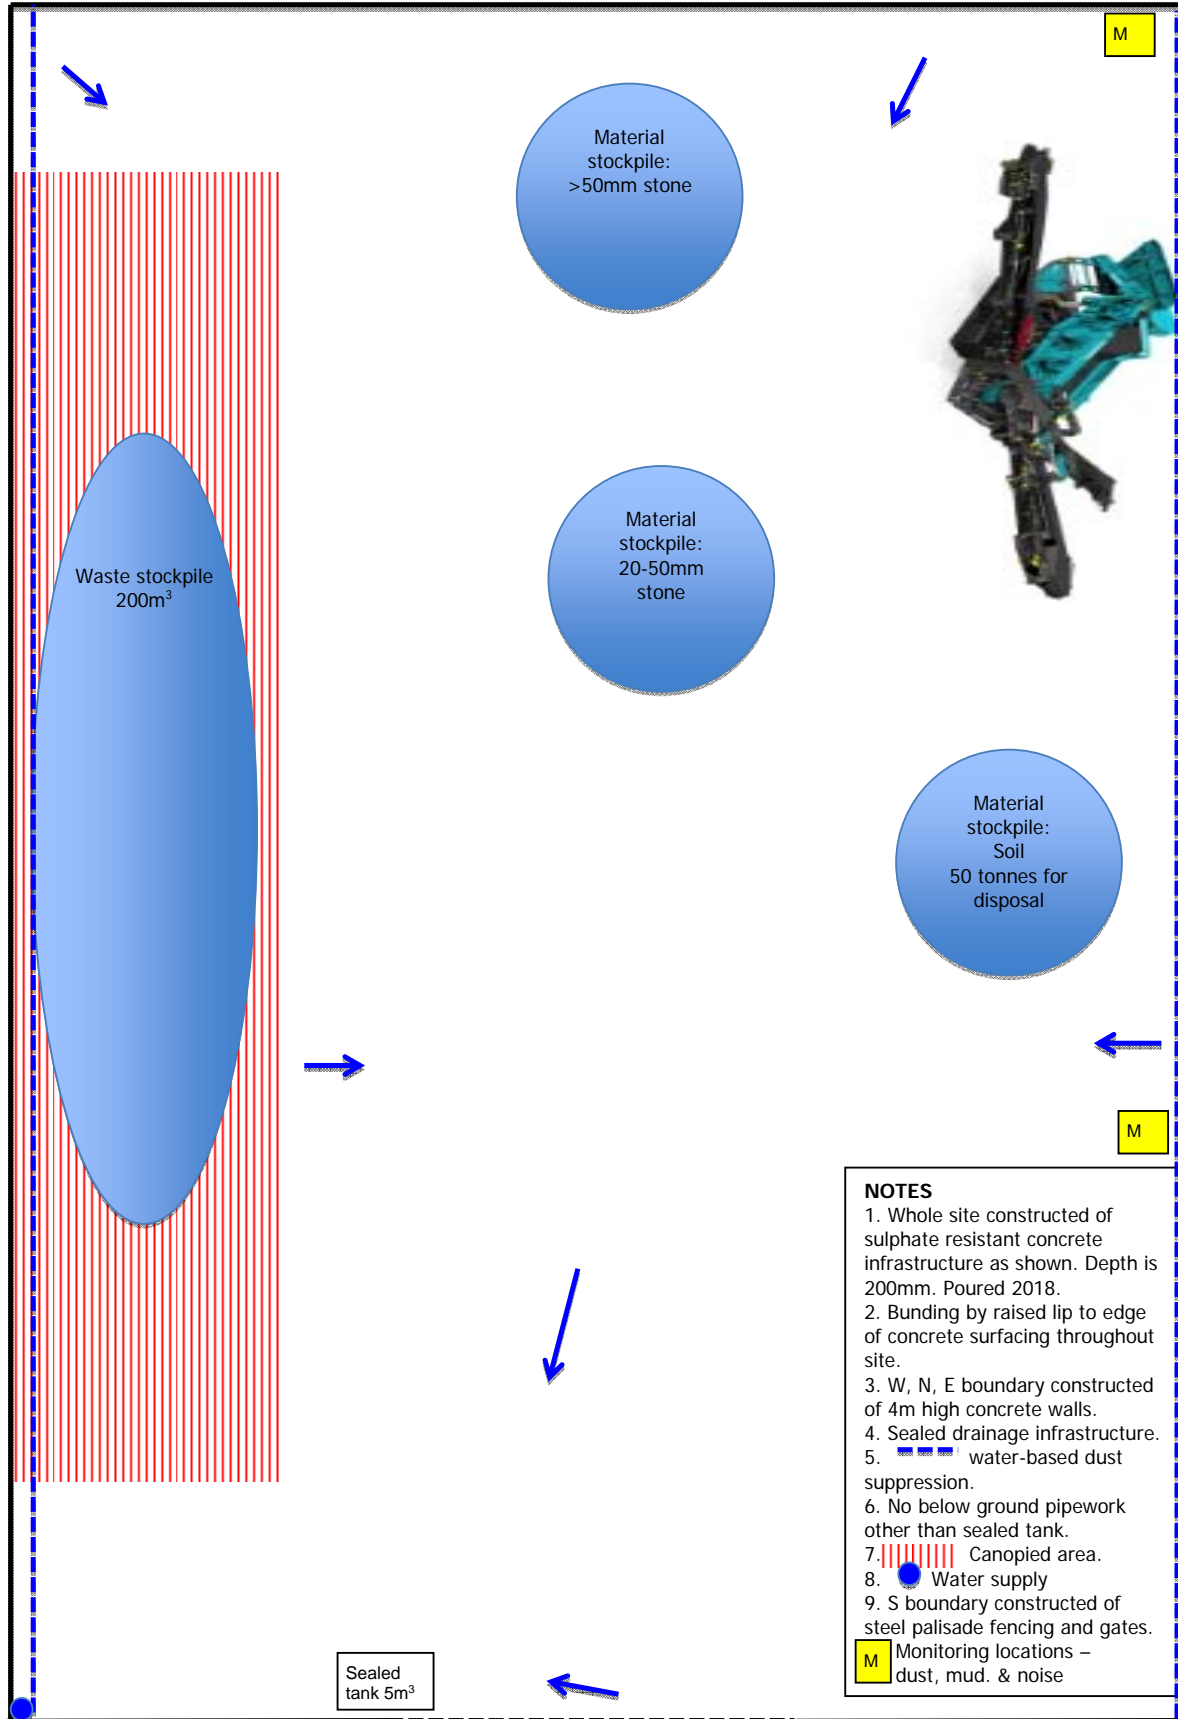
1. Whole site constructed of sulphate resistant concrete infrastructure as shown. Depth is 200mm. Poured 2018.
2. Bunding by raised lip to edge of concrete surfacing throughout site.
3. W, N, E boundary constructed of 4m high concrete walls.
4. Sealed drainage infrastructure.
5.

water-based dust suppression.
6. No below ground pipework other than sealed tank.
7.

Canopied area.
8.

Water supply
9. S boundary constructed of steel palisade fencing and gates.

Monitoring locations – dust, mud. & noise
