SITE INFORMATION

Client Name **Royal Hallamshire Hospital**

Job Number **PROS116637**

Tank Name	Tank farm bulk tank 3		Form tank number	3	
Tank Purpose	Heating and generator		Photo

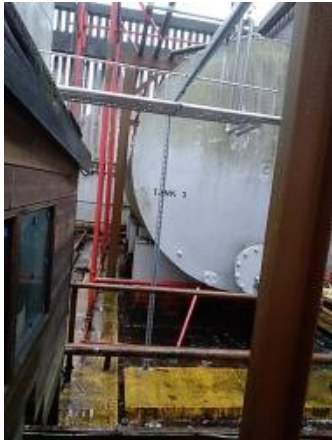
Remarks	Gauge reads 6100lts				
Does the tank have an identification mark or number actually painted or marked on the tank itself or on a plate attached to it?					Yes
Are there openings on a tank top that would interfere with correct venting or allow water ingress?					No
TYPE of OIL	Gas Oil				
Tank Measurement Type		Diameter/Length-Height (mm)			
Long		Wide		High	
Diameter	2760			Length/ Height	6130
Capacity	36674.86			Age	>15
Material of construction	Painted Steel				
Shape	Horizontal cylindrical				
Lagged?	No				
Skin	Single Skin				
Tank Support Condition	Good (no visible problems)				
Damp-proof membrane	Not required				
					Fireproof at least 300mm beyond edge of tank? Yes Impact protection Good (no problems, no danger)

Size of Bund			
Long (mm)	21400		
Wide (mm)	1285		
High (mm)	300		
Capacity (L)	8249.70		
Capacity compliant (e.g. 110%)?	No		
Is bund open to weather (e.g. no roof)?	Yes	Bund Visual Condition	Good
Remarks			
Construction of bund	In situ Concrete

Internal finish of bund			
Rendered?	Yes	Painted?	Yes
Remarks			
Are there obvious cracks or holes?			Yes
Are there any outlets/valves through bund walls (not continuous pipes)?			No
Are there any pipes passing through bund walls?			Yes
		If yes, are they well sealed?	No
		Are there tank/bund drains external to the bund?	
Oil in the bund?	No signs of any oil		
Water retention of bund			
Is bund watertight?	Yes		
Is there water in the bund?	No

Contents Gauge - Type	Hydrostatic (e.g. Normond)		
Is gauge known to be inaccurate, faulty, damaged?			
Date of last calibration if known			
ALARMS			
Is an alarm fitted?	Yes		
State Type	Overfill		
Alarm make	Hytek	Is test facility provided?	Yes
Alarm Power	Battery	Is mute facility provided?	Yes
Is the alarm apparently functioning?	No		
Remarks:

General condition of:							
Tank	Adequate	Pipes	Good	Gauges etc.	Poor	Bund	Dangerous
Does the tank comply with the DEFRA Oil Storage regulations 2001?						No	
Remarks: Holes in bund wall for cables							
Replace batteries in alarm
