**RIDING COURT FARM, DATCHET,
BERKSHIRE**

Stability Risk Assessment Report

GEC JOB NO: GE160270908

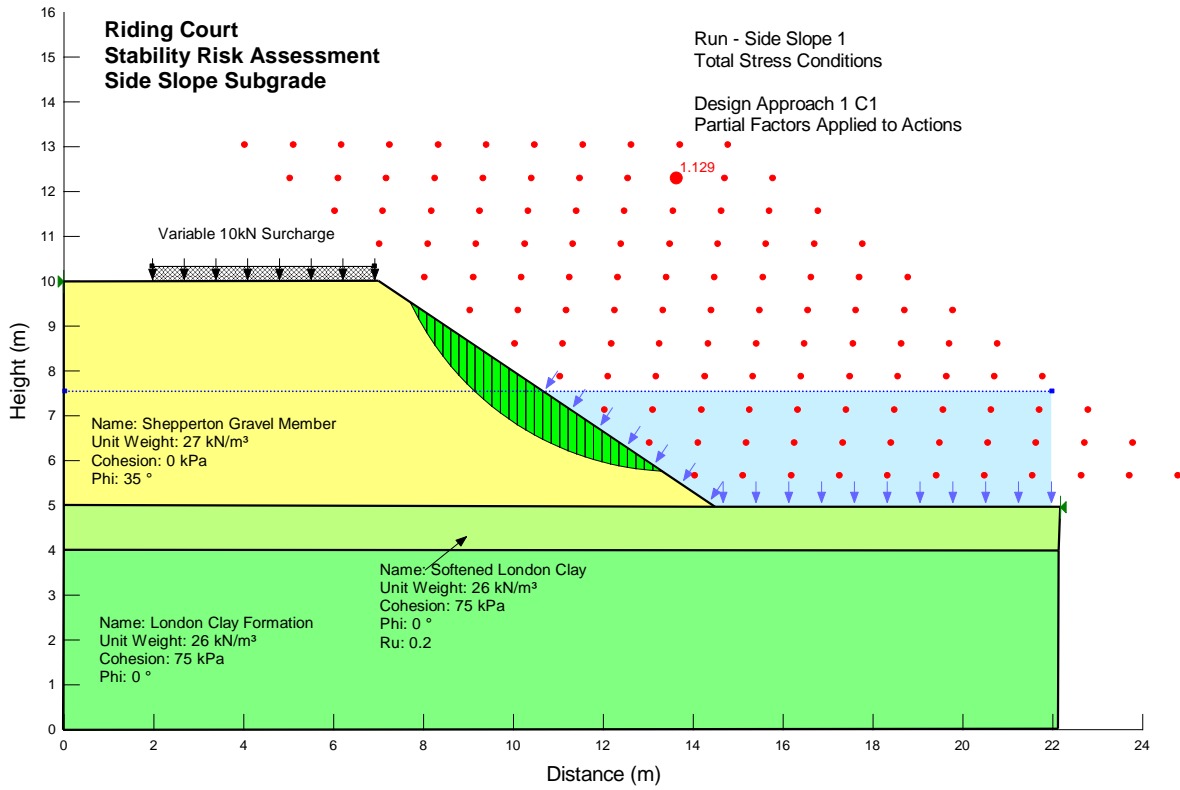
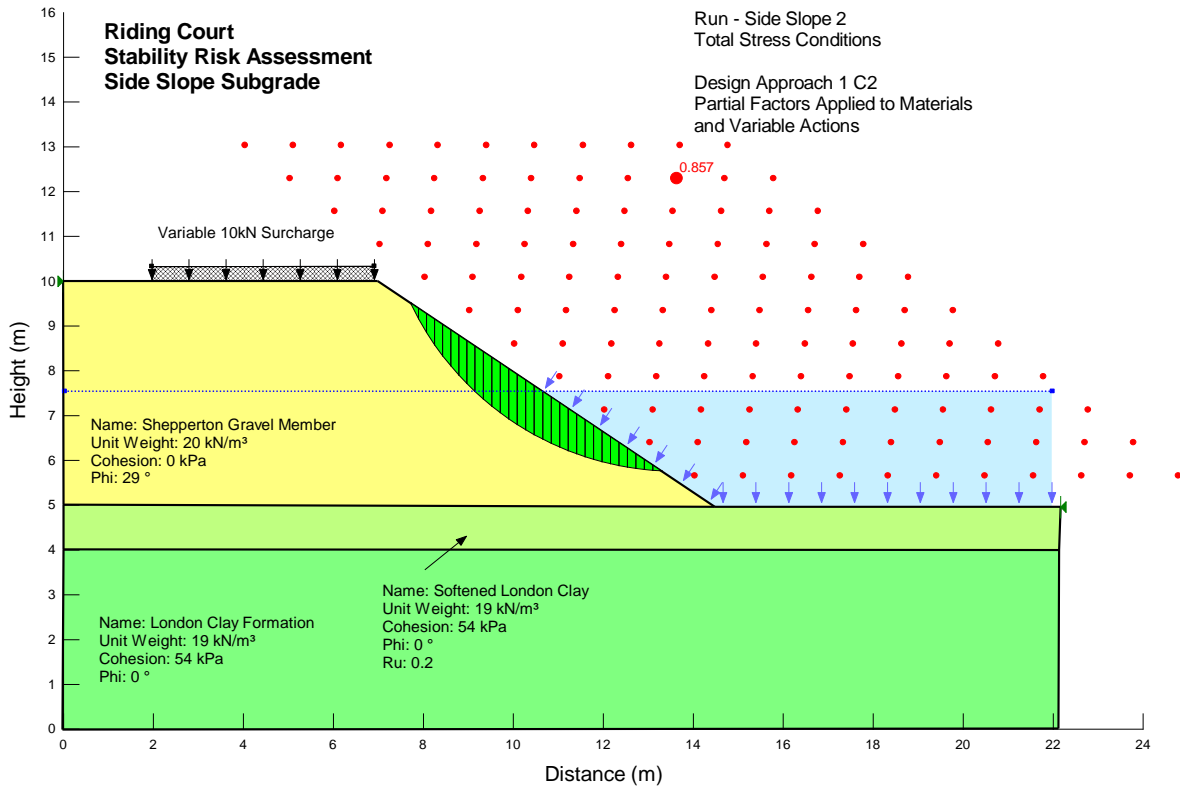
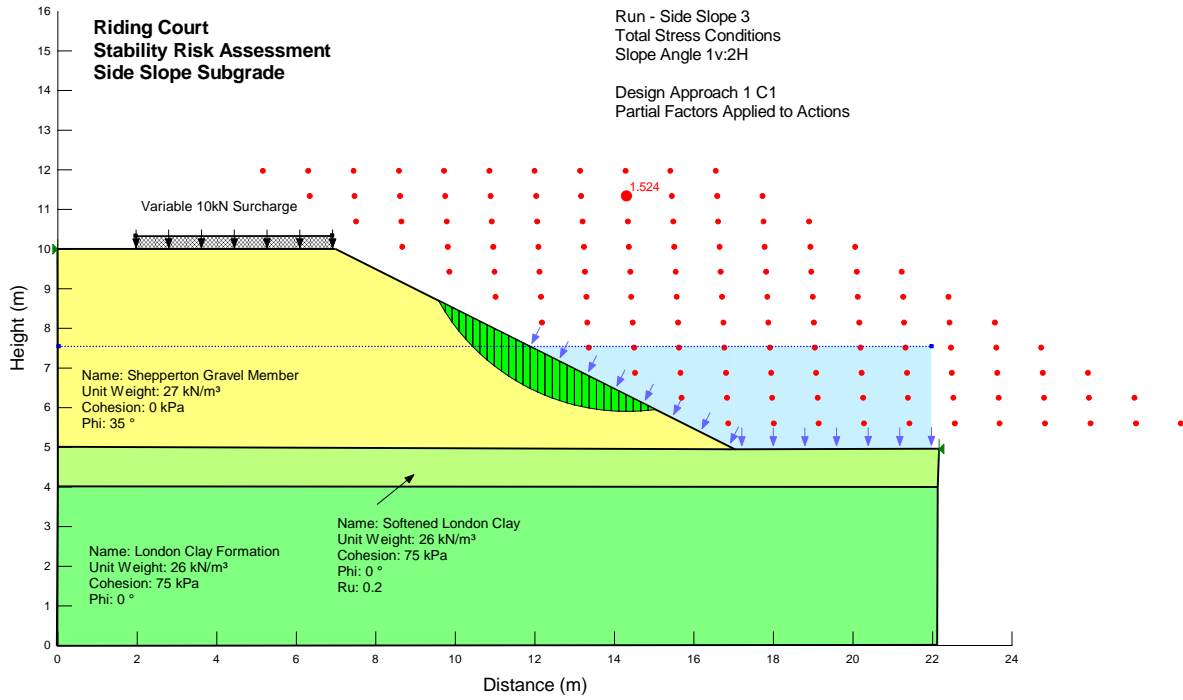
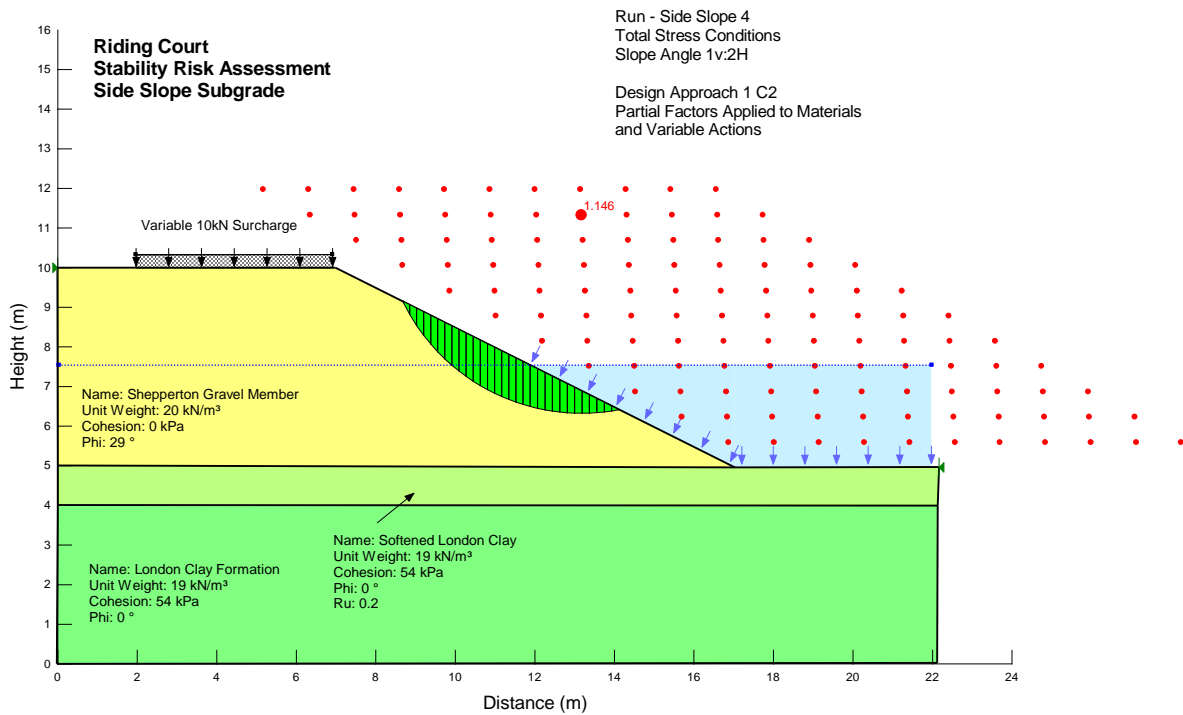
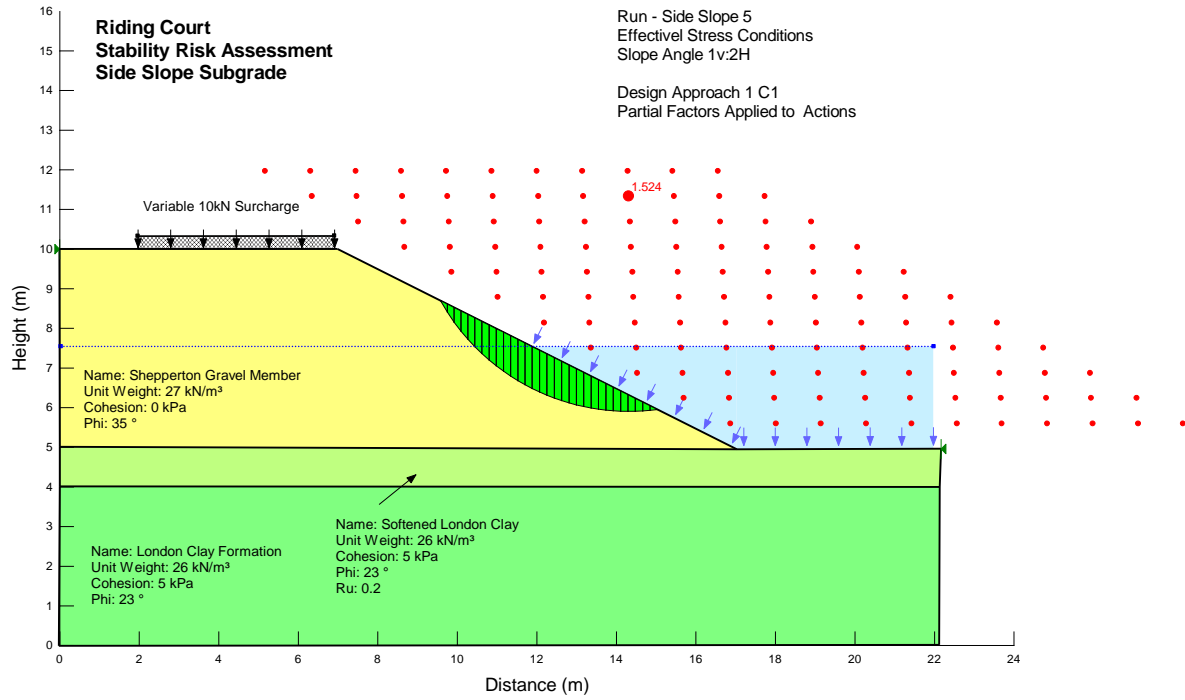
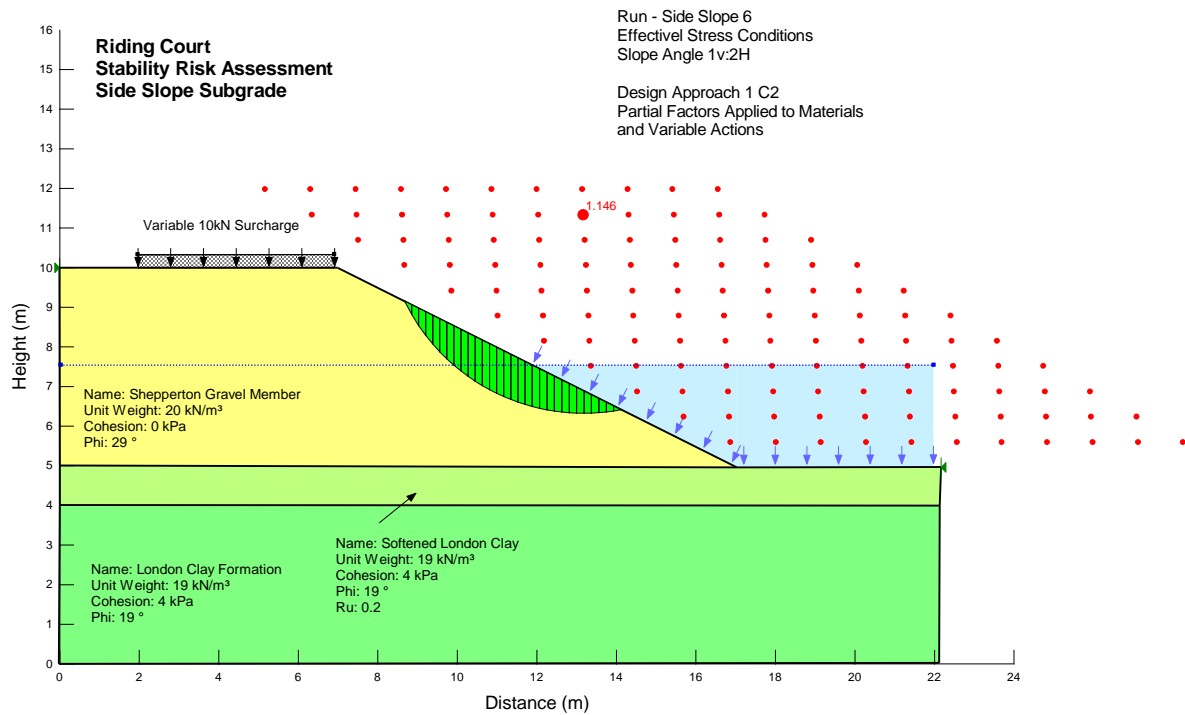
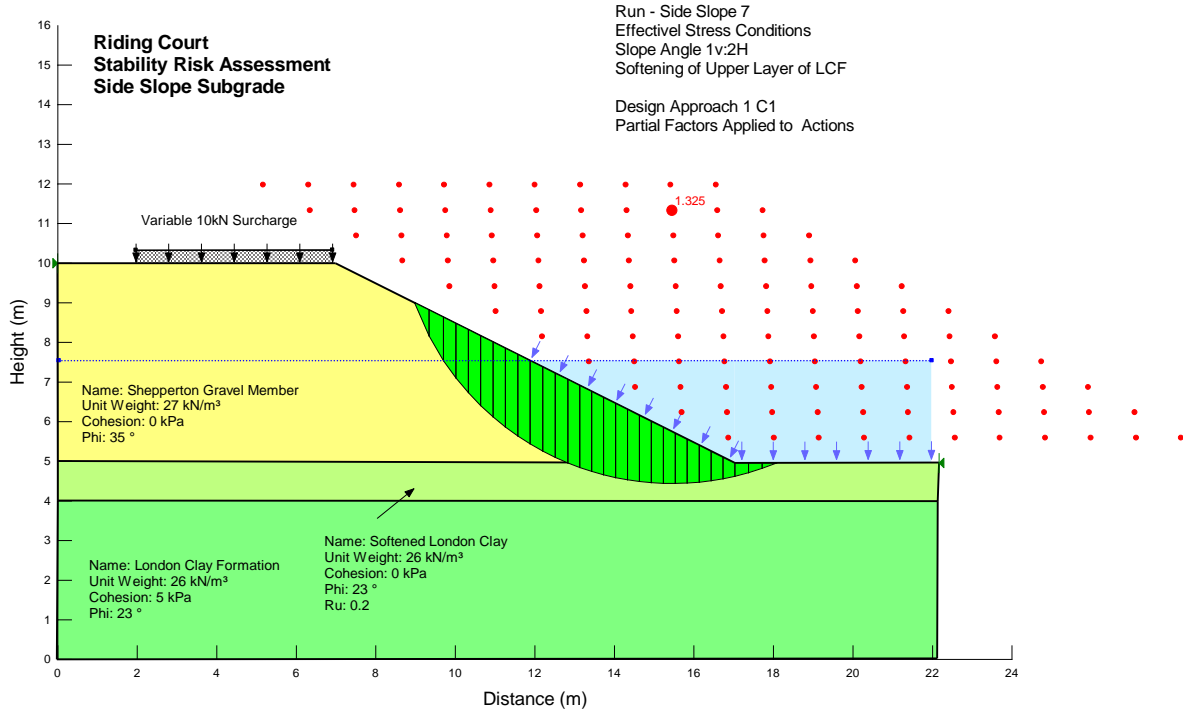
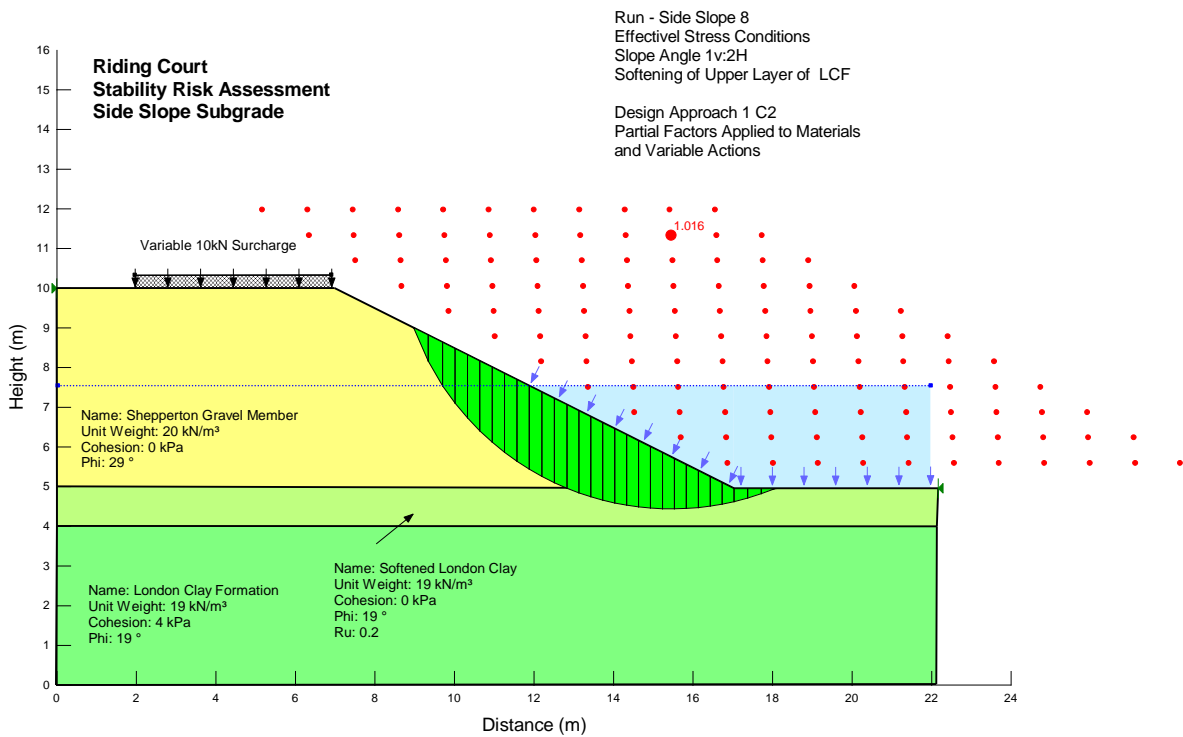
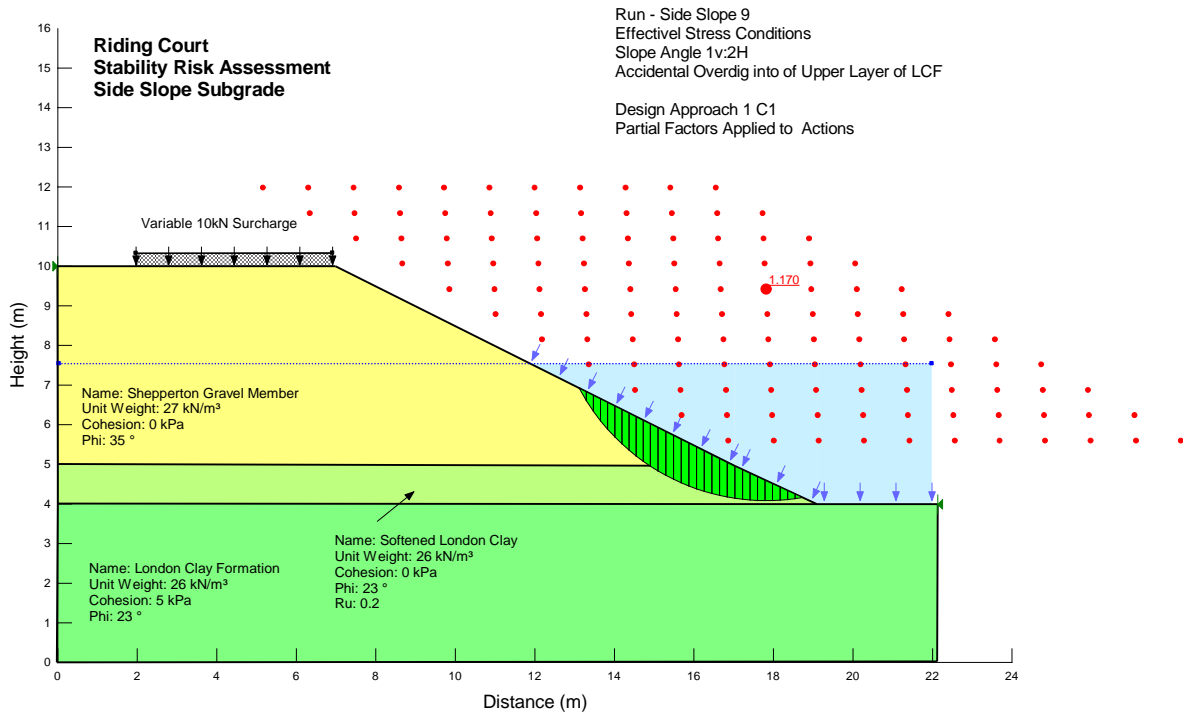
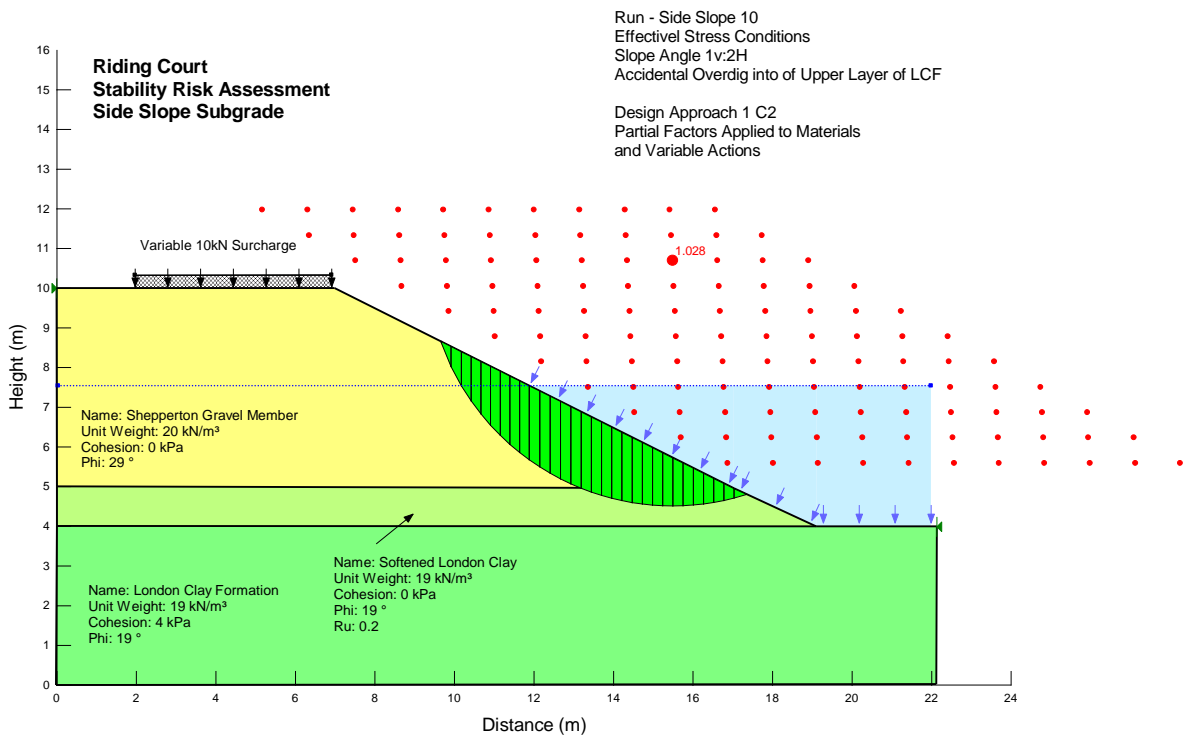
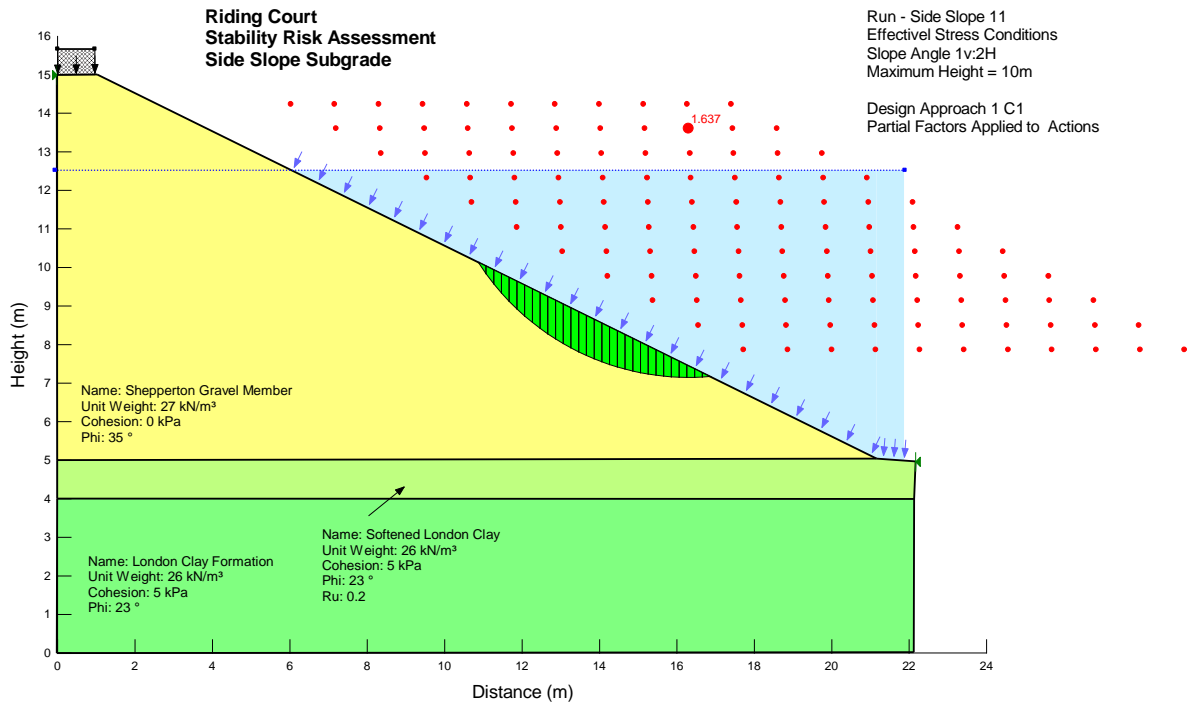
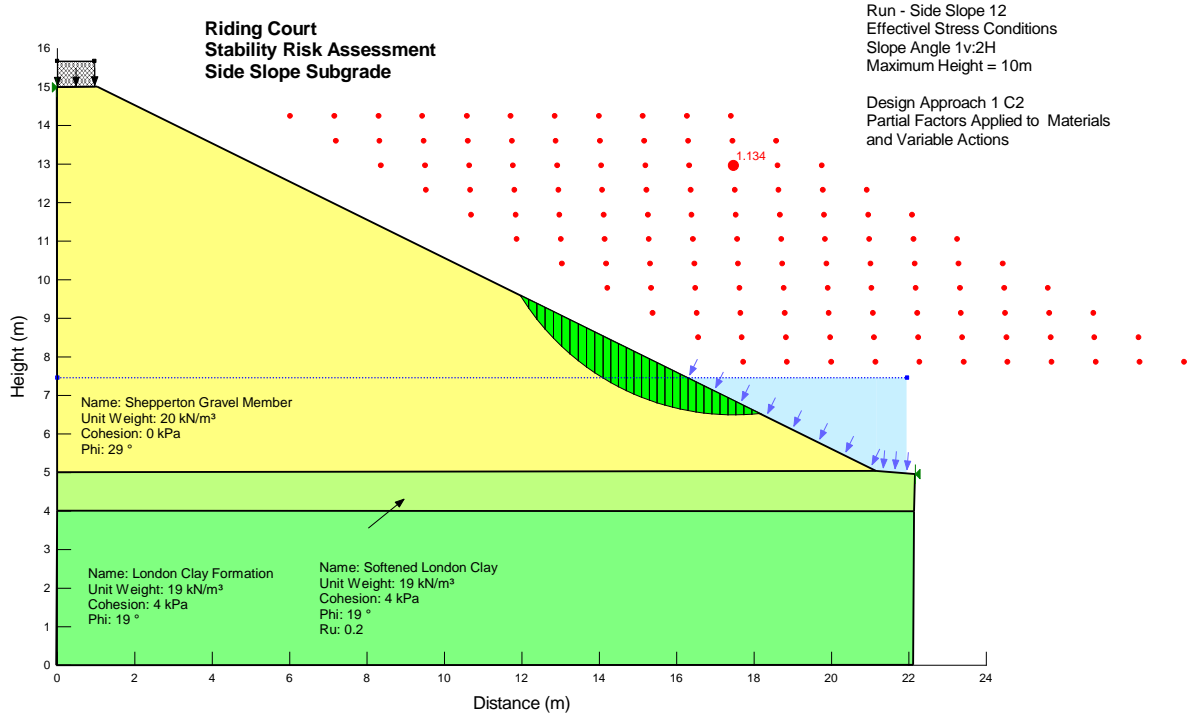
Slope/W Worksheets – Side Slope Subgrade

Run	File Name	Stress Condition	Factor of Safety		Notes
			C1	C2	
01	Side Slope 1	Total	1.13		Side slope subgrade maximum face angle 34° Slope failure under combination 2 factors
02	Side Slope 2	Total		0.86	
03	Side Slope 3	Total	1.52		Slacken of Face angle to 27° (1v:2h)
04	Side Slope 4	Total		1.15	
05	Side Slope 5	Effective	1.52		Effective Stress Conditions will only effect the shear strength of the fine-grained materials
06	Side Slope 6	Effective		1.15	
07	Side Slope 7	Effective	1.33		Softening of the Upper level of the London Clay
08	Side Slope 8	Effective		1.02	
09	Side Slope 9	Effective	1.17		Accidental overdig 1.00m in softened LCF
10	Side Slope 10	Effective		1.03	
11	Side Slope 11	Effective	1.64		Side Slope Height up to 10m
12	Side Slope 12	Effective		1.13

- 2.27 Both the short and long term stability of the side slope subgrade have been assessed using the Slope/W software for a range of circular failures using total and effective stress parameters.
- 2.28 The analysis has included an accidental overdig of 1.00m into the basal subgrade and the effect of subsequent softening of this material.
- 2.29 Results of the Side Slope Subgrade analyses are presented in Appendix 1 and summarised below.

- 2.50 SlopeW runs 01 – 04 (Table SRA 7) indicate that the post mineral extraction slopes should not exceed 1(v): 2(h) to ensure long term stability.
- 2.51 SlopeW Runs 07 – 10 illustrate the effect of accidental overdig and softening of the London Clay basal subgrade. The results of the analyses indicate that the side slope subgrade will remain stable even in the unlikely event of systematic overdig into the London Clay and or softening of the basal London Clay Formation.
- 2.52 Although the majority of the extractable mineral is within 6.00m of the ground surface Slope W runs 11 -12 show that the side slope subgrade will remain stable with slope heights up to 10m.
- 2.53 It is concluded that the side slope subgrade will be stable at heights of up to 10.00m provided the side slope gradient does not exceed 1(v) : 2(h) (27°).

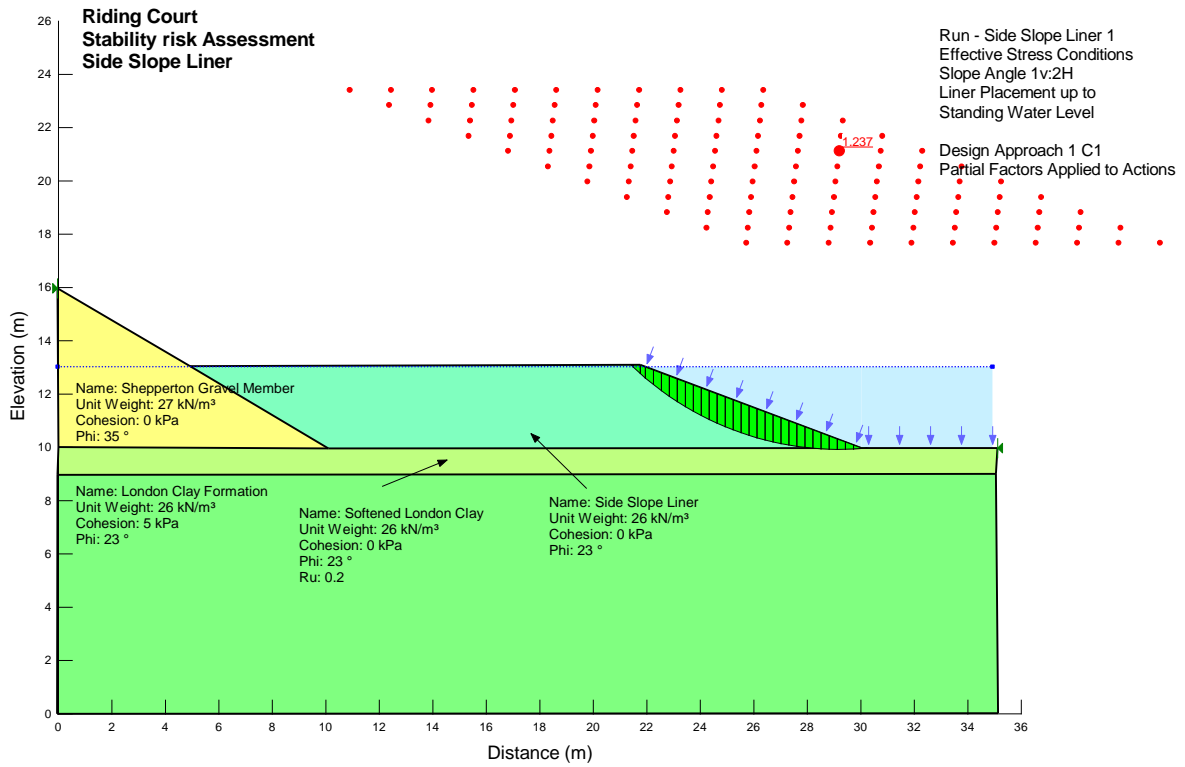
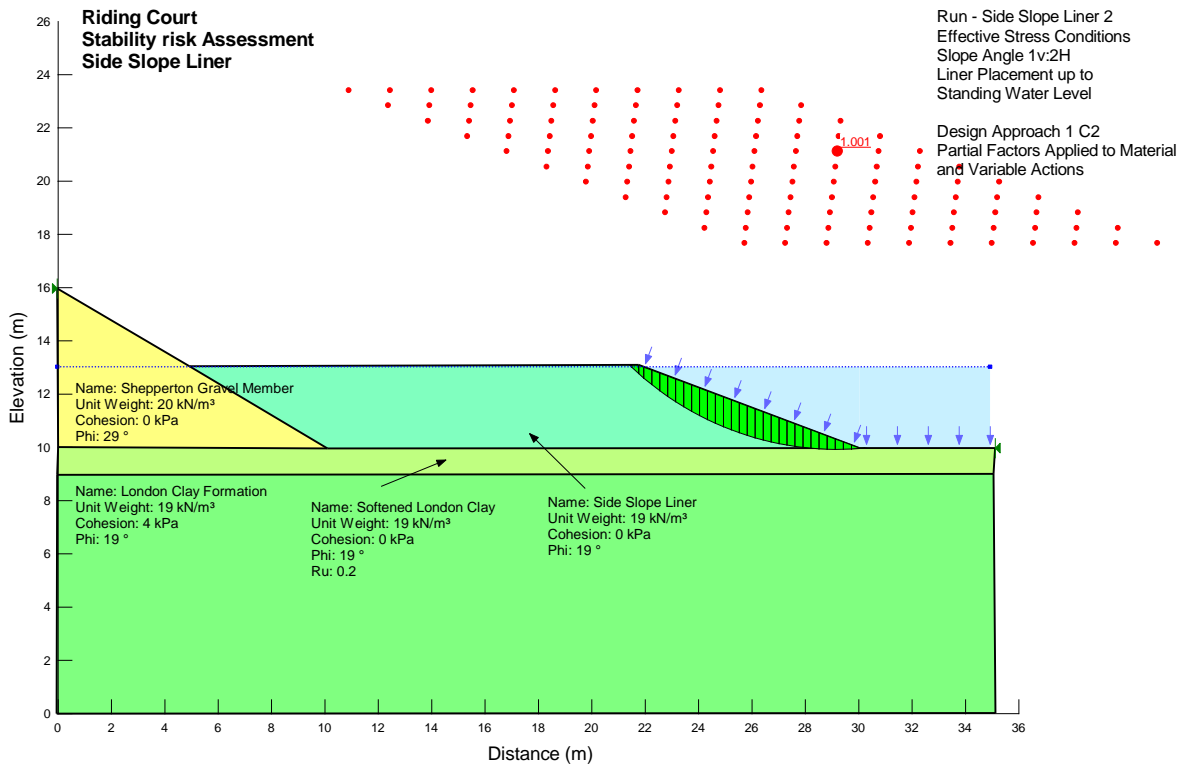
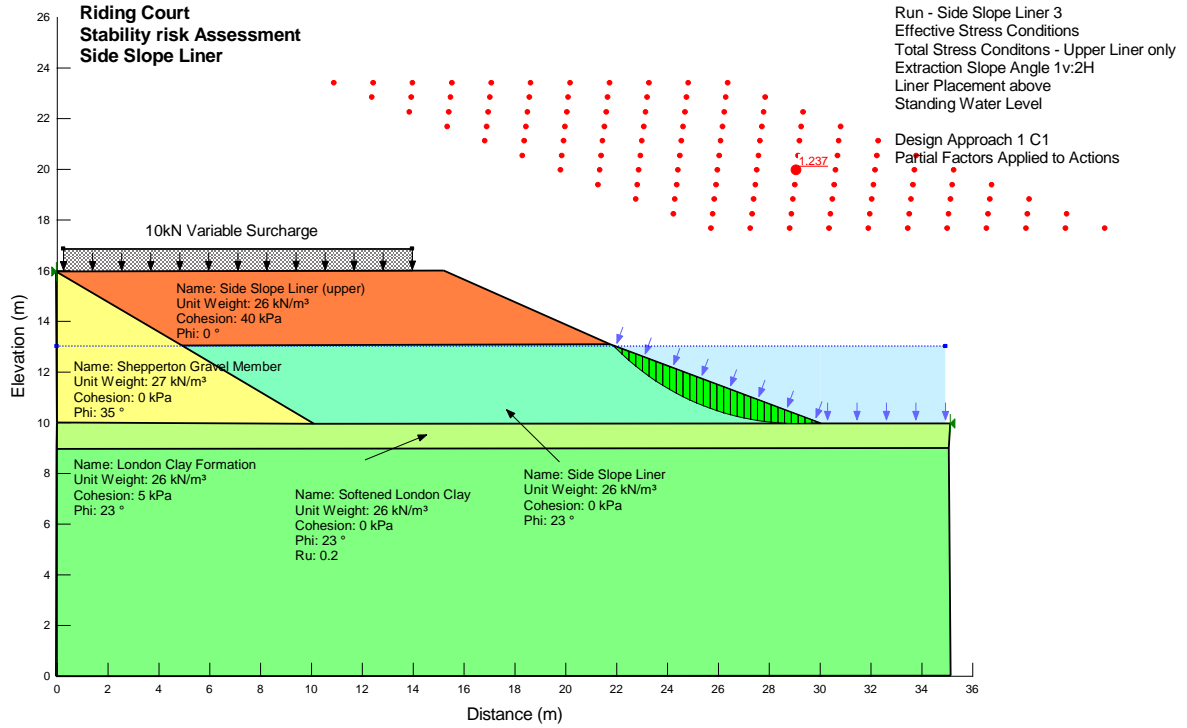
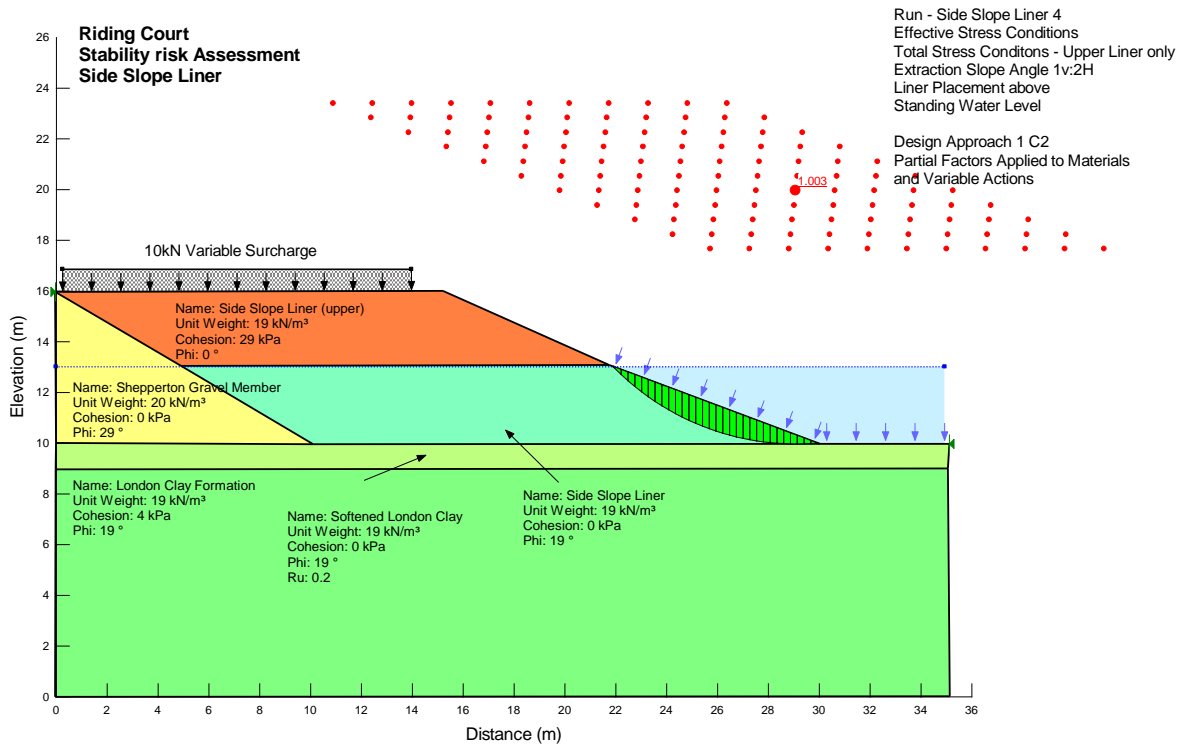
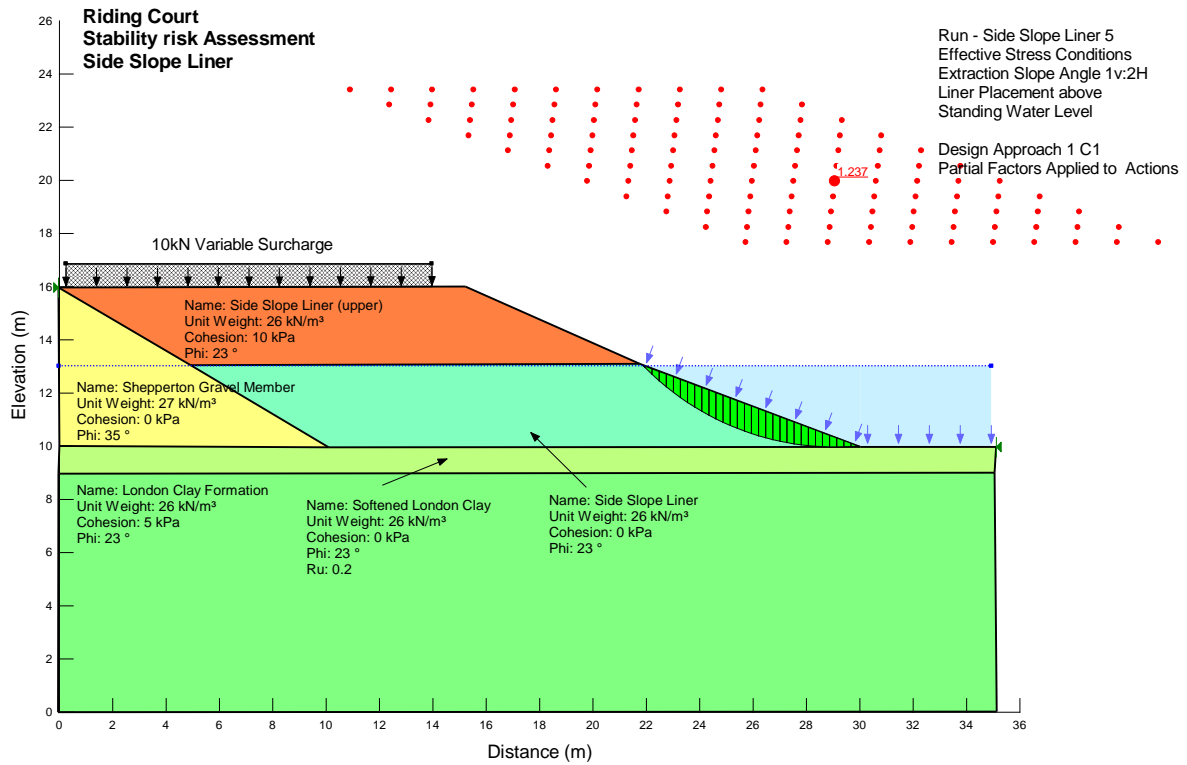
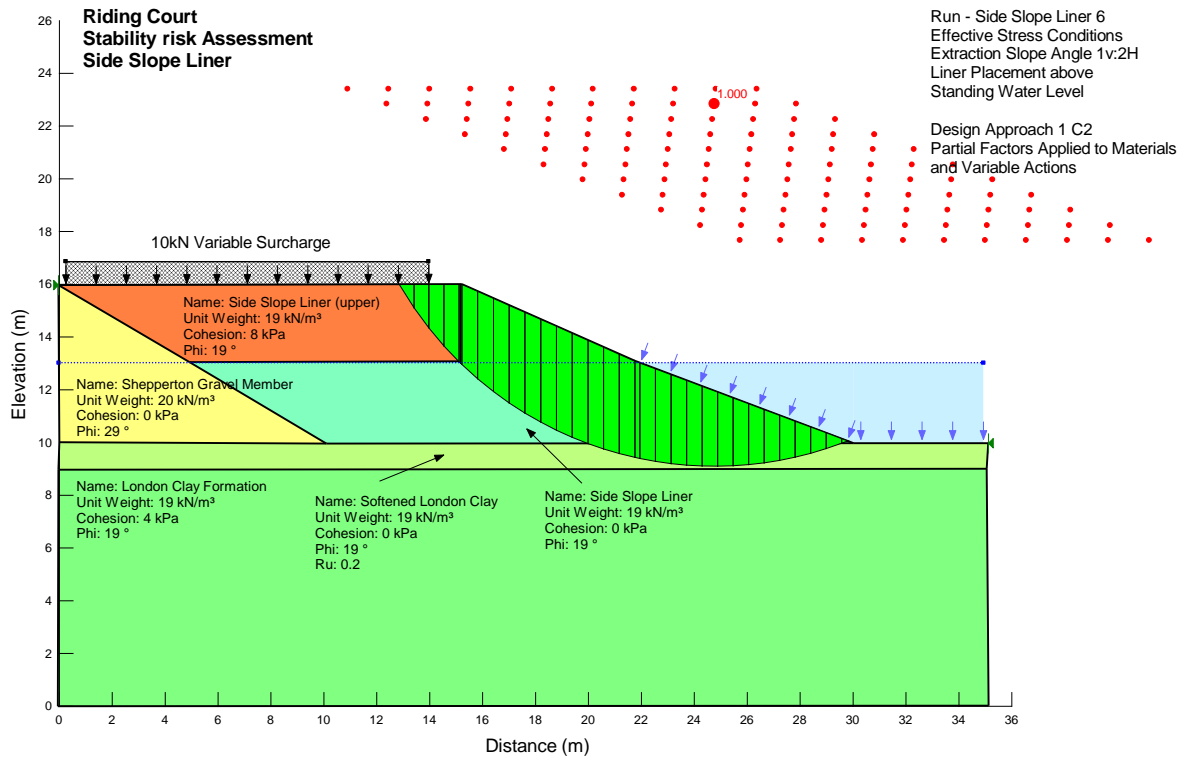
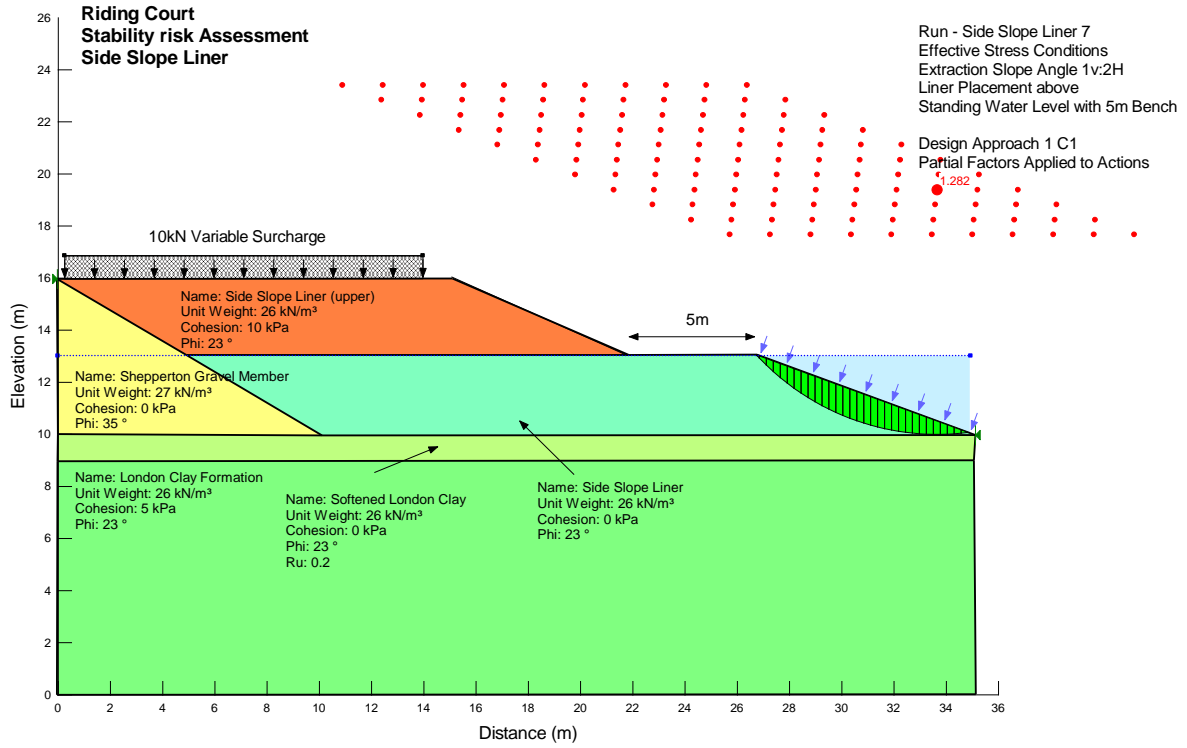
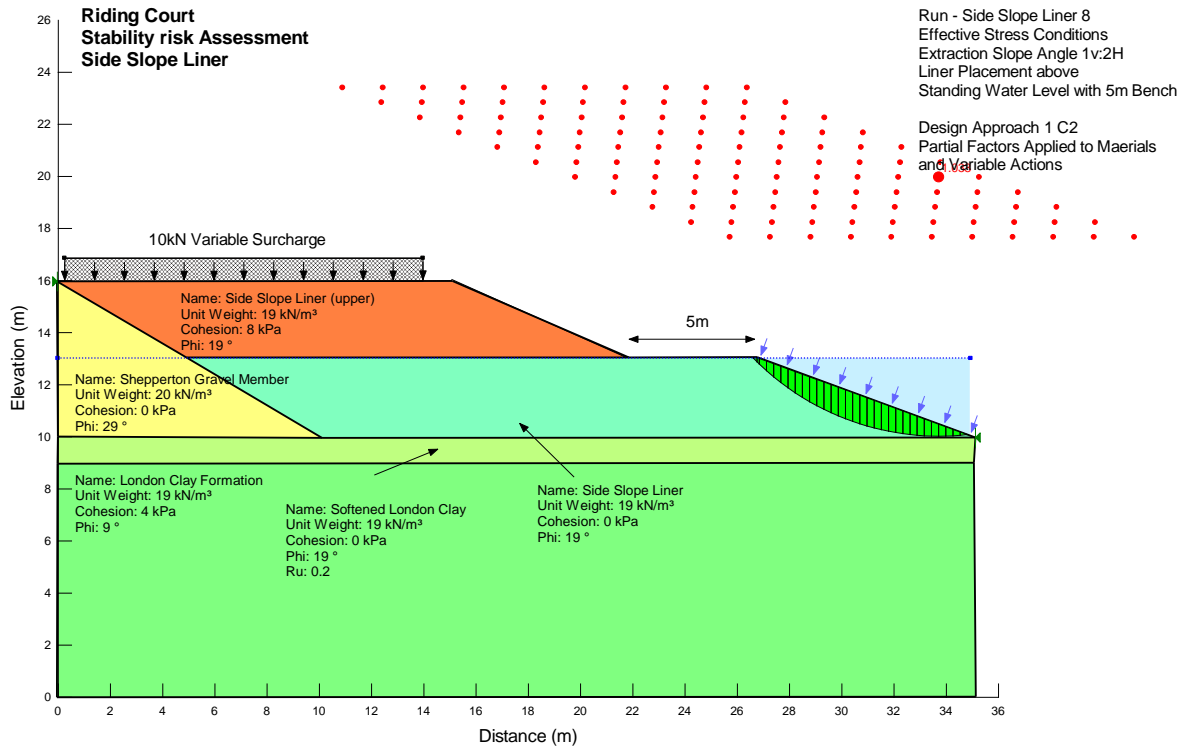
Slope/W Worksheets – Side Slope Liner

Run	File Name	Stress Condition	Factor of Safety		Notes
			C1	C2	
13	Side Liner 1	Effective	1.24		Underwater Placement of material consolidation under self-weight. Liner face angle = 17°
14	Side Liner 2	Effective		1.00	
15	Side Liner 3	Total / Effective	1.24		Placement of upper liner material, minimum 15.00m crest width, short term undrained conditions.
16	Side Liner 4	Total / Effective		1.00	
17	Side Liner 5	Effective	1.24		Placement of upper liner material, minimum 15.00m crest width, long term drained conditions.
18	Side Liner 6	Effective		1.00	
19	Side Liner 7	Effective	1.28		Placement of upper liner material, minimum 15.00m crest width and 5.00m bench, long term drained conditions.
20	Side Liner 8	Effective		1.03

- 2.30 Initially the side slope liner material will be end tipped and allowed to consolidate under its own weight at its natural angle of repose.
- 2.31 The stability of the side slope liner was analysed using the computer programme Slope/W to calculate the factor of safety against failure entirely within the liner for a range circular failure surfaces using Morgenstern and Price's method.
- 2.32 The side slope liner stability analysis will initially investigate the placement of the material below standing water level and then investigate the effect of placing additional material above the standing water level. Effective stress conditions only will be analysed for the below water analysis whilst both total and effective stress conditions will be considered in the above water model.
- 2.33 Results of the side liner analyses are presented in Appendix 2 and summarised below.

- 2.55 Initially the stability of the side slope liner beneath the standing water level was investigated using the software program SlopeW. The results indicate that partial factor combination C2 offers the most onerous conditions and to achieve a factor of safety of 1.00 the face angle of the side slope liner material is 17°. Although a factor of safety of 1.00 is indicative of a material on the point of failure if a slope is allowed to attain its own natural angle of repose by definition this will be at a factor of safety of 1.00.

- 2.56 SlopeW Runs 15 -18 (Table SRA 8) indicate that there is no effect to the liner stability from by the placement of the upper liner material with the factor of safety remaining at 1.00.

- 2.57 SlopeW Run 19 -20 investigate the effect of including a 5.00m bench and set back between the upper and lower side slope liner material. The analyses indicate that using combination 2 factors, a slight increase in factor of safety from 1.00 to 1.05 can be achieved by adopting the benched geometry.
