**RIDING COURT FARM, DATCHET,
BERKSHIRE**

Stability Risk Assessment Report

GEC JOB NO: GE160270908

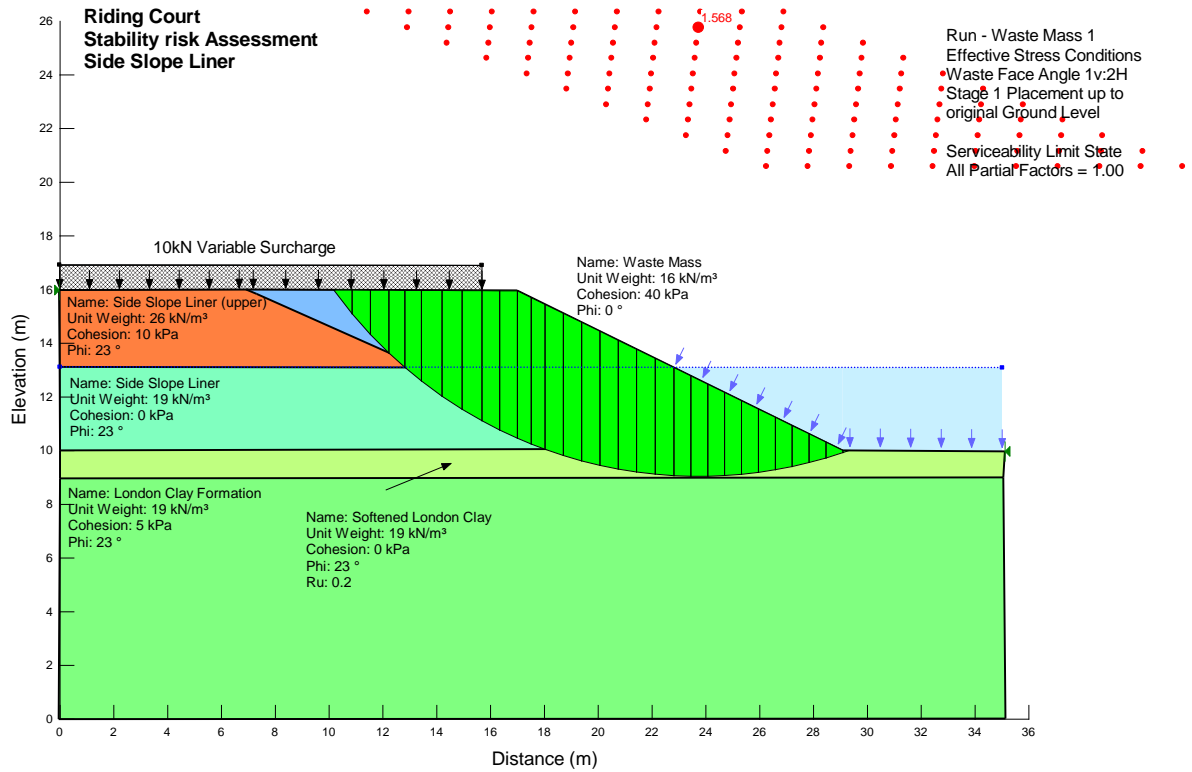
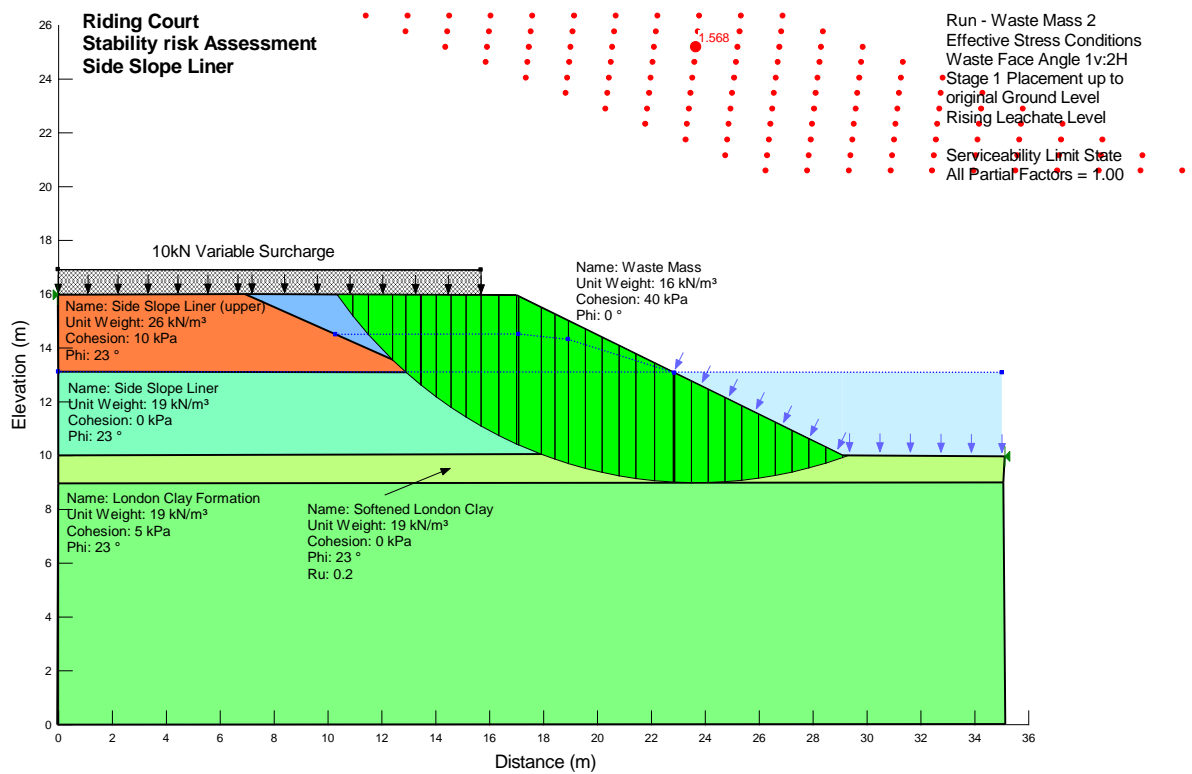
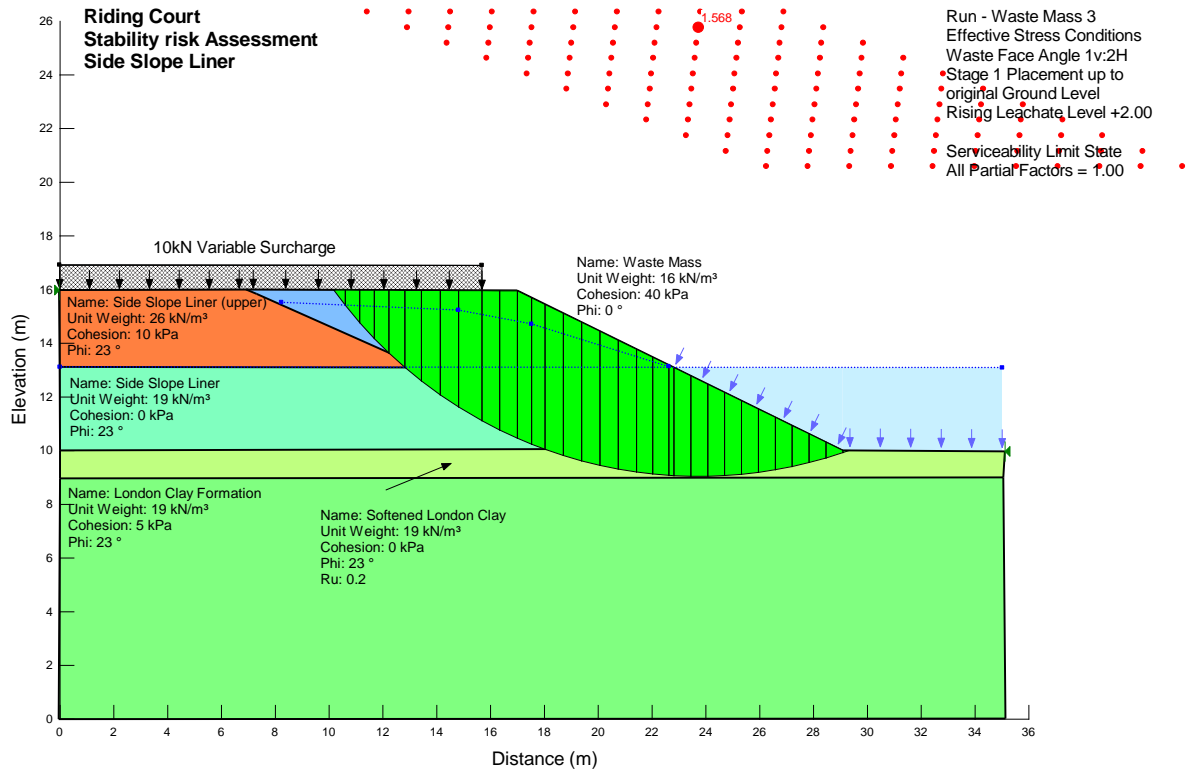
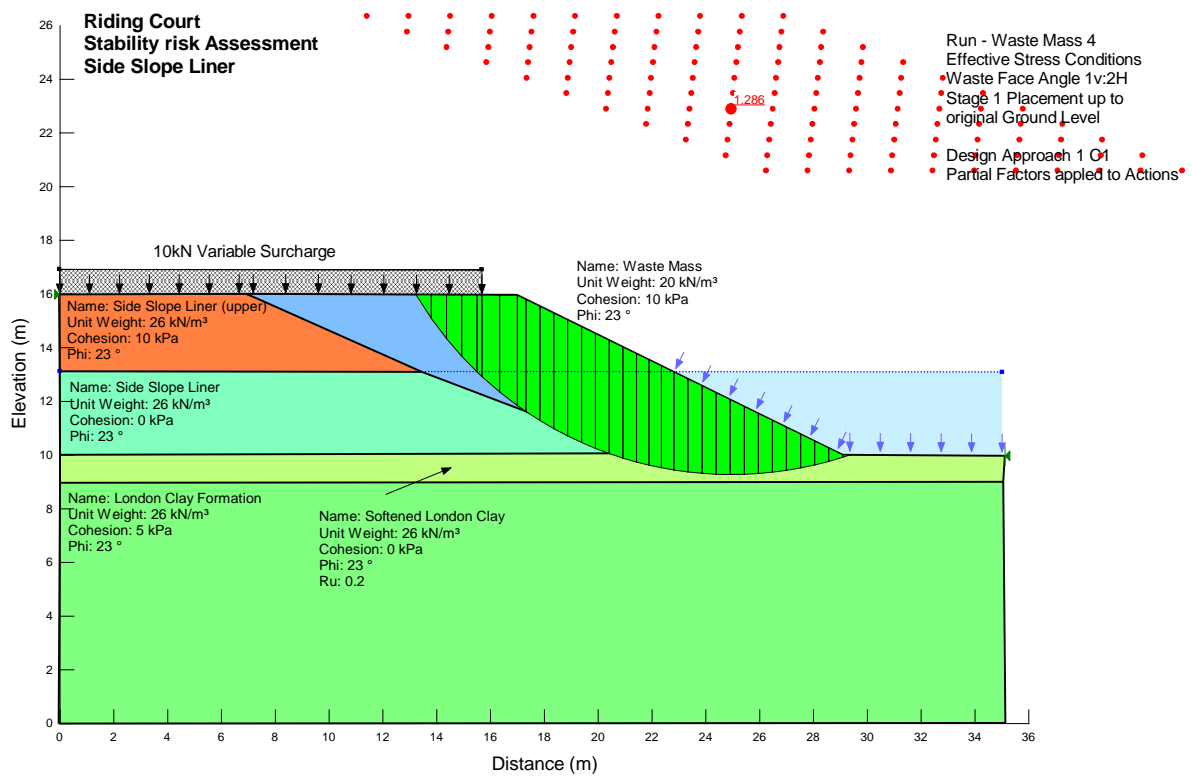
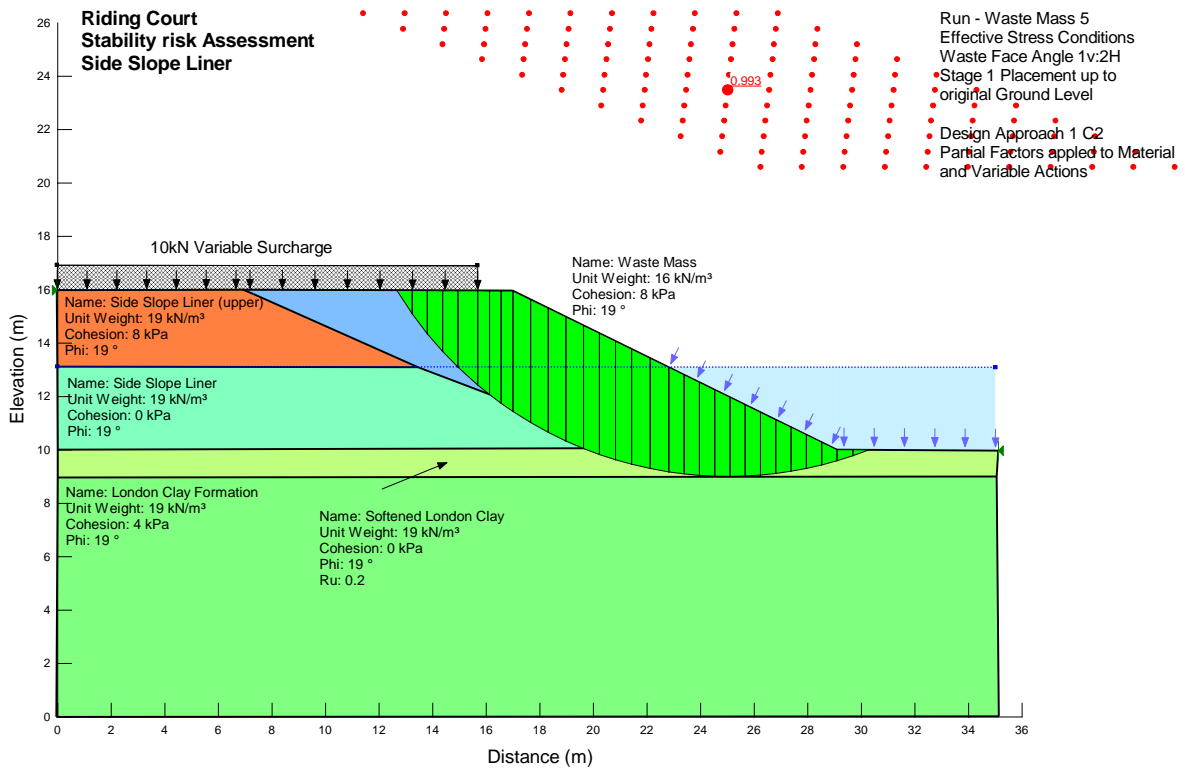
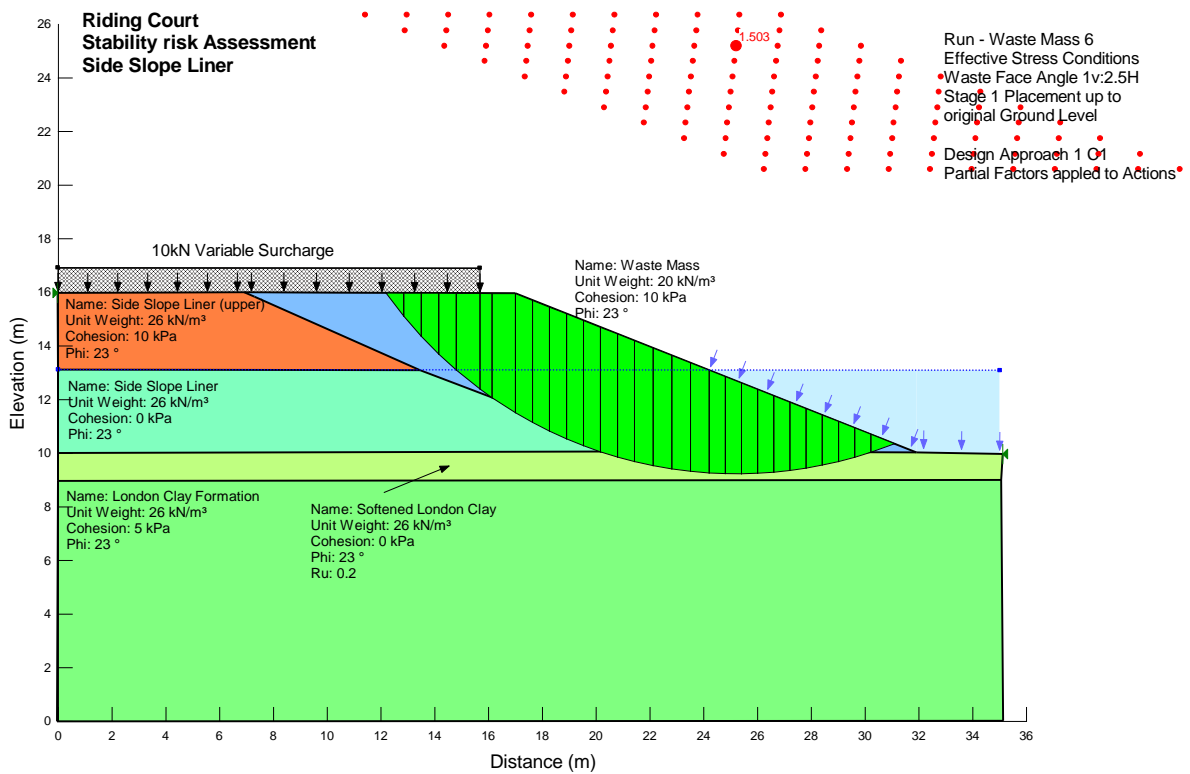
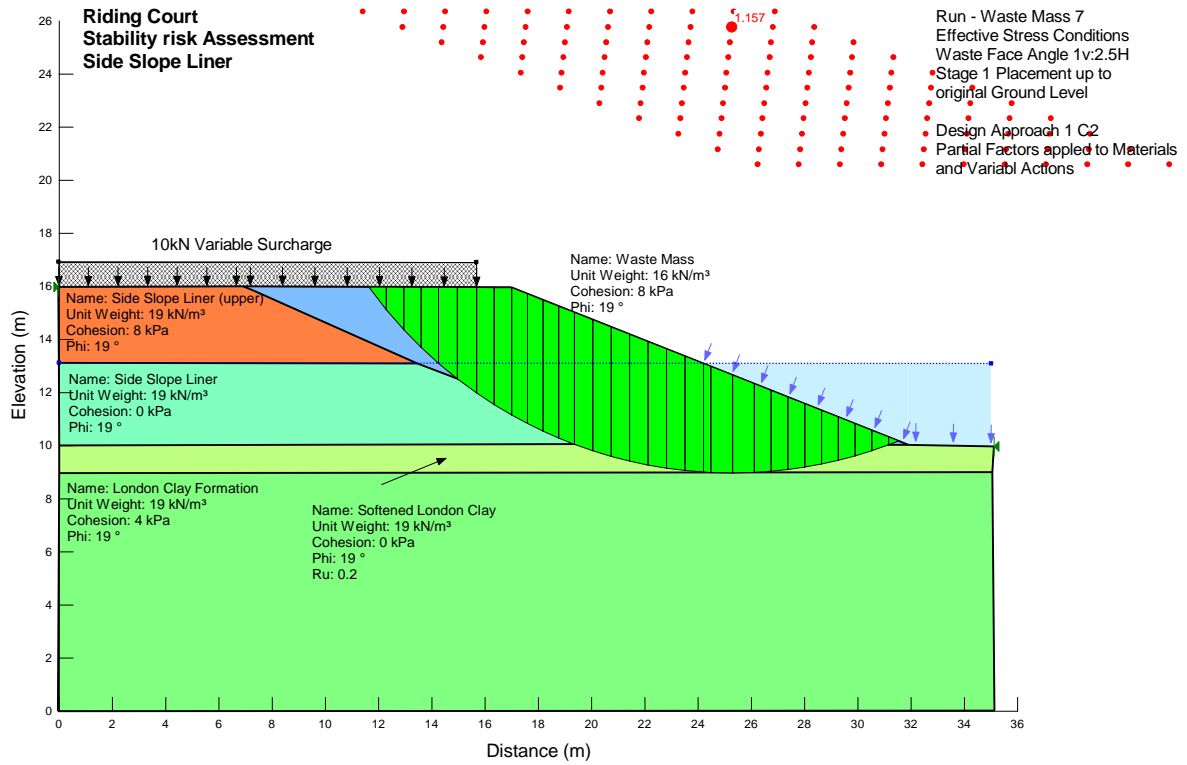
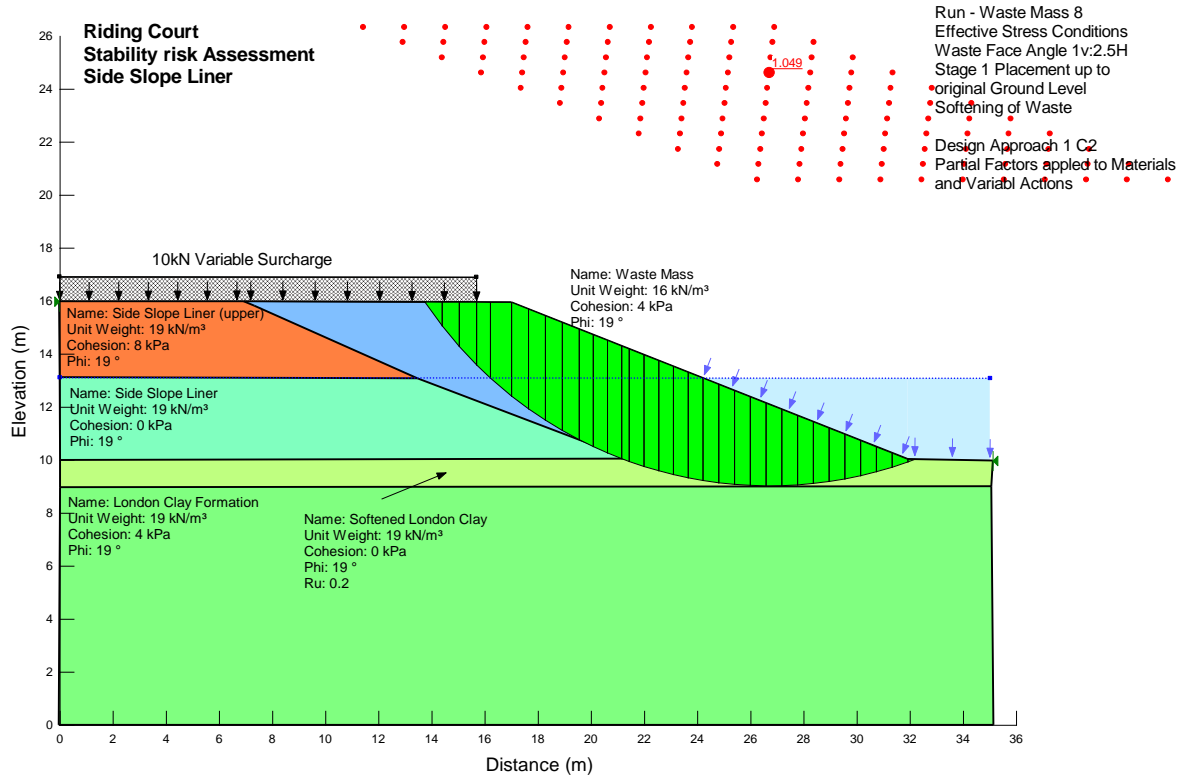
Slope/W Worksheets – Waste Mass

Run	File Name	Stress Condition	Serviceability Limit State	Notes
21	Waste Mass 1	Total / Effective	1.57	Temporary Waste Mass Face at 1(v):2(h) Stage 1 Placement. Waste Mass undrained
22	Waste Mass 2	Total / Effective	1.57	Rising leachate level in Waste Mass + 1.00 above standing water
23	Waste Mass 3	Total / Effective	1.57	Rising leachate level in Waste Mass + 2.00 above standing water

Run	File Name	Stress Condition	Factor of Safety		Notes
			C1	C2	
24	Waste Mass 4	Effective	1.29		Permanent Waste Mass Face at 1(v):2(h) Stage 1 Placement. Waste Slope marginally unstable under C2

25	Waste Mass 5	Effective		0.99	Partial Factors
26	Waste Mass 6	Effective	1.50		Slacken Batter of Waste Face to 1(v):2.5(h)
27	Waste Mass 7	Effective		1.16	
28	Waste Mass 8	Effective		1.05	Long term softening of Waste Mass

- 2.39 Given the composition (inert materials), landfill gas pressures are unlikely to develop within the waste mass.
- 2.40 SlopeW has been used to undertake a serviceability limit state (SLS) investigation into failures wholly within the temporary waste slopes under short term total stress conditions.
- 2.41 The results of the SlopeW stability analyses are presented in Appendix 3 and in Table SRA 9.

- 2.43 Temporary waste slopes left for long periods should be considered as permanent and to represent these conditions an effective stress stability analysis has been carried out. Initially the waste mass has been modelled using the long term drained conditions and then the effect of softening has been considered.
- 2.44 The results of the Permanent Waste Mass Slope analyses are presented in Appendix 3 and a précis of the results is shown in Table SRA 10.

- 2.65 The long term softening of the waste mass as a result of exposure to water infiltration or inclusion during placement has been modelled by reducing the effective cohesion to 4kN/m². SlopeW Run 28 indicates that the waste mass remains stable with a factor of safety of 1.05 even after considerable softening of the waste mass has taken place.
