Phase I

Preliminary Risk Assessment For former British Airways and Vodafone Plots

Former British Airways and Vodafone Plots, North Hyde Gardens, Hayes, UB3 4QQ

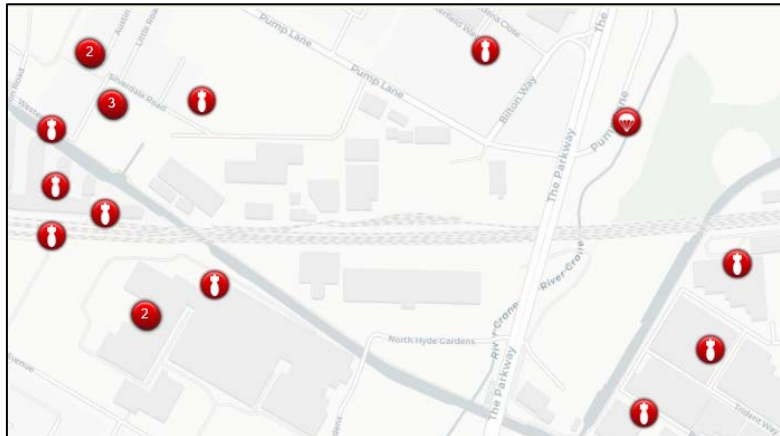
Online information indicates that there were several bomb strikes recorded around the site during World War II.

Accessed: <http://bombsight.org/#16/51.5028/-0.4112>

2.	<p>Online information indicates that there were several bomb strikes around the site area and so a survey for Unexploded Ordnance should be completed.</p>

A UXO Desk Study should be completed and an on-site presence by a UXO specialist may be required to check each borehole as it is advanced.
