SUPPORTING INFORMATION SECTION 2

SITE CONDITION REPORT

1.1. Name of applicant; I'Anson Bros Ltd

1.2. Activity address;
Waterloo House
Wellington Way
Dalton Airfield Industrial Estate
Dalton
Thirsk
North Yorkshire
YO7 3SS

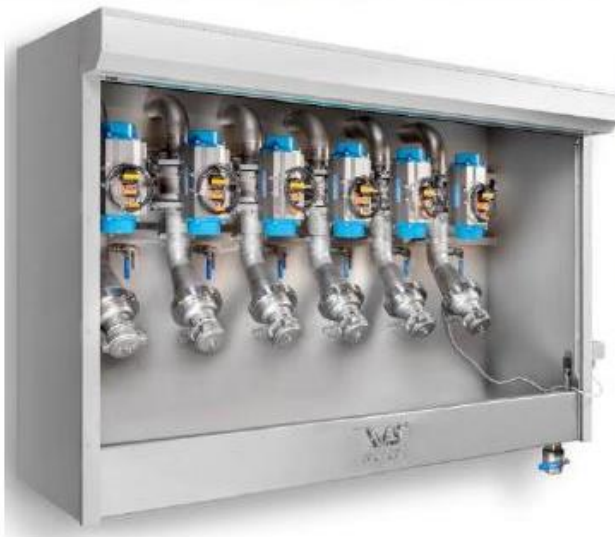
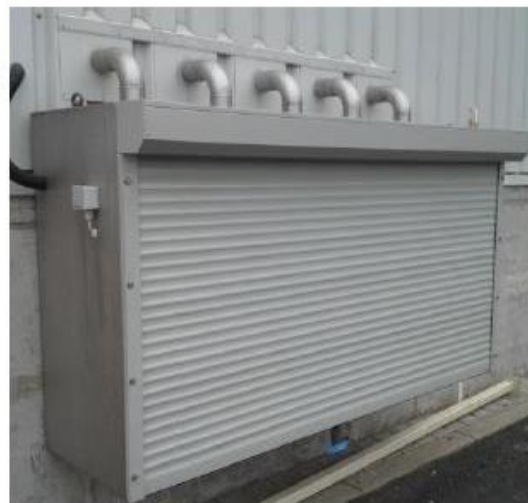
The principle liquids (molasses x 2, ruminant fat, monogastric fat & soya oil) are to be stored in purpose designed tanks (5 x 60,000 litre tanks) within a common bund which is to be constructed inside the mill building. The fill points are located outside of the bund on the outside wall in an enclosed intake cabinet (example below).

The bund will be constructed in a compliant manner and shall have a capacity of 99.13m³ (6.435 x 11.850 x 1.300), well in excess of the largest tank (60m³). The minor liquids will be stored in fixed specialist integrated tanks within the mill building, these are complete with liquid delivery pipework direct to the incorporation point. An alternative arrangement for the most modest inclusion levels is bunded liquid IBCs, these can be positioned as required for products manufactured occasionally or seasonally.
