Site	Escrick Waste Treatment Facility		Permit Ref	104658		
Operator/ Permit holder	ACUMEN WASTE SERVICES LIMITED					
Date	13/07/2023		Time in	11:00	Out	15:00
What parts of the permit were assessed	Amenity, Management & Emissions					
Assessment	Site Inspection	EPR Activity:	Installation	Waste Op	X	Water Discharge
Recipient's name/position	TCM					
Officer's name	[REDACTED]		Date issued	26/07/2023

This Compliance Assessment Report has been produced following an odour assessment and site visit at Acumen Waste Services Limited on 13th July 2023. This CAR should be read in conjunction with CAR Form 104658/0465164 issued on 16th June 2023. The compliance assessments set out in that CAR Form and the compliance assessments set out below are both linked to the storage of a large pile(s) of mixed waste fines that contain significant quantities of biodegradable material.

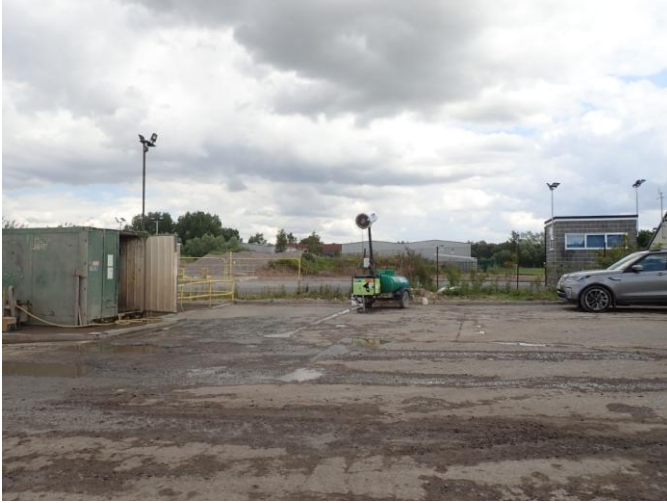
Fig. 1

During the inspection we observed three odour suppression units in operation on site. The smaller odour cannon was located along the eastern boundary of the site and was not in operation when we first observed it (Fig.1). However, the cannon was seen to be in operation shortly after. Both multiple nozzle odour suppression systems were in operation, one located near the eastern boundary (Fig.2) and one located to the south near the lagoon (Fig.3). The odour suppression systems had a masking fragrance that could be described as cotton fresh. This masking agent was not detected at any point during the offsite odour monitoring. Although they may have some localised impact on site in respect of odour, they were not an effective measure for mitigating offsite odour pollution.

- Explore the use of further appropriate measures to minimise the impact of odour from waste stored onsite.
- Put measures in place to contain and prevent leachate run off.
- Provide the OMP within the previously agreed deadline.

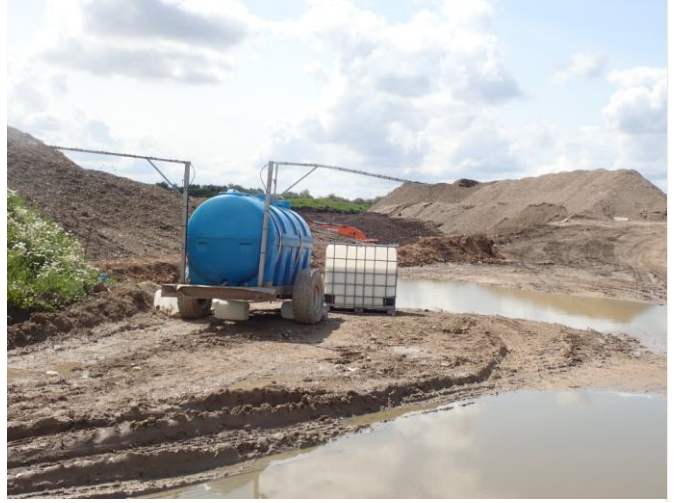
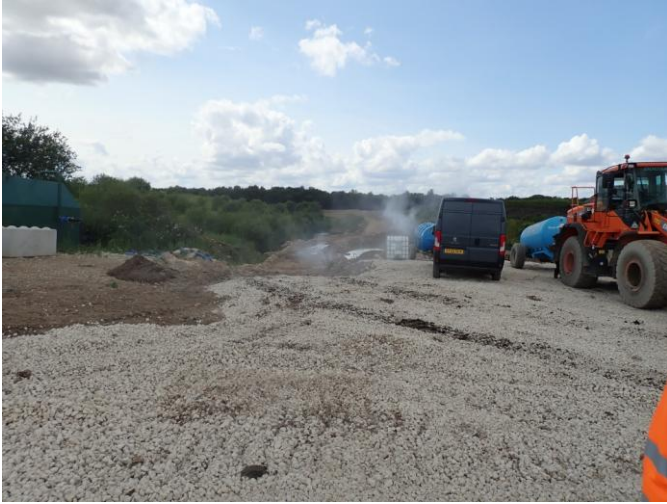
Fig. 2

Large quantities of biodegradable waste fines remain in situ which are evidently still producing odorous gas akin to landfill gas as a degradation product. Officers detected a very strong offensive odour while inspecting the waste. The operator has stopped further movements of waste fines from the main pile to the new pile located on the concrete pad. This is to prevent the double handling of the waste as the intent is to now remove the waste from site. We did not witness any further deposits of waste fines which confirms the operator's commitment to cease accepting this waste stream during the period of non-compliance.

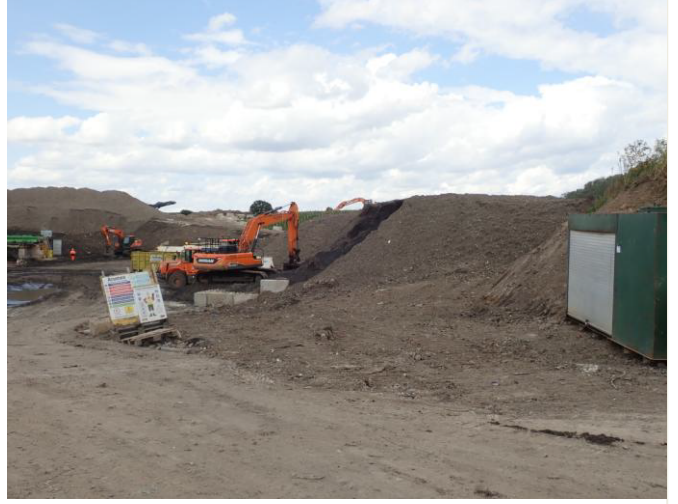
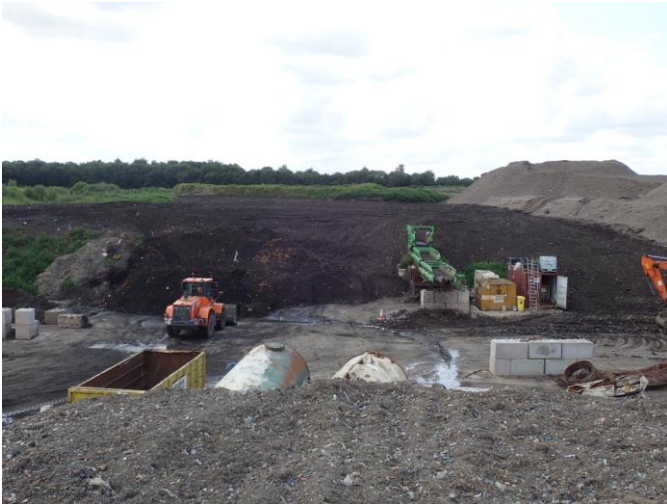
Fig. 4

The larger fraction 'trash' mixed waste identified in Fig.2 and Fig.4 on CAR form 104658/0465164 has been removed from site (Fig.4-5). The site continues to receive and process road sweeper waste with the non-compliance related to storage to be addressed in the revised compliance action plan.

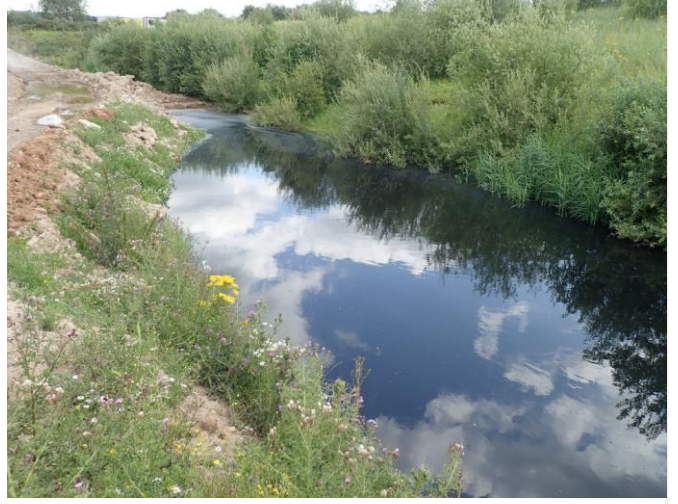
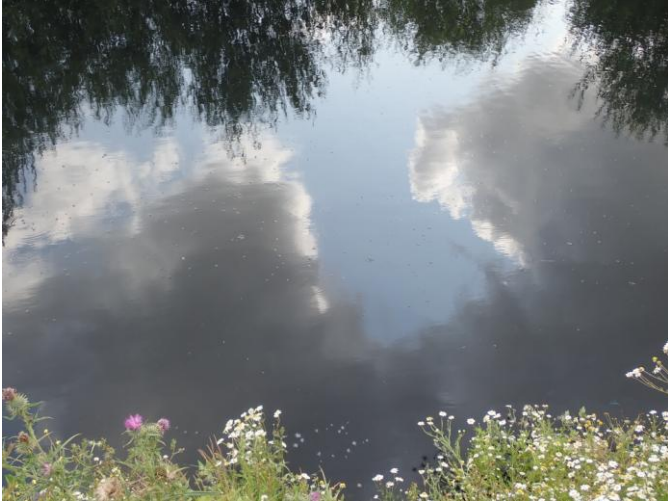
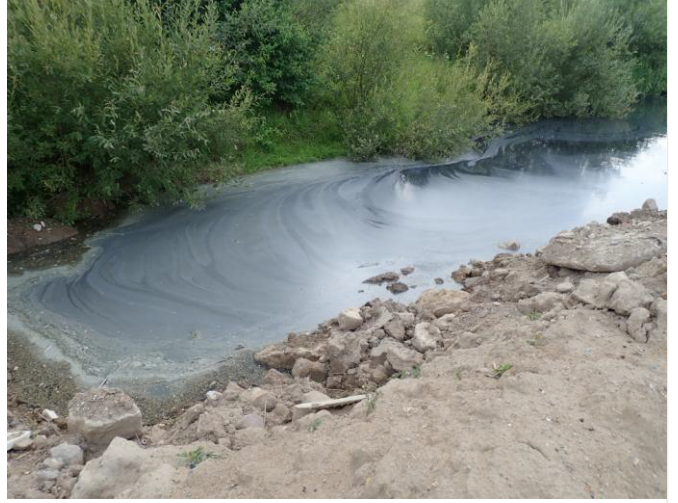
Fig. 6

During the walkover officers observed the lagoon situated along the southern boundary of the site running parallel to the closed Biffa landfill site (Fig.6-8). The lagoon contained dark coloured water that was emitting a strong waste like odour. The discolouration of the water and associated odour suggested that it has been heavily contaminated with leachate from the waste fines stored on the Acumen site. There is no clear boundary marker between the site and the adjacent closed landfill. When a comparison is made to the site plan on the permit it appears that the lagoon may be wholly or partly within the Acumen permit boundary, further investigation is required to establish the boundary. Due to the leachate contamination the surface water must be removed for treatment offsite. Before the water is removed you must carry out a full WM3 assessment to correctly classify the waste and establish if it has any properties. If the lagoon is located outside of the Acumen permit boundary then you must engage with the operator of the closed landfill to arrange for its disposal. Measures should be put in place to prevent further polluting runoff contaminating the lagoon and to control leachate run off from the waste piles on site.

- Identify the permit boundary for the site and establish if the southern lagoon is situated within the permitted area. _
- Carry out a full WM3 assessment of the contaminated water within the lagoon and remove offsite for treatment.
- Liaise with the operator of the adjacent permitted closed landfill if the lagoon is within

their boundary and notify them of the contamination.
